CZ-15-626

FINAL REPORT

**Investigation of causes of a serious incident
of ATR 72-500 aircraft,
Registration mark OK-GFS,
PRAGUE / Ruzyně Airport,
On 17 September 2015.**

Prague
November 2017

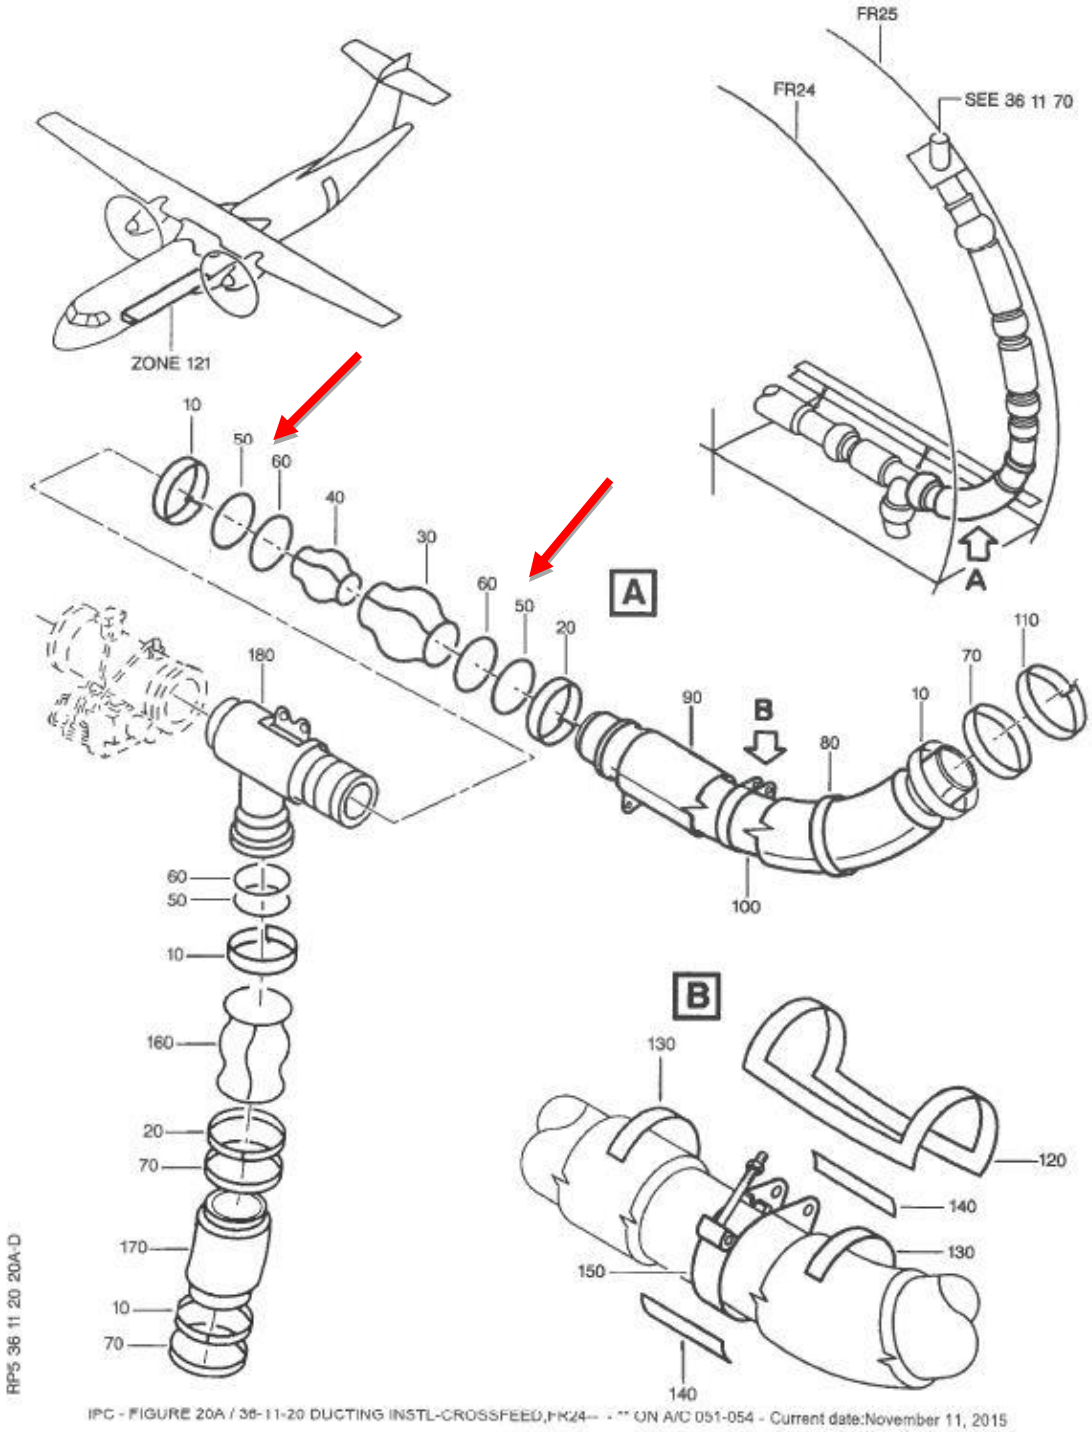
When performing the steps in accordance with WO 7081248, leakages were detected in the sealing gaskets of the compensator of the pneumatic pipeline on the left side under the passenger cabin floor. There were four gaskets found in the compensator which were out of good working order (see positions 50 and 60 in the figure below). The air leakage from this area into the space under the passenger cabin floor was determined as the primary origin of the smoke emergence in the cabin where the smoke was generated due to the hot air leaking from the pipeline (the air temperature up to 200 °C) and affecting the dust present in the given area. This air drawn in by the left recirculation fan placed also in the same area was subsequently distributed into the passenger cabin.

Fig. 1 Damaged gaskets of the compensator

The occurrence of smoke in the passenger cabin was caused by the hot air leakage (air temperature up to 200 °C) due to the faulty leak tightness of the pneumatic system compensator. The faulty tightness properties were caused by the damage of the rubber-textile gasket rings in the compensator in the left-hand branch of the pneumatic

To perform inspection and replacement of the gaskets in the compensators of the pneumatic pipelines in the area under the passenger cabin floor in this type of aircraft at the next closest suitable ground time.

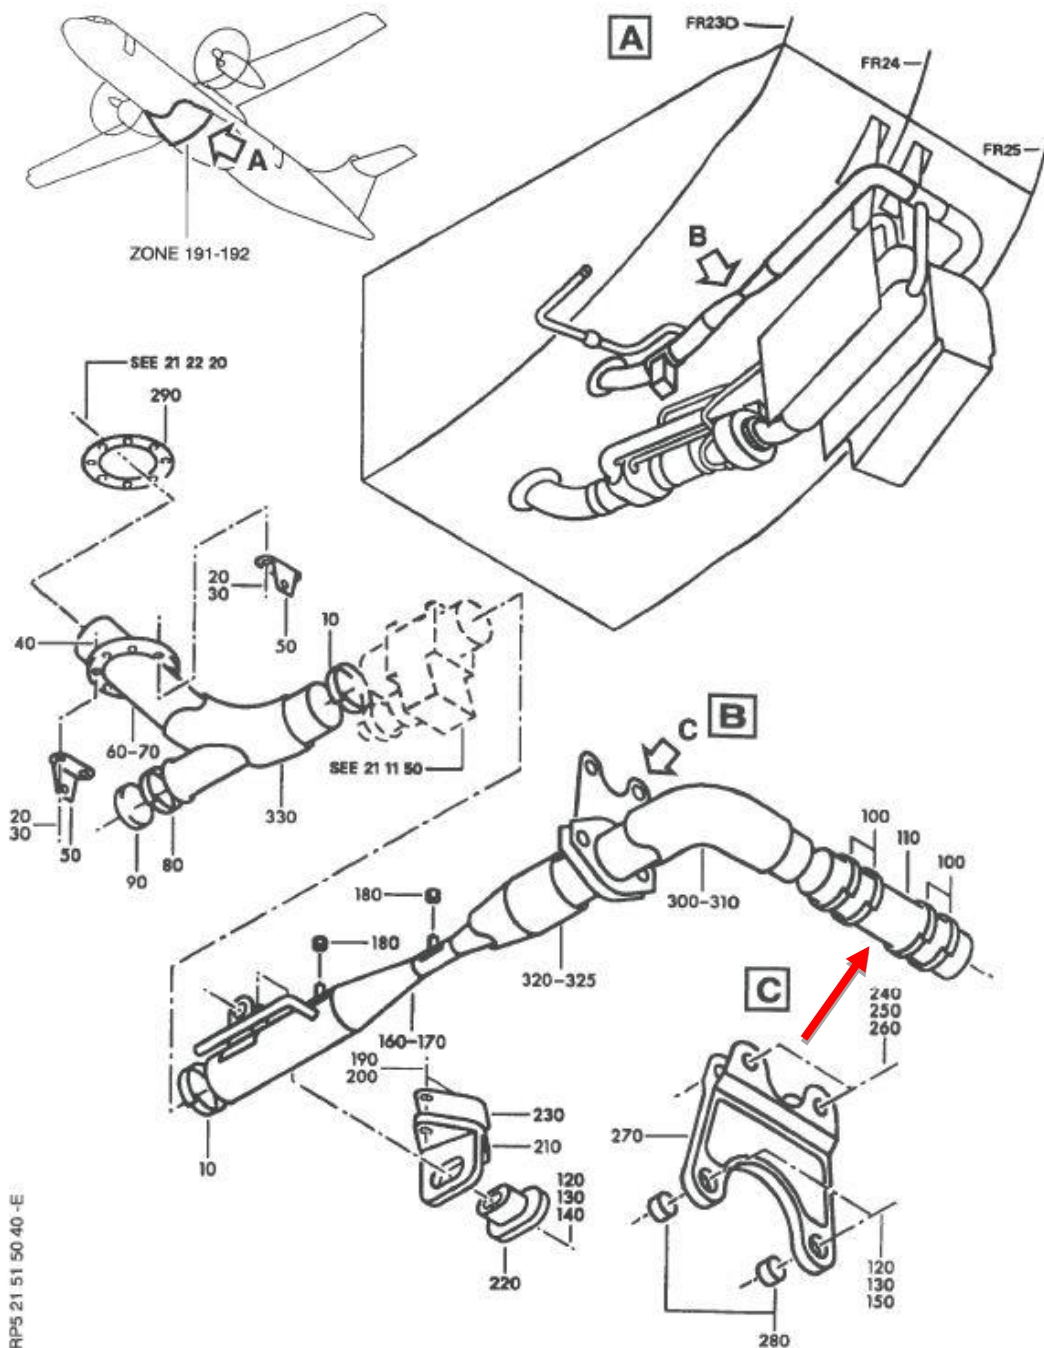
IPC - FIGURE 40 / 21-51-50 DUCTING INSTL-AIR COOLING,Z19-- ** ON A/C 051-054 - Current date:November 11, 2015

During performance of the steps in accordance with WO 7081248, damage to the rubber-textile compensation bellows in the left a/c pack (see position 110 in the figure below) was further detected.

As a result of the air leakage from this bellows the controls regulating the temperature in the relevant air-conditioned zone were not functioning properly. The air leakage from the damaged bellows was determined as the primary cause of the rising temperature indication in the air-conditioning pipeline.

Fig. 2 Damaged rubber-textile compensation bellows

The rise of the air temperature was caused by the hot air leakage from the damaged rubber-textile compensation bellows connecting the heat exchanger of the air-conditioning system with the air-conditioning pipeline which led to incorrect regulation of the temperature in the system and to rising of temperature in the air-conditioning system pipeline and to “TEMP SEL OVHT CABIN” signal.
