CZ-20-0419

# FINAL REPORT

**Investigation of causes of an accident  
of the BB42Z hot-air balloon  
registration mark OE-RAP  
in the field near the village of Ostřetice (north-eastern part of ATZ LKKT)  
on 27 July 2020**

Prague  
November 2021

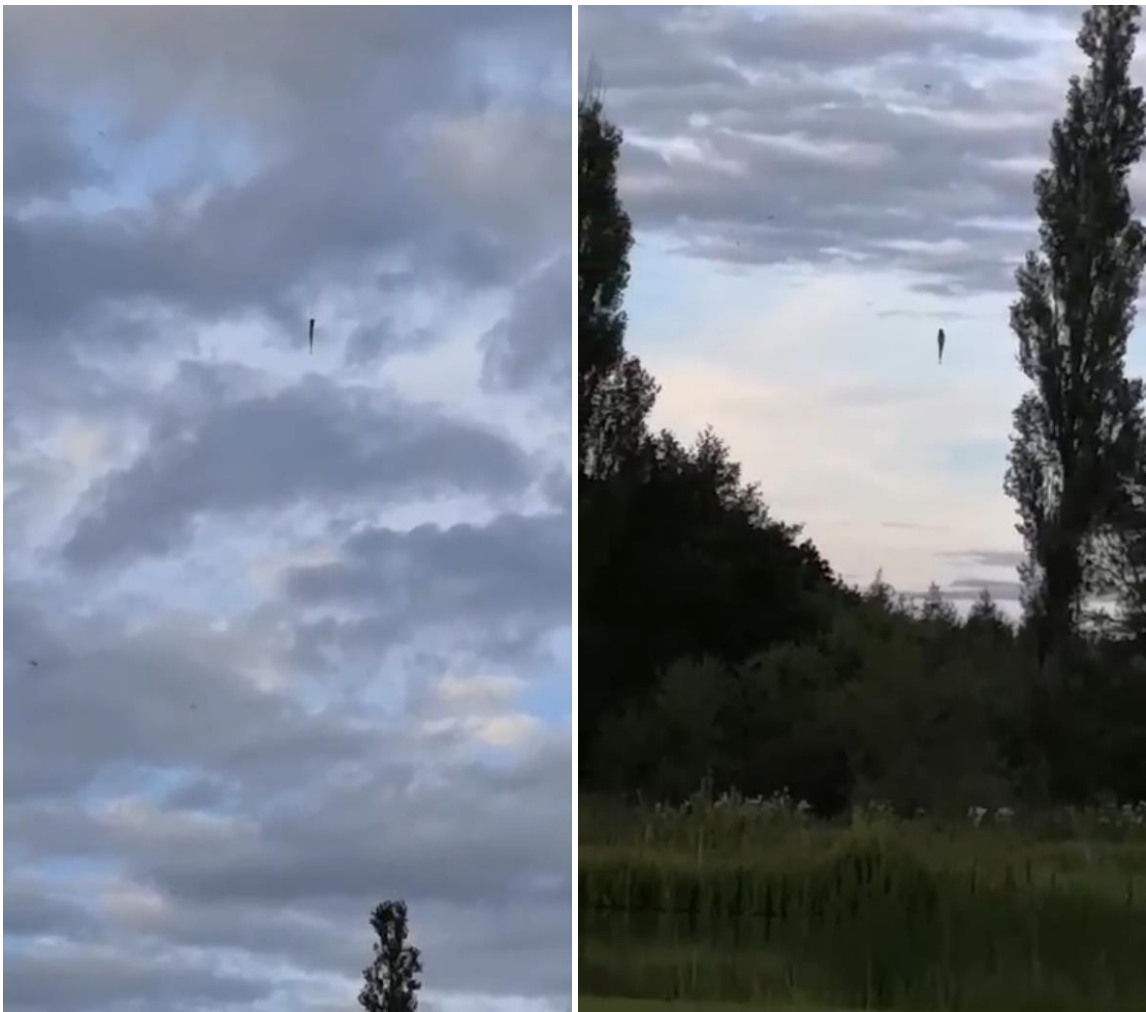
Fig. 1 – Condition of the envelope at the beginning and at the end of a videofootage lasting 36 seconds, taken by an accidental observer.

Witness No. 3 was observing the flight of the balloon from his place of residence in Mlýnské Struhadlo and, among other things, said in his testimony: *“I noticed a balloon flying towards us from Klatovy, and it was not low. I watched it fly. It was flying smoothly as no wind was blowing here at that time. All of a sudden, from my perspective, the balloon tilted to the left, remained tilted for a few seconds, and then returned to the original state. However, its shape*

*was not round any more, it was deformed like a bitten apple. Immediately, the balloon deflated to the shape of a cigar and was slowly falling to the ground. I took my binoculars and continued to watch it. The balloon was falling smoothly, was not swagging, and after a while, it disappeared behind the horizon.”*

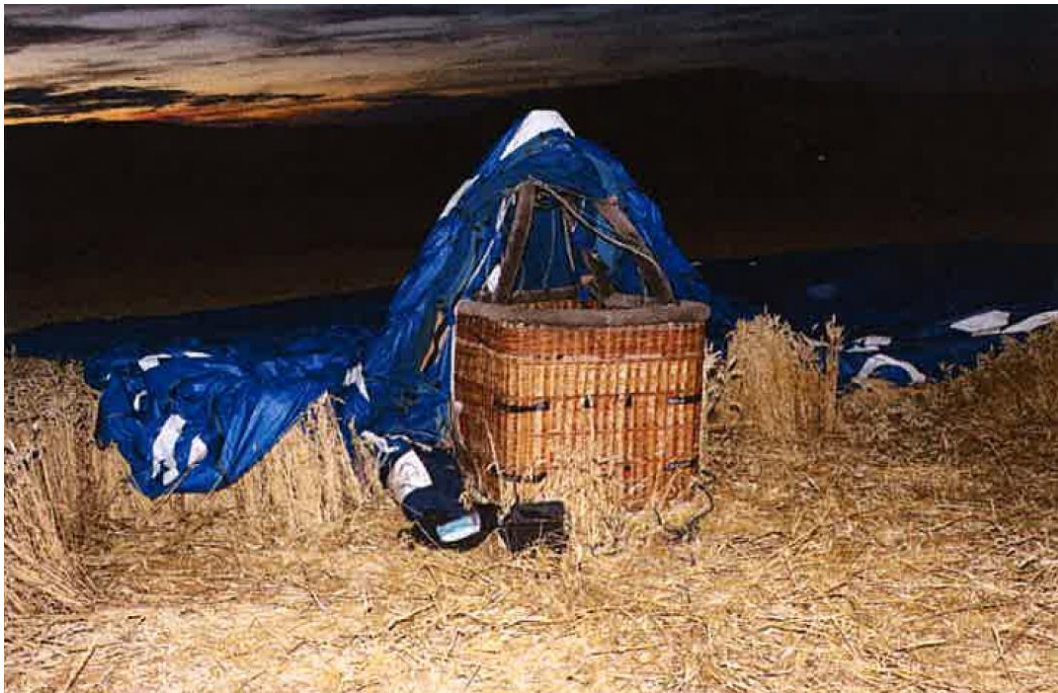
Fig. 4 – Balloon at the place of the accident

The balloon was inspected at the accident site by a patrol of the Police of the Czech Republic. At the accident site, the basket of the balloon was found standing upright in a wheat field at the impact site, with no signs of damage. A portable radio transceiver, turned off at this time, and the pilot's black backpack were located near the basket. The fuel bottles attached to the basket on the inside were undamaged and their taps were closed. The metal structure above the basket holding the burners was partially damaged. The burners and half of the structure with the basket were covered by the balloon envelope which was spread in the direction from the nearby road down a gentle slope towards the village of Měcholupy. Upon superficial inspection of the balloon envelope no damage was found. When the envelope material was removed from the burners, they were inspected, and no damage was found on them. During the packing of the envelope, the parachute valve with the flap at the top of the balloon were inspected and the cords were found tangled. The balloon envelope was placed in the balloon basket and, together with the pilot's backpack and radio, was transported to Klatovy Airport to the hangar of Aircraft Service spol. s r.o.

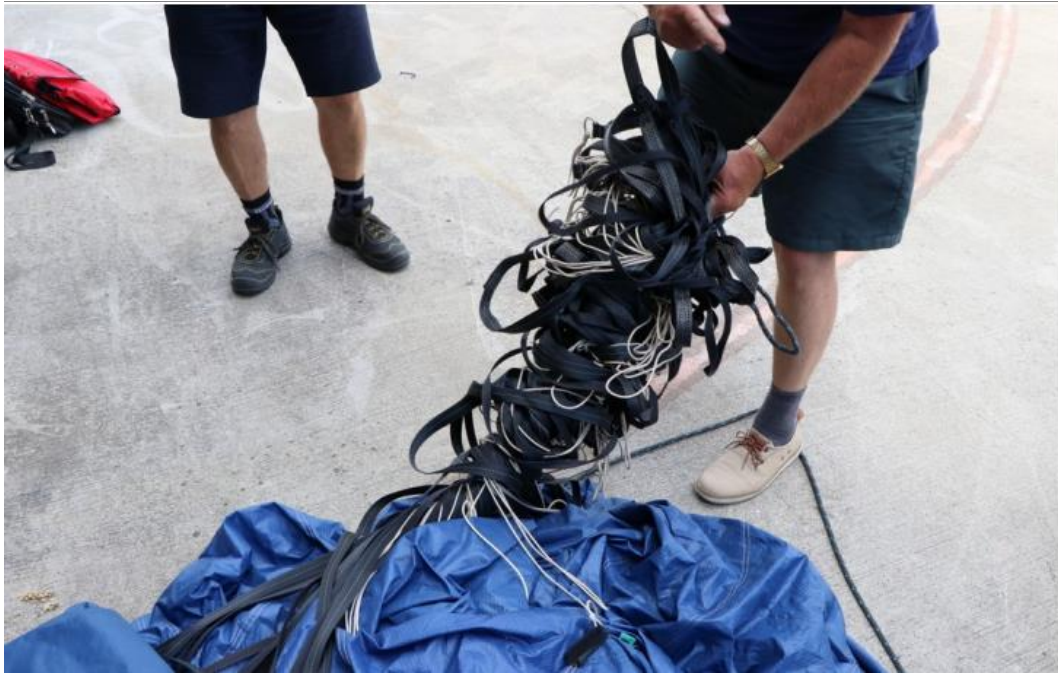
A total of 5 panels near the parachute valve were damaged, 2 of which sustained extensive and serious damage. There were 7 burnt panels near the mouth. The red-and-white parachute valve control line had spontaneously released and was pulled high into the mouth of the envelope, where the anchor mechanism of the line lug became jammed in the pulley mechanism. This control line became entangled in the centring lines at the parachute valve anchorage area. The inner frame rigging of the burner was significantly deformed in the downward direction at the burner attachment point. All of the hitching fixtures on the sides

of the basket were damaged and items stored inside were thrown onto the basket floor. The wooden flooring was cracked in two places in the middle and also in the area under the fuel bottles.

Fig. 5 – The control lines, straps, and centring lines condition during the inspection of the hot-air balloon

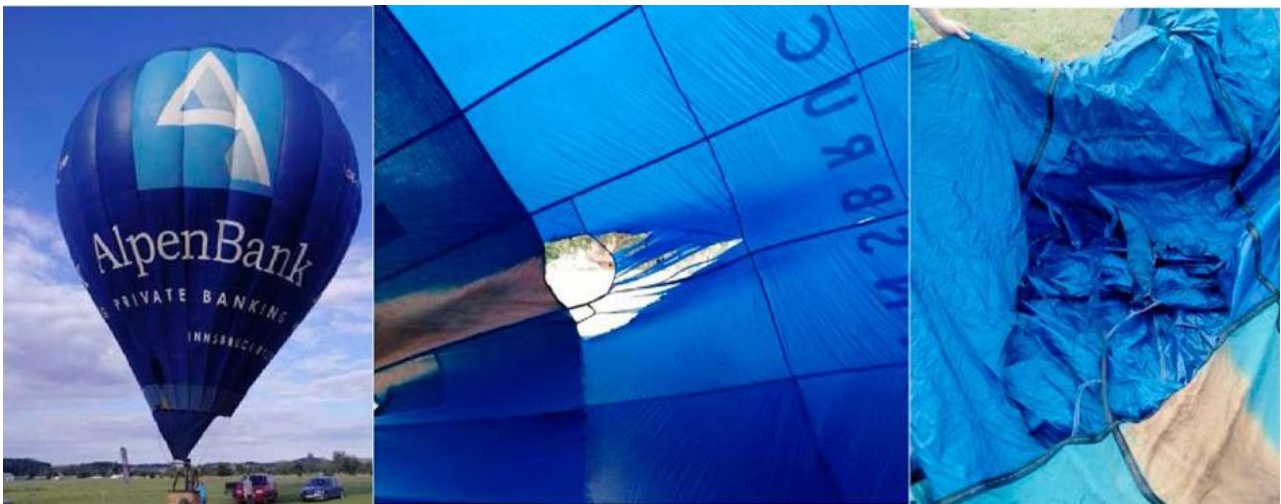
The fabric around the envelope mouth on vertical tapes Nos 14 and 15 was damaged by fire (nomex panel twice, PES panels/1 and 2 four times). A major damage to the fabric was located in the area of the centring cord loop sewing on 3 panels and in the area of the top license plate location on 1 panel. Several smaller holes were at a similar height of the envelope. One of the holes demonstrated temperature affected edges. The flap seal fabric was damaged in several places around the edge of the parachute valve. In one location, the auxiliary flap strap was torn out.

Fig. 6 – Detail of the fabric damage

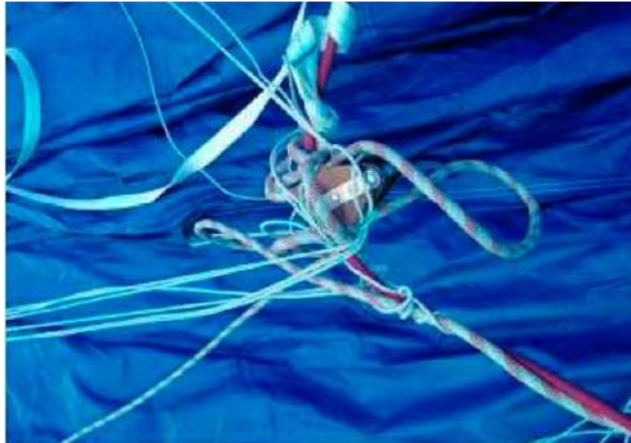
The control cables, cords, straps, and pulley mechanism were tangled together. After untangling, all cords were undamaged, as were the pulleys and straps. The red control line remained undamaged throughout its full length. The end of the red-and-white rope was free of the rope clamp forming the lug. The cable clamp was pushed up higher on the cable and minor damage was found on the cable (core partially pulled out of the braid).

Fig. 7 – Entangled control cables and lines.

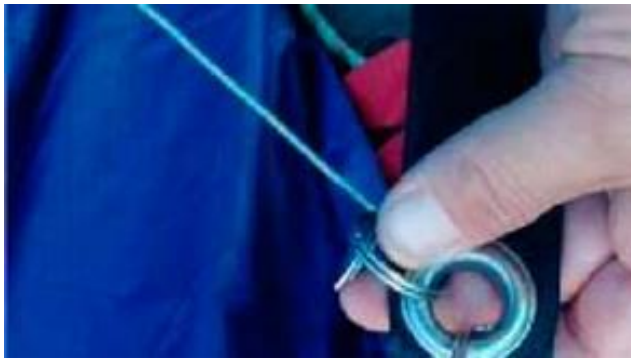
The thermal fuse was left hanging in the envelope. The envelope was not overheated.

Fig. 8 – Thermal fuse.

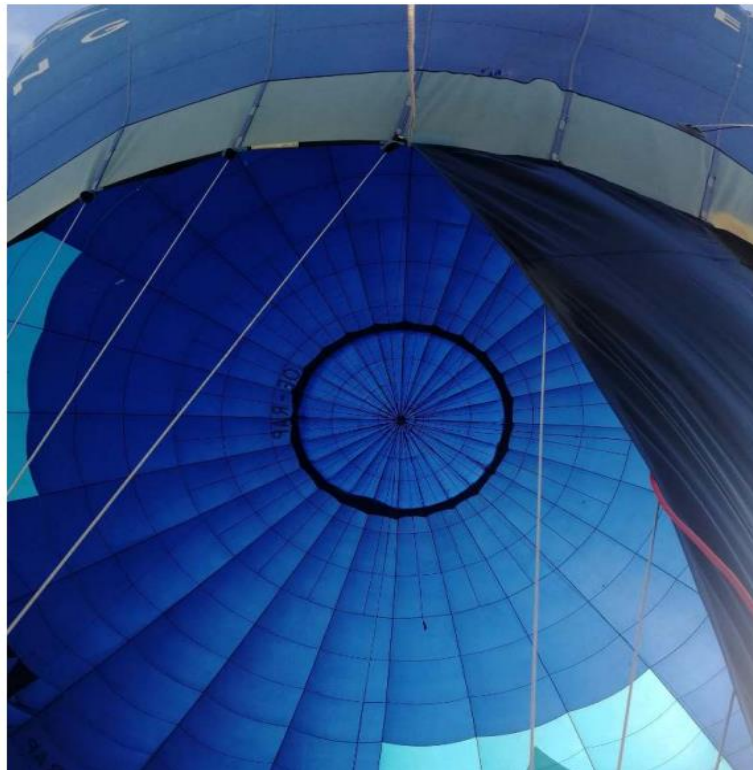
The functionality of the deflating system was tested after the air in the envelope was heated with the burner. The deflation system worked properly in all modes. Only a minor leak in the valve was observed, caused by damage to the fabric and the sealing valve strap.

The automatic return of the valve (also referred to as the valve panel/parachute valve/Smart Vent) was tested when the envelope was placed on the ground under low envelope pressure. The valve was repeatedly fully opened with a red-and-white cable and the automatic return to the opening was monitored. The valve returned back even upon the fifth opening. Only upon the sixth opening the valve panel did not return, when the envelope was almost pulled down to the ground. The correct functioning of the valve was verified even under low pressure in the envelope.

Fig. 9 – View of the deflation mechanism assembly inside the envelope
