Investigation Report

Type of Occurrence:	Accident
Date:	14 September 2009
Location:	Near Jena-Schöngleina Airfield
Aircraft:	Airplane
Manufacturer / Model:	G. J. Vicherek, Czech Republic / Europa XS
Injuries to Persons:	Two persons fatally injured
Damage:	Aircraft destroyed
Other Damage:	Minor damage to forest
Information Source:	Investigation by BFU external experts for field investigation
State File Number:	BFU CX014-09

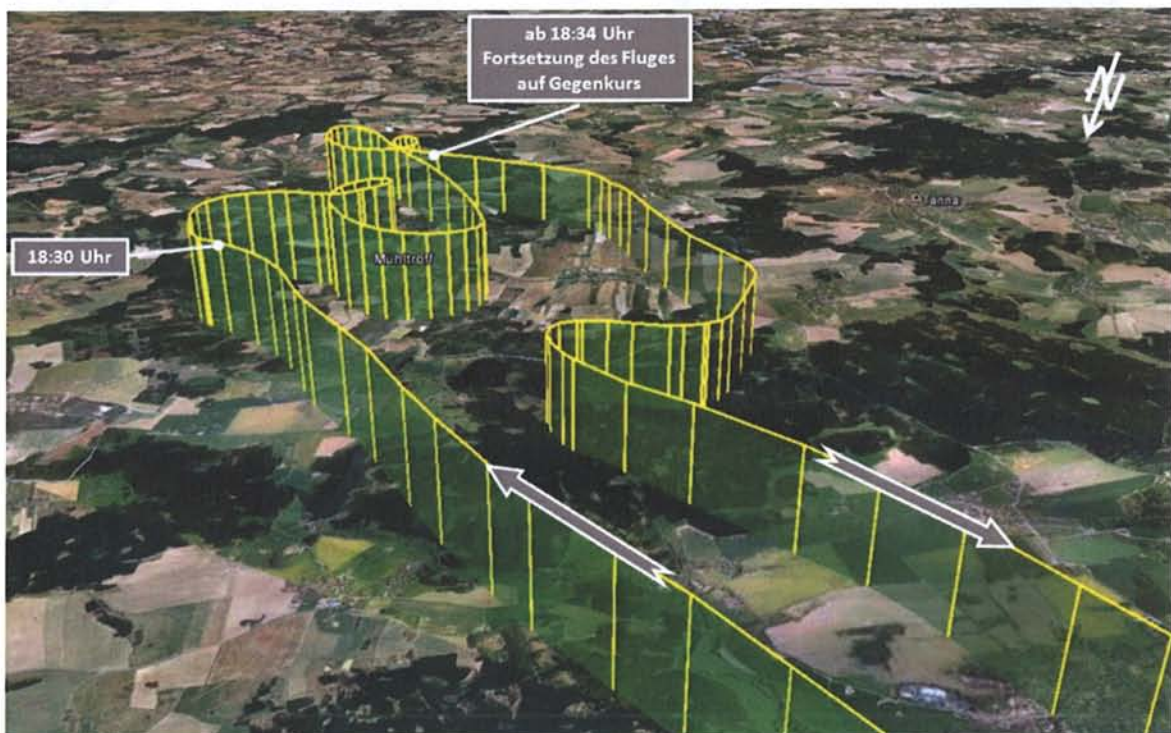
Flight path between 1824 hrs and 1843 hrs

According to the GPS recording, until 1830 hrs the airplane flew with almost constant south-east heading and constant altitude toward the destination airport.

After several changes in heading, at 18:34 hrs it was on opposite course, i.e. on a north-west track.

Until 1830 hrs, the airplane's south-east track and flight altitude remained almost constant. At that time the distance to the destination was still about 115 NM. The subsequent heading change and the decision made at 1834 hrs show that the pilot estimated that the visual meteorological conditions might not be sufficient to continue the flight.

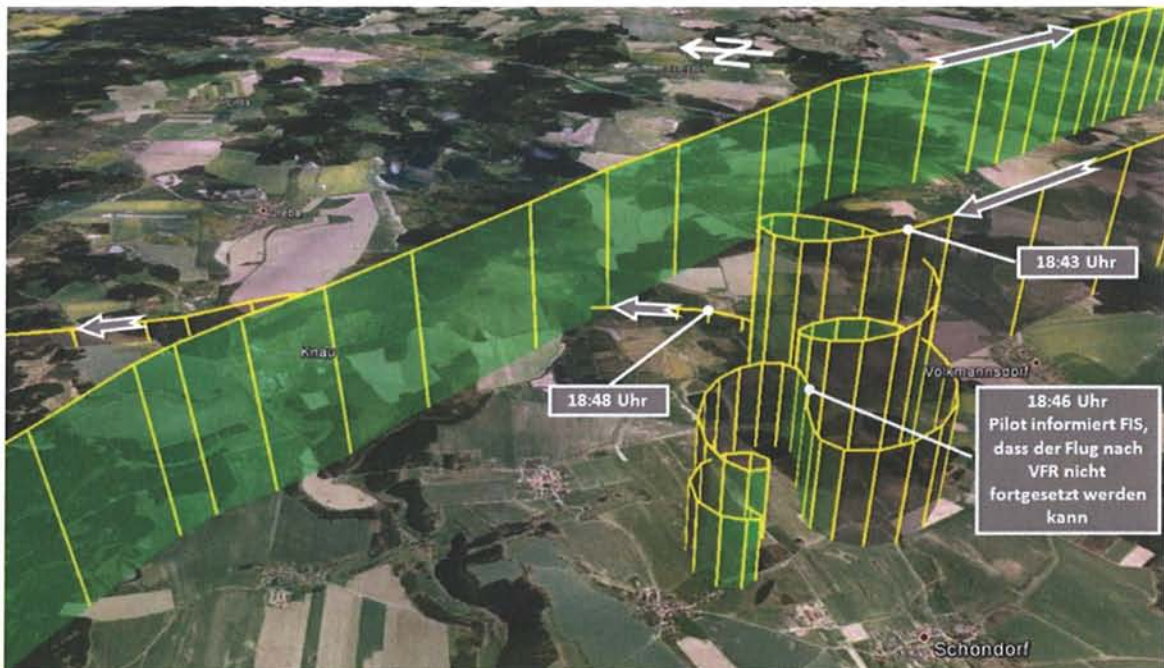
Flight path between 1843 hrs and 1851 hrs

At 18:43 hrs the airplane left the cruising altitude, according to the radar recording it was at about 3,600 ft AMSL, and continued the flight in approximately 1,600 ft AMSL on a north-west track.

At 1846 hrs the pilot informed FIS that he could not continue the VFR flight: "[...] I don't think we can continue further VFR so we'll try go back and take a landing at an airport nearby, can you give us the current weather at Hof please."

The subsequent descent to approximately 1,600 ft AMSL and the information to FIS at 1846 hrs that the VFR flight could no longer be maintained show that the weather conditions in the area had worsened rapidly. It is to be assumed that due to weather conditions the return flight to Erfurt Airport, 36 NM away, was impossible as well.

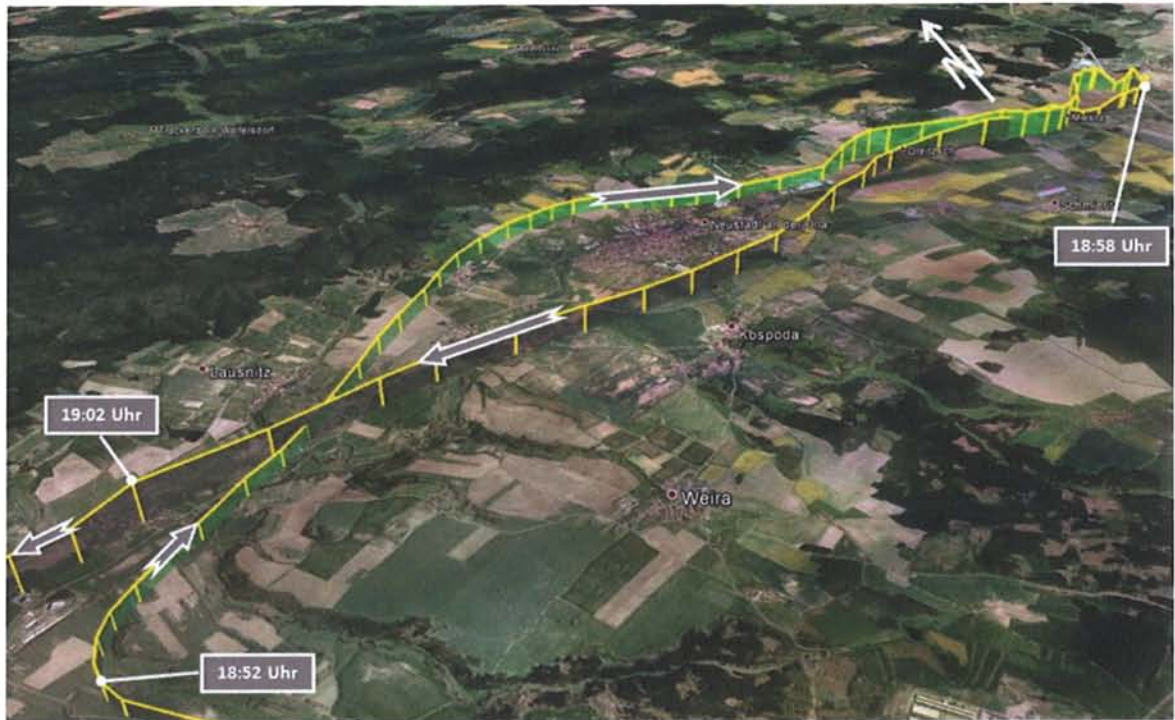
Flight path between 1852 hrs and 1902 hrs

At 1852 hrs the airplane was on an eastern track and had entered a wide valley located between the towns Neustadt an der Orla and Triptis. At 1858 hrs shortly before reaching Triptis it changed course again to a western track. The flight altitude recorded by radar was between 1,600 ft AMSL and 1,500 ft AMSL.

After 1852 hrs, the pilot flew east between 1,500 ft AMSL and 1,600 ft AMSL from Neustadt an der Orla to Triptis in a valley which toward the east rises slightly (terrain height about 900 ft rising to 1,200 ft). Shortly before he reached Triptis, he turned back to a western heading and flew back through the valley. It is likely that the poor visual meteorological conditions towards the east were the motivation for the pilot's decision.

Due to the weather conditions two attempts to fly south-east or east failed; return to Erfurt Airport in the north-east was probably impossible or not an option and flying south to Hof Airport was also impossible. At this point the pilot had all knowledge about the weather conditions and a suitable assessment of the situation would have been possible. The terrain surrounding Neustadt an der Orla and Triptis was suitable for a precautionary landing with this type of airplane.

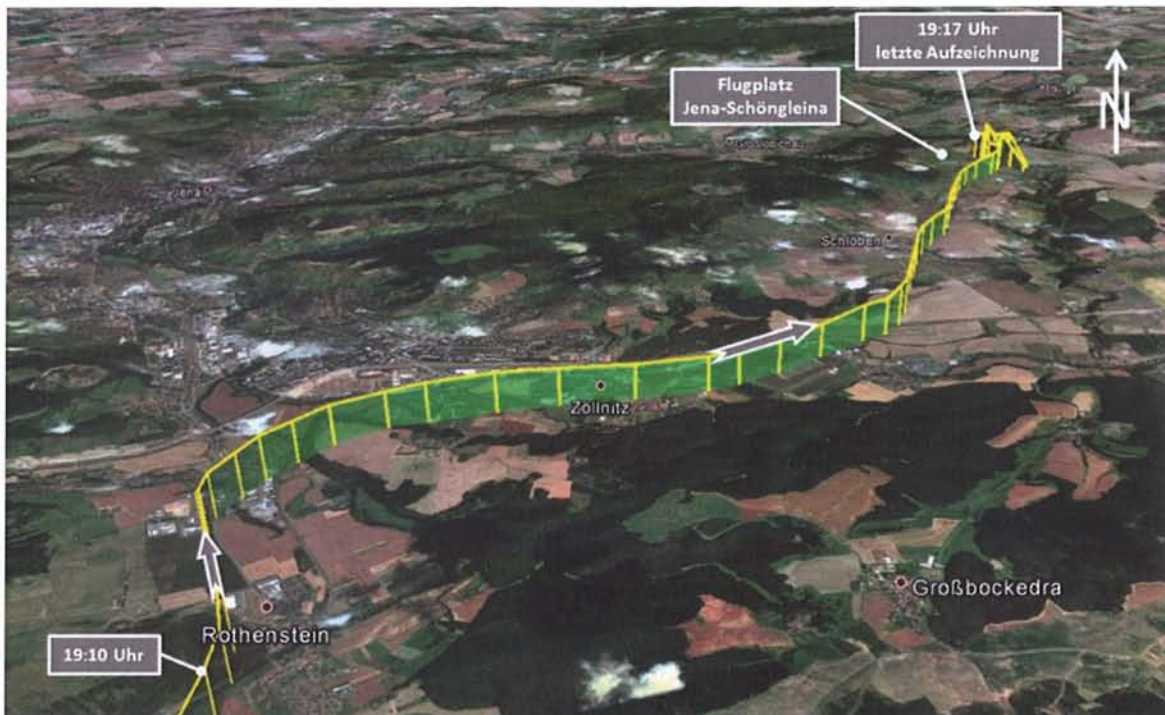
Flight path between 1910 hrs and 1917 hrs

The GPS recording shows that the airplane had followed two valleys north and at 1910 hrs it reached the town of Rothenstein, 1.5 NM south of Jena. Afterwards the flight ran parallel to the motorway A4 on an eastern and north-eastern track.

After 1902 hrs, the airplane followed two valleys north and after 8 minutes reached the motorway A4 running crossways to the direction of flight. Initially the pilot followed the motorway directly to Jena-Schöngleina Airfield.

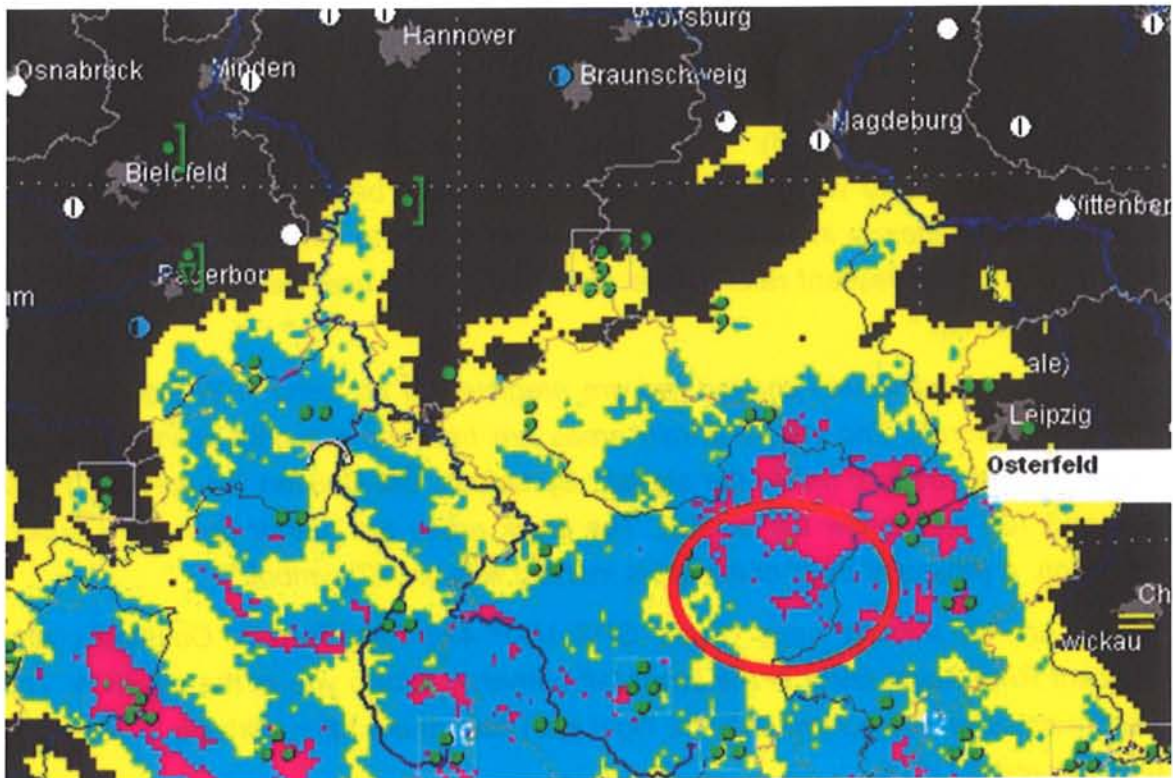
Moderate to heavy rainfall at 1900 hrs in the accident region

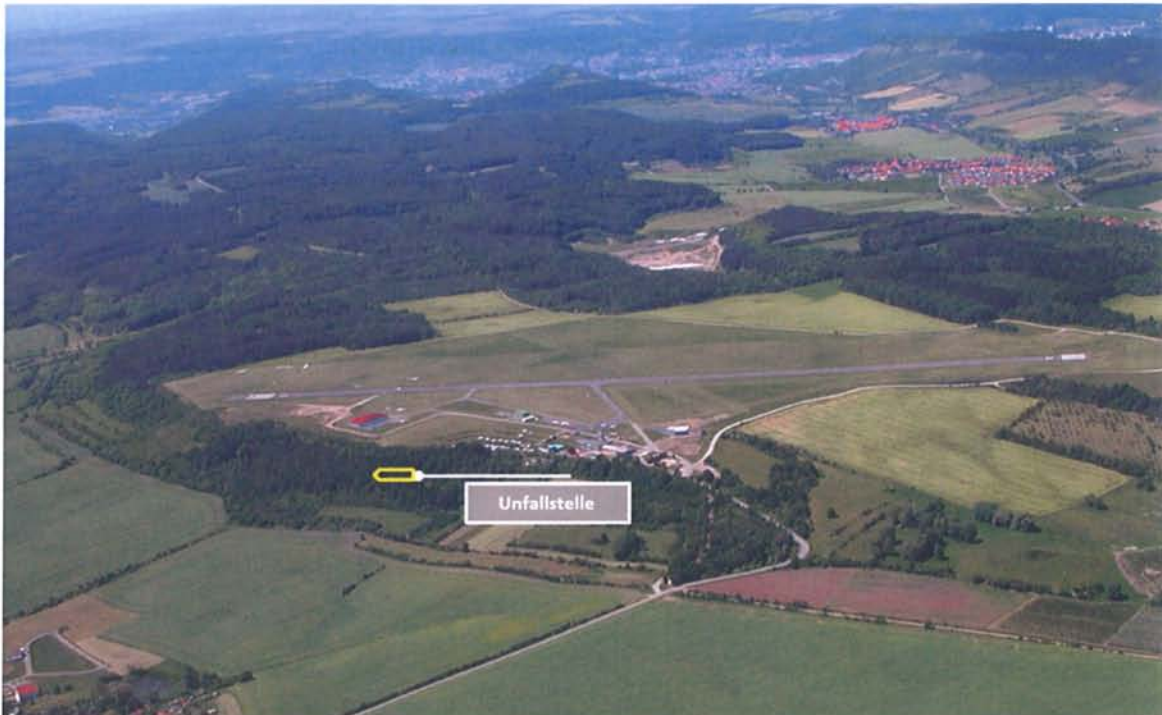
The accident site was located about 20 m below the airfield elevation on a hillside which slopes to the south-east and has a dense, broad-leaved forest with 10 - 15 m high trees. The collision occurred with the tress parallel to the hillside with a south-western heading.

The accident site including the collision direction

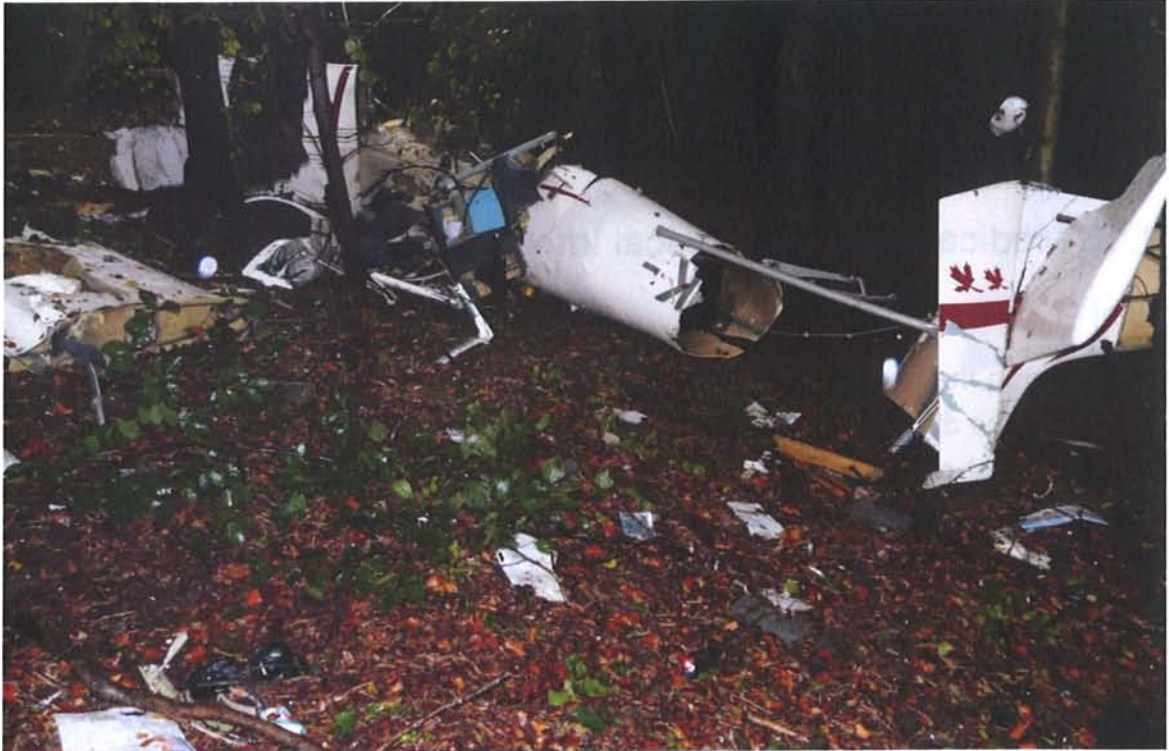
During the initial collision both wings had their end parts on a length of about 2 m torn off. One of these pieces became stuck in about 5 m in one of the thick treetops. The subsequent collisions also occurred with trees. The impact marks on the trees show a slope angle - compared to the horizontal - of about 25° . The inner wing parts, the tail section, the engine and the fuselage were found distributed in collision direction on the forest soil. The wreckage was distributed over a distance of about 50 m with very little lateral distribution.

High degree of destruction due to the collision with trees

Fuselage, wings, landing gear, tail section and control surfaces were either severely damaged or destroyed.

The traces on the trees, the high degree of destruction and the characteristic of the wreckage distribution indicate a collision with trees with regular cruise speed and horizontal flight attitude (controlled flight into terrain).

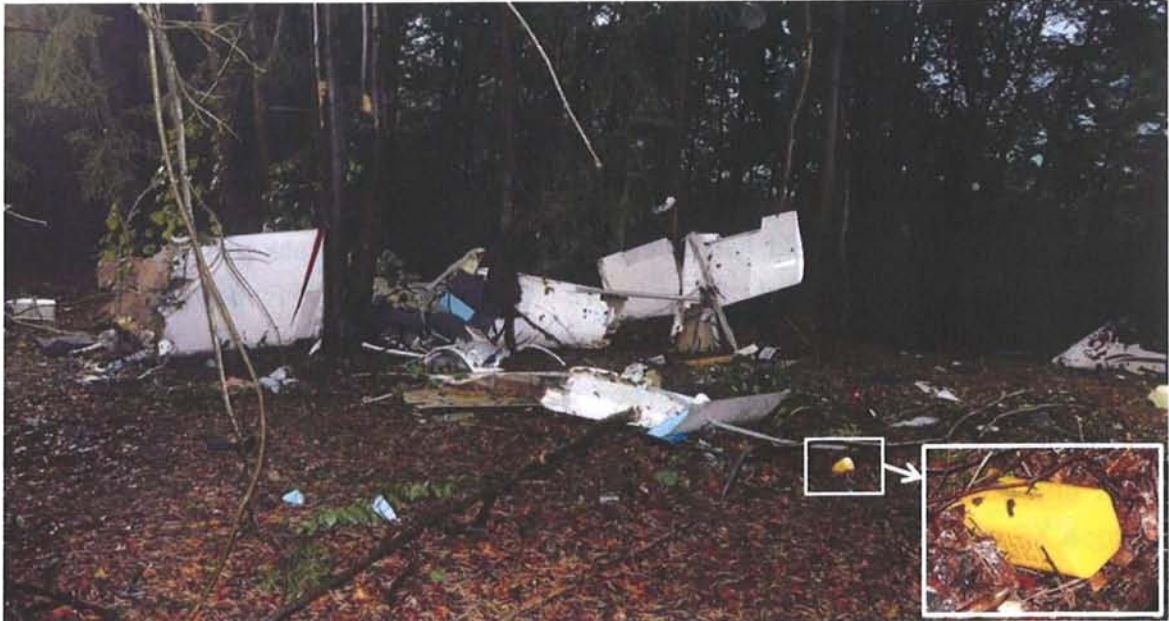
The antenna of the Emergency Locator Transmitter (ELT) was torn off.

The damaged ELT did not send any signals.

Location of the ELT within the wreckage area

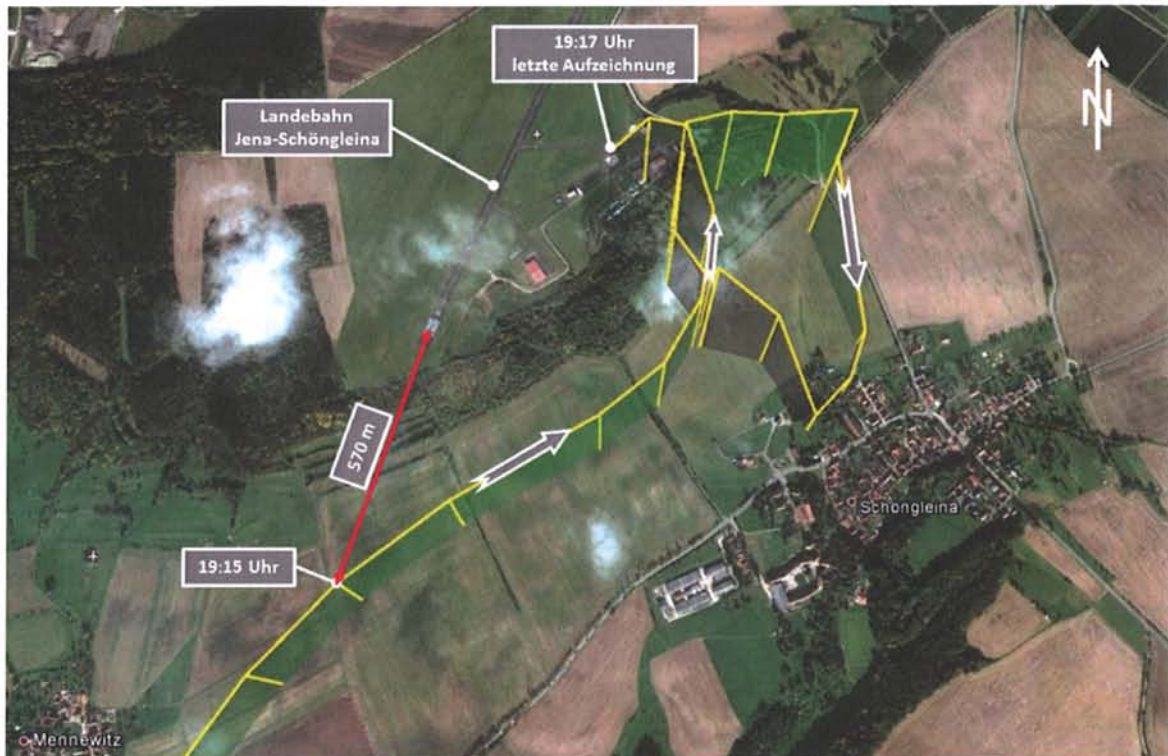
At exactly 1915 hrs the airplane was on the extended centre line 570 m away from runway 02. However, the airplane veered right and remained in the valley south-east of the airport. Witnesses observed it there as it was flying twice very low across a field. The BFU is of the opinion that there was suitable terrain available in this valley also for a precautionary landing due to weather conditions.

After a full right circle the airplane flew towards the hill on the south-east side of the airfield which was in clouds at the time. Under these circumstances the collision with terrain was inevitable.

Approach attempt to Jena-Schöngleina Airfield
