FINAL REPORT

**Investigation of causes of an incident
of the R 22 Beta II helicopter,
registration mark OK-OBA
at the Podhořany aerodrome,
on 2 April 2014**

Prague
October 2014

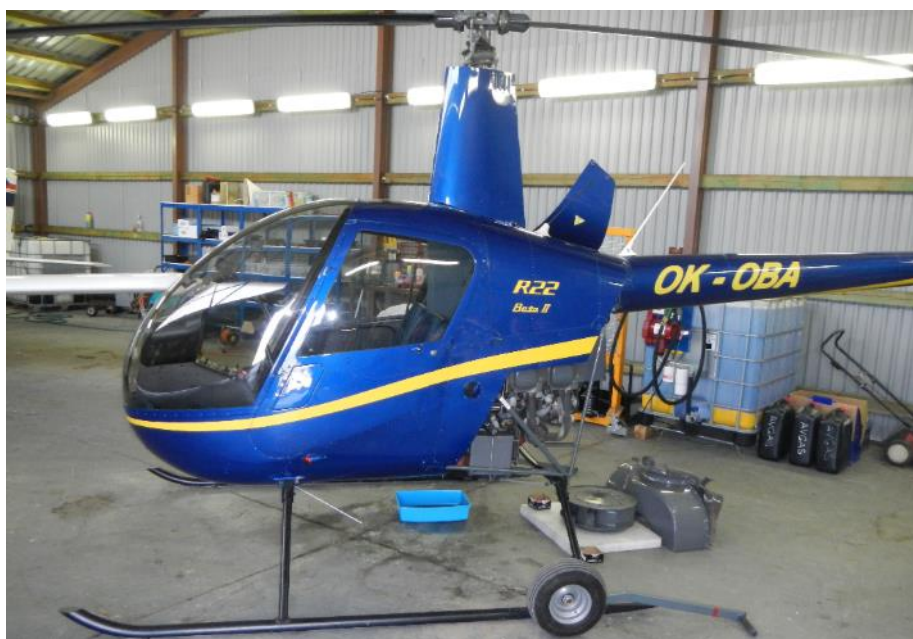
Fig. 1 Helicopter after the incident with the engine cooling fan removed

- construction of Lycoming SB388C (AD 2005-0023R3) – check of exhaust valve clearances,
- replacement of all damaged parts of the engine cooling fan assembly and air conduits, engine test and dynamic balancing of the new fan.

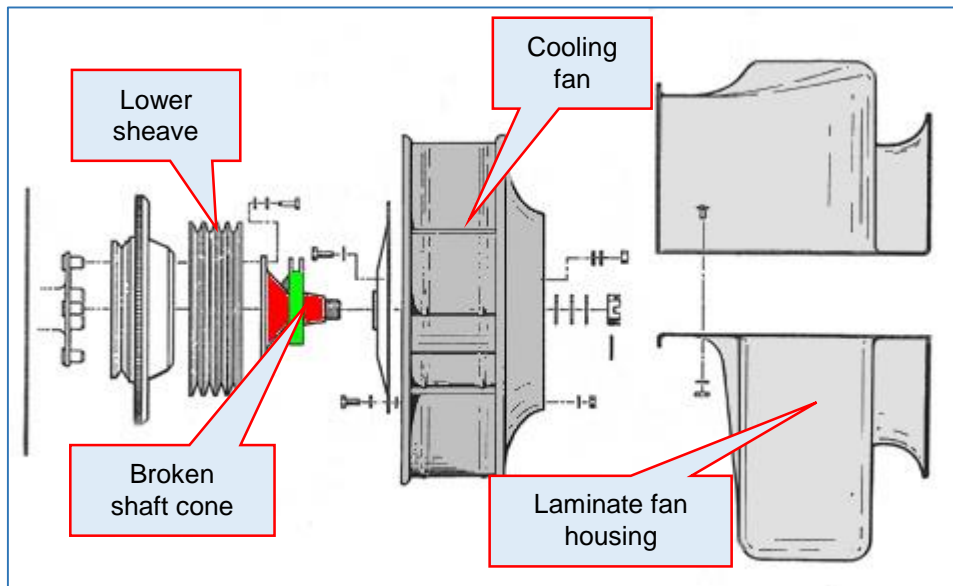
Fig. 2 Installation of the radial cooling fan

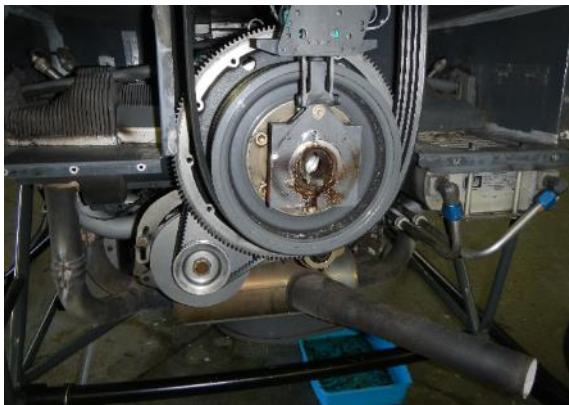
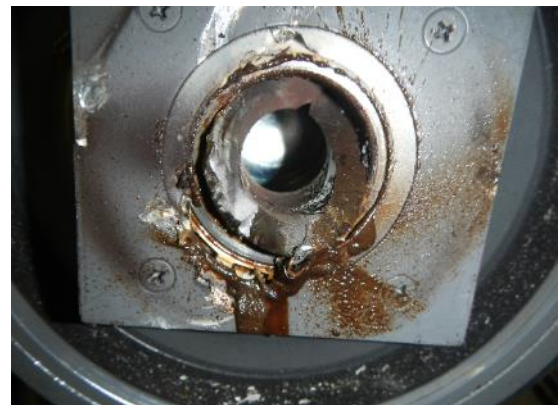
During the flight, a failure occurred – an engine cooling fan separated due to a break up of a cone in the assembly of the fan shaft and lower bearing of the expanding mechanism. As a result of that the engine temperature increased above the permitted upper limit. No logger, the record of which might be used in the flight analysis, was installed on the helicopter board.

Fig. 3 Broken fan shaft cone of the R22 helicopter

As a result of the broken cone in the shaft bearing housing the fan separated from the lower bearing of the expansion mechanism, damaged and deformed the laminate fan housing. The fan stopped performing its function, the engine was not cooled down during the flight, as a result of which the permissible engine temperatures were exceeded.

The helicopter was operated and serviced in compliance with the documentation specified by the manufacturer. During the take-off until the time the incident occurred, the pilot did not notice any abnormality in the helicopter control or engine operation and its performance. The technical inspection of the helicopter confirmed that a mechanical failure of a part of the helicopter cooling system occurred, probably due to a fatigue fracture or material defect on the fan shaft cone.

The incident was caused by a failure of the engine cooling fan due to a break up of a cone in the assembly of the fan shaft and lower bearing of the expanding mechanism.

In carrying out the pre-flight preparations, post flight inspections and prescribed work according the R22 Maintenance Manual pay increased attention to the state of operational wear critically stressed parts in the assembly of the fan shaft.
