FINAL REPORT

**Investigation on the accident
to RV-7 registration LN-DSF
at Špičník, 7 km S Modrava
on 23 August 2014**

Prague
April 2015

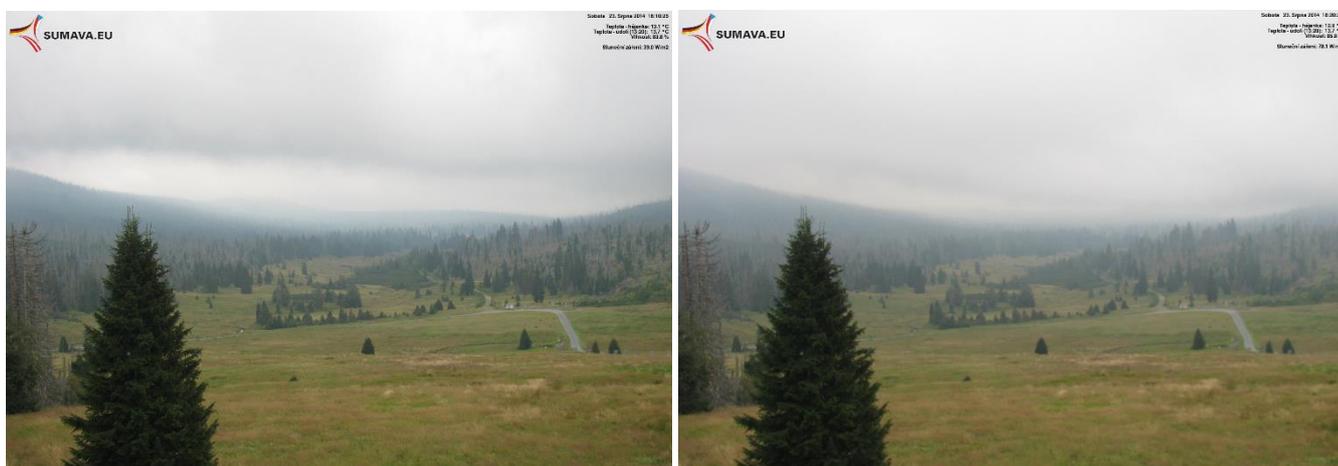
Figure 2 The camera records at Březník station at 18:10 a 18:20 local time (CEST)

The photographs allowed for evaluation of an approximate location of the cloud base on the mountainside of Špičník at approx. 1,200 m AMSL.

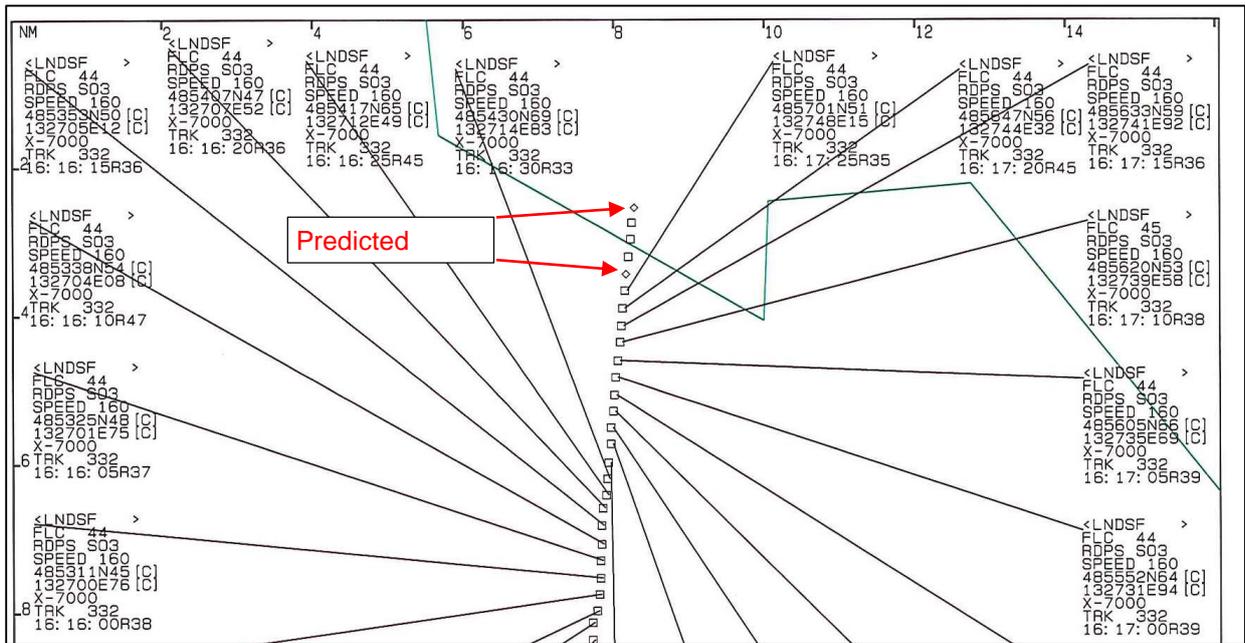
Figure 4 The plotted positions of the aircraft LN-DSF processed in the multitrack (16:16:00–16:17:25)

Figure No. 4 shows plotted positions of the aircraft LN-DSF processed in the multitrack during a time span of the flight track between 16:16:00 and 16:17:25. The plots show positions processed based on predictions up to 16:17:50. For the plots of indicated positions of the LN-DSF aircraft from the time of the flight see Appendix No. 3.

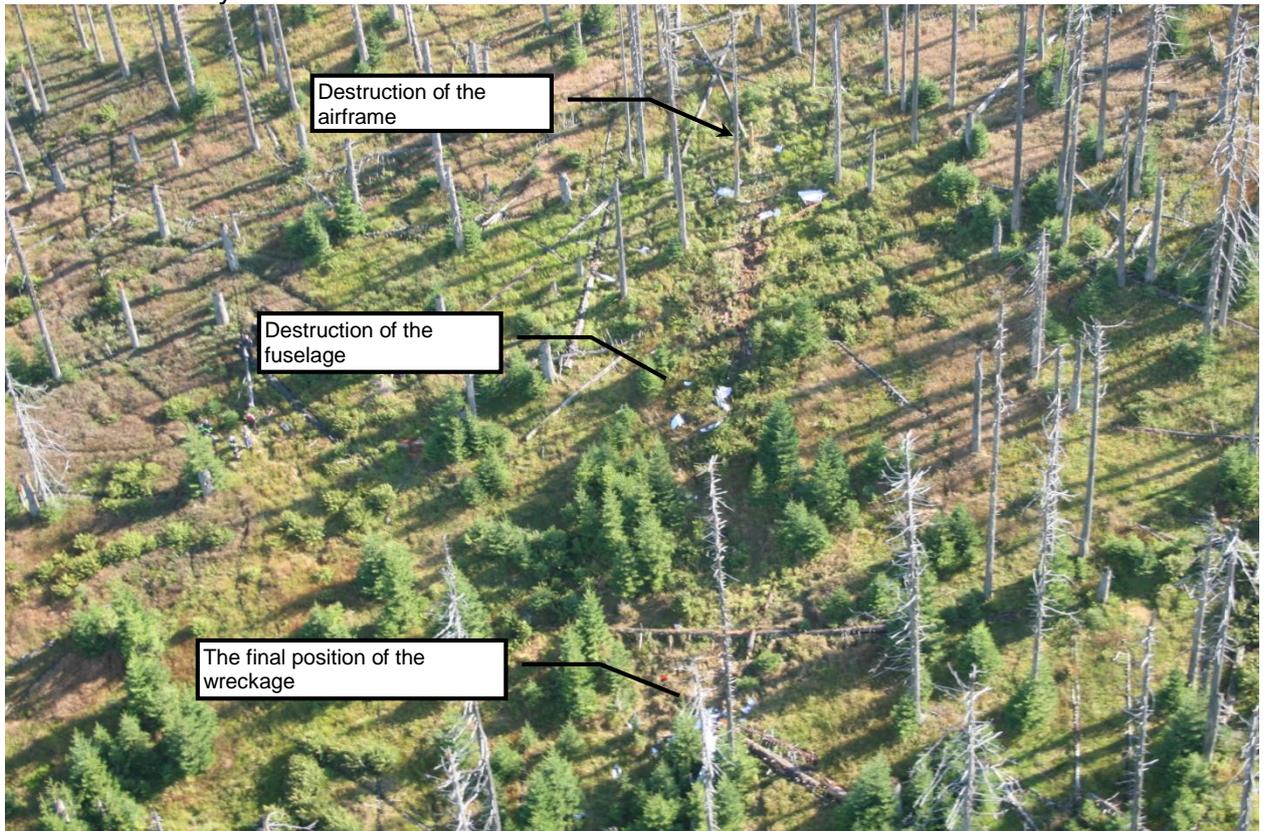
Figure 5 View of the accident site

At the location of the aircraft fuselage debris, the ELEV is 1,305 m and the coordinates are: 49°57'49.8" N and 013°27'55.8" E. From the on-site evidence it was

clear that after the first impact to the tree trunks at the summit of the Špičník mountain the cockpit canopy was shattered. The inspection of the air accident location and of the aircraft debris corroborated the fact that no important part of the airframe structure was detached or separated from the aircraft prior to the crash. The aircraft movement trajectory, most likely uncontrolled, continued along the mountainside. The complete destruction of the aircraft fuselage, the wing, and the tail assembly was a consequence of a succession of impacts into the tree trunks and into the ground. Parts of the debris were scattered in a short distance from the places of collision with the trees. Fragments of paint and metal from the aircraft structure have been found in the wood mass of the trees, and scrape marks and cuts on the surface of the trees. The fuselage wreckage had to be divided on the site for the purpose of transportation into the terrain accessible for machinery suitable for loading and transporting the said fuselage into the place designated for its depositing.

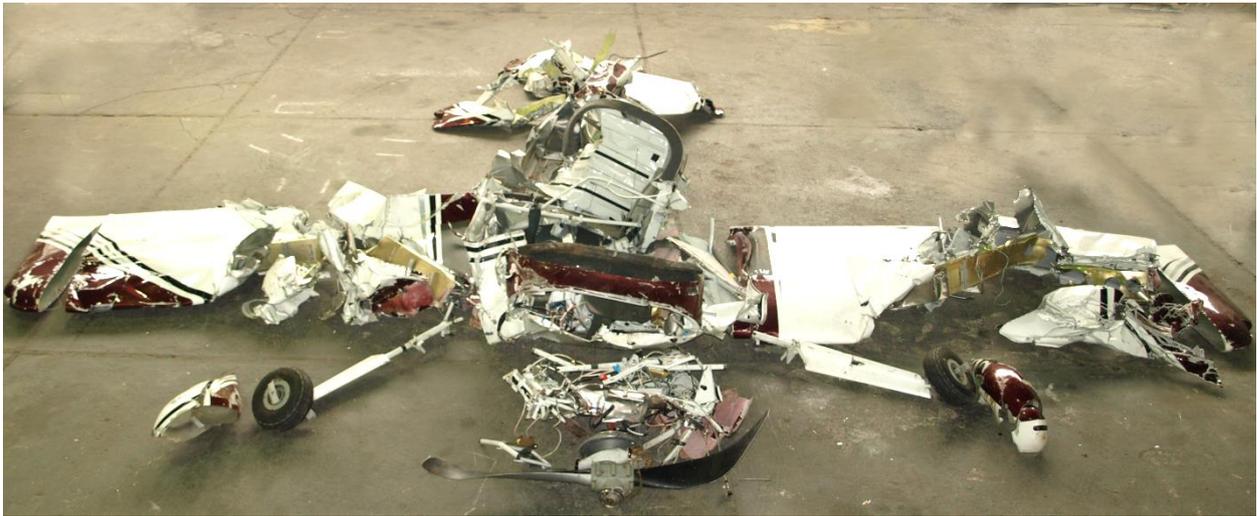
Figure 6 The wreckage at the deposit area

The assessment of the condition of the engine and systems and the analysis of detected damage prove that the engine wear-and-tear corresponds to the number of hours flown and that the damage was caused by the collision of the front part of the aircraft against a solid barrier. It is possible to conclude on the basis of the condition of mechanical engine parts and contamination of the inflow piping with the laminate particles from the inflow sleeve that the engine was running immediately before the collision.

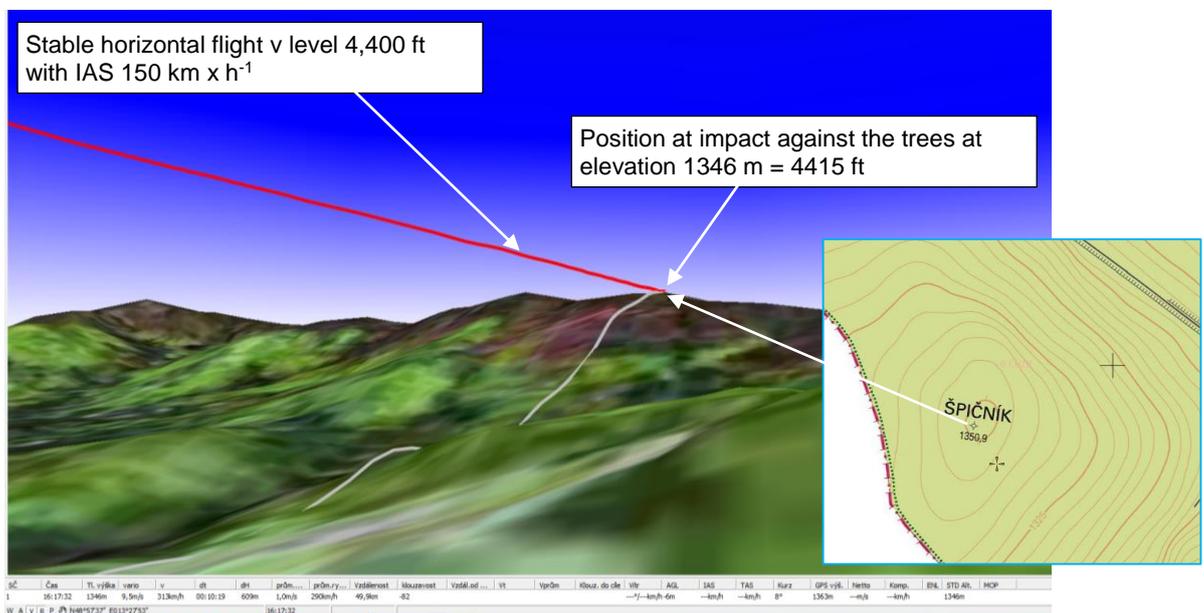
Figure 7 Animation of the trajectory before the collision into the trees

It may be deduced from the traces of impacts left by the aircraft and from the aircraft debris on the spot that immediately before the first impact against the trees at the summit of the mountain the aircraft was performing a horizontal flight. The aircraft collided against at least two tree trunks and broke the treetops. Although it is not possible to precisely determine the location of the aircraft after the first impact, it is obvious that the destruction of the aircraft was a result of an impact against one tree trunk by a root of the left side of a wing and of another impact by the middle part of the leading edge of the right side of a wing; due to rotation of the aircraft, the impact was directed from the right-hand side to the root of the keel area and to the fuselage before the leading edge of the horizontal tailplane. During collision against the ground the propeller was torn off and the fuselage was further vastly deformed.

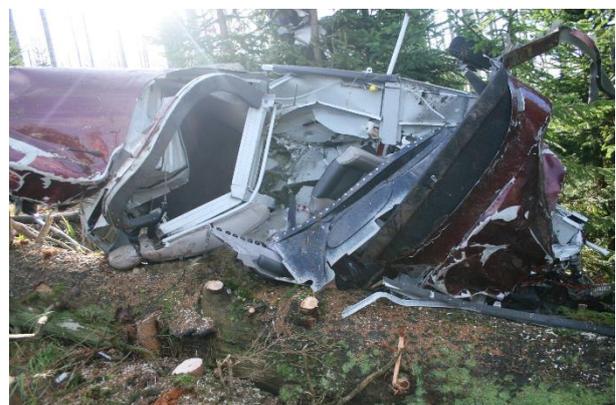
The cockpit structure and the canopy frame were severely deformed due to the collision. The Plexiglas glazing of the canopy was shattered. Number of fragments had been found already in the location of the first contact with the tree trunks. The instrument board was torn out from the assembly. The navigational equipment consisting of two EFIS devices was damaged. The pointer in the speed indicator was at the zero position. The pointer in the altimeter which had been set for the pressure of 1,014 hPa was pointing to the level of 3,990 ft. The radio station and the SSR transponder were regarded by visual inspection as only slightly damaged. Electrical switches and other controls were found set in different positions. The position of controls of wing flaps and of the pitch balance could not be determined. The fuel tap was in the "Right Tank" position.

Closeup view of the deformed cockpit

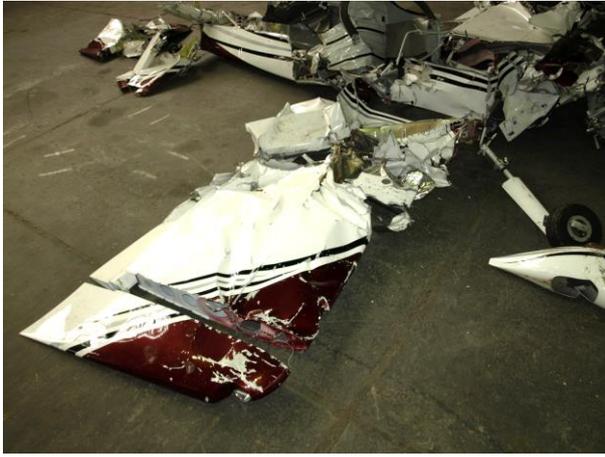
Both the halves of the wing were torn off at the root and torn into several badly deformed parts. On the left half of the wing, in the area just before the connection of the wingtip arc, there was a deformation mark left after a collision with a cylindrical object whereas the remaining part of the leading edge to the depth up to the wing spar was torn and deformed. The flap remained attached in the damaged hinges, the aileron was torn off due to the collision. On the right half of the wing, which had been torn into two parts, the leading edge was torn at the area of the fuel tank up to the half of the span and deformed from the frontal direction. The flap was broken and torn out from the hinges, the aileron was torn off.

The right part of the wing

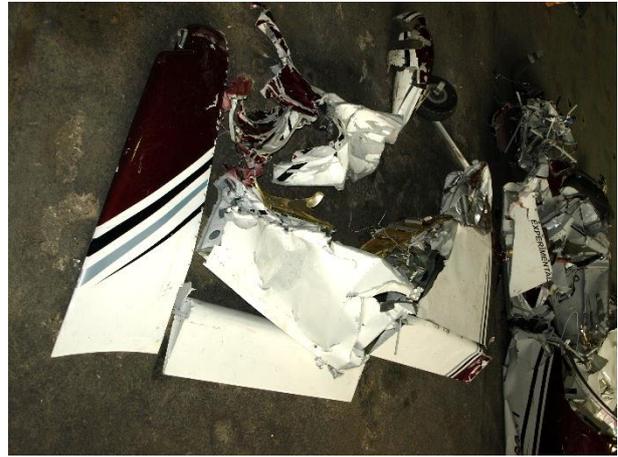
The left part of the wing

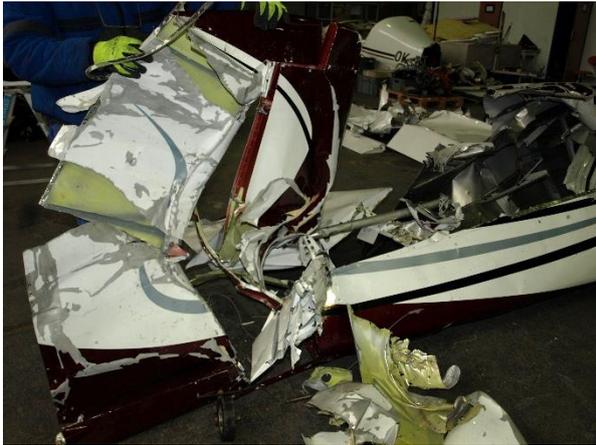
The keel area and the rudder were torn off as a consequence of a collision with a tree trunk from the starboard side. Only a part of the wing spar remained connected to the fuselage wreckage. Both halves of the horizontal tailplane were torn and there was a deformity caused by a collision with a tree trunk. The right side of the elevator was torn off. The pitch-trim tab was connected by a pull rod.

The deformation of the tail and the root of elevator

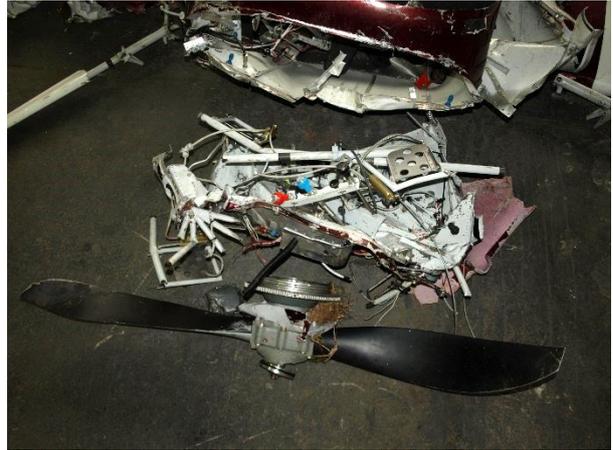
The engine without the propeller and the gear rim for starting together with a part of the engine bed were broken off by a collision to the right. Due to deformation and destruction of the engine bay it was impossible to determine the settings of control levers. The engine was detached from the debris of the wrecked aircraft fuselage and was transported from the place of debris deposition to the AAll disposal site and then to the authorised maintenance organisation's operation site. The propeller with the gear rim was located approx. 15 m before the fuselage debris. Both blades were unevenly bent with marks of collision.

The propeller blades and the engine bed

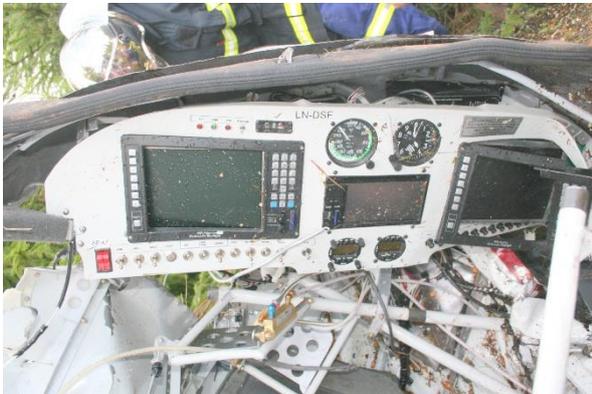
The damaged dashboard

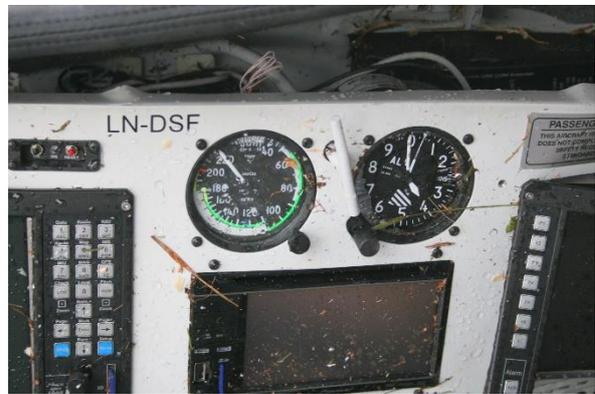
Inspection of the cockpit debris has revealed that the altimeter scale was set at the pressure value of 1,013.5 hPa, which corresponds to a difference of approx. 1.5 hPa against the areal QNH (the difference equals 26 ft). The pointer of the altimeter found in the debris showed the value of 3,990 ft.

The airspeed indicator and the altimeter
