# FINAL REPORT

## of civil aviation safety investigation

<b>CLASSIFICATION</b>	<b>Accident</b>
Owner	Romanian Air Club
Operator	Romanian Air Club
Manufacturer	Moravan, n.p., Otrokovice Czech Republic
Aircraft	ZLIN Z 142
Registration country	Romania
Registration	YR-ZCC
Location	Climceni Aerodrome
Date and time	23.08.2013 / 08:40 LT

**NR. A 16-03**  
**Date: 10.06.2016**

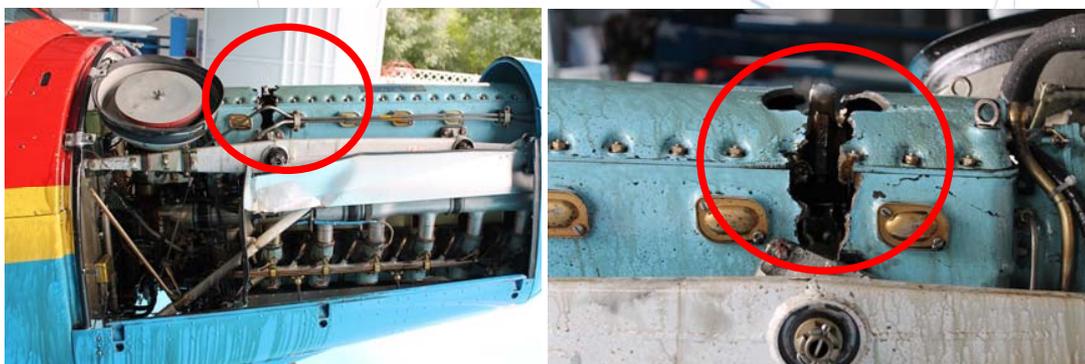
- The aircraft engine was seriously damaged: the cylinder rod 6 broken, and the engine block was sectioned by the broken rod.
- The left support of the engine frame broke from the firewall wall.

**Fig. 1 – Sectioned engine block**

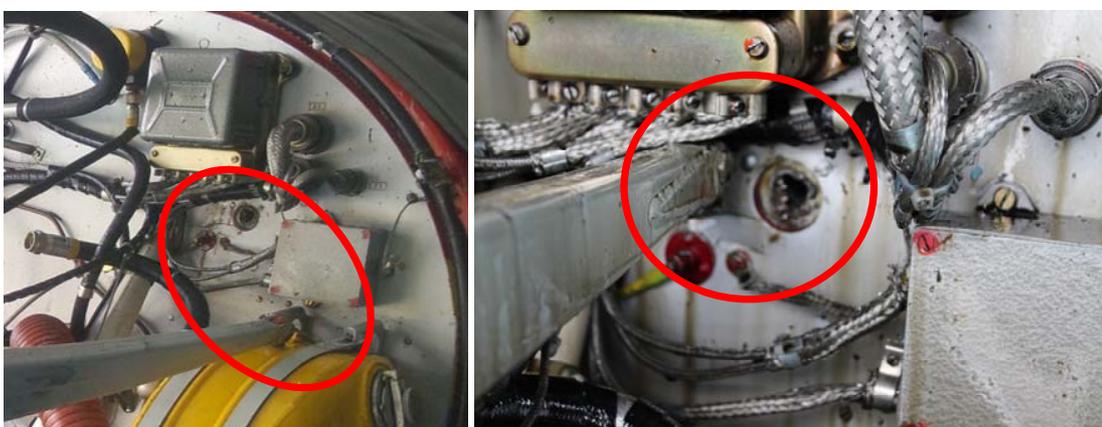
Fig. 2 – Broken engine frame from the firewall wall

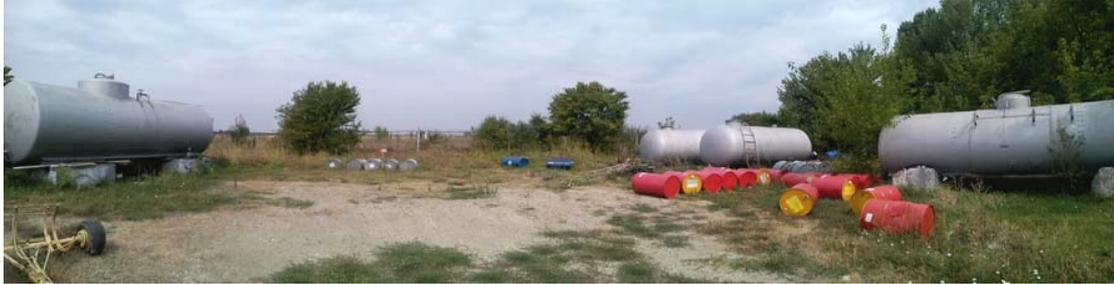
Oil samples were taken from the barrel of 200 liters, from which they used for engine maintenance and they were sent to the laboratory to test the oil quality. At that moment the investigation commission noticed that the oil barrels were stored outdoors in a fenced location.

**Fig. 3 – Oil barrels storage**

2. When the accident took place, the investigation commission found that the oil barrels were stored outdoors in a fenced location.
3. The analyzes bulletins corresponding to the oil samples taken from the engine oil tank and from the engine crankcase showed a very high content of metal particles, but also a high content of ash.

3. It is recommended for the RCA to audit the maintenance organization of the Romanian Air Club in order to:
  - verify how the chemical products are stored, especially the oil barrels used for the maintenance of aircraft under the operation of the Romanian Air Club;

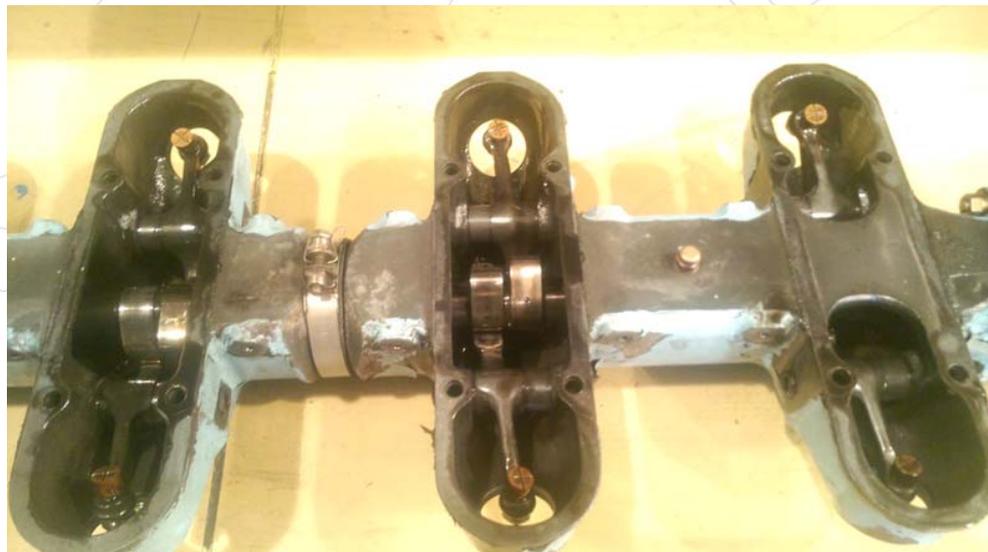
It was demounted and verified the cam shaft – no marks of usage were found on the cams or on the shaft.

**Fig. 6 – Cam shaft**

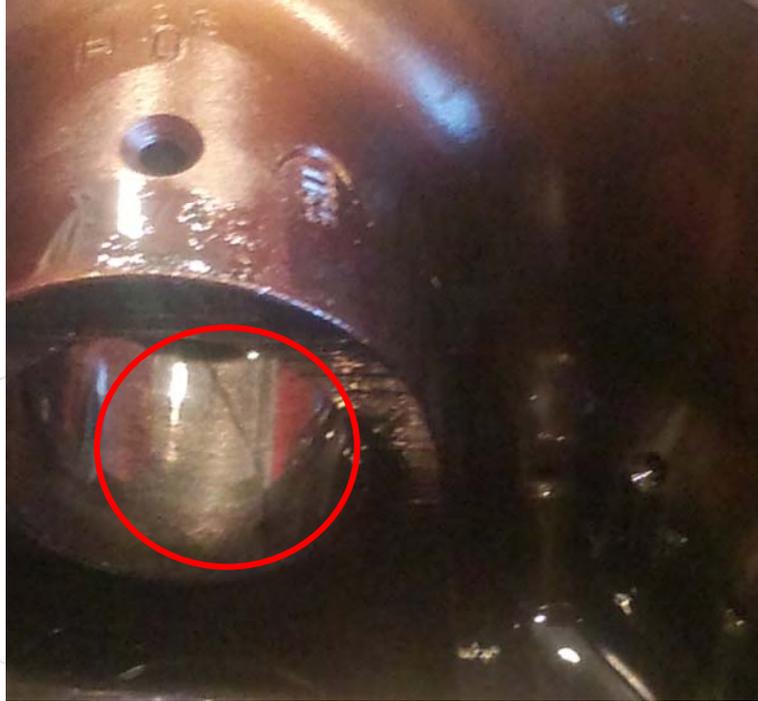
There were demounted the cylinders and the pistons. At piston no. 5 it was found a crack in the piston shoulder area where the piston bolt is fixed.

**Fig. 7 – Crack of piston no.5**

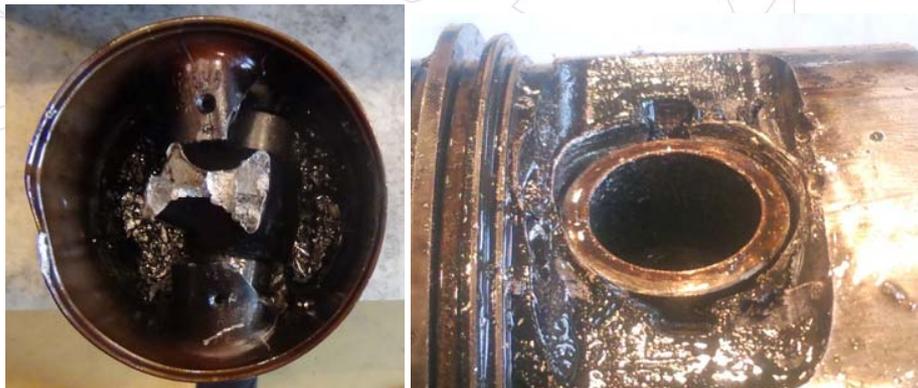
- Broken rod, with missing pieces from the central part,
- Broken piston and a missing locking snap ring of the piston bolt. It was subsequently found broken in two pieces, in the engine oil collector,

**Fig. 8 – Broken rod/piston no. 6**

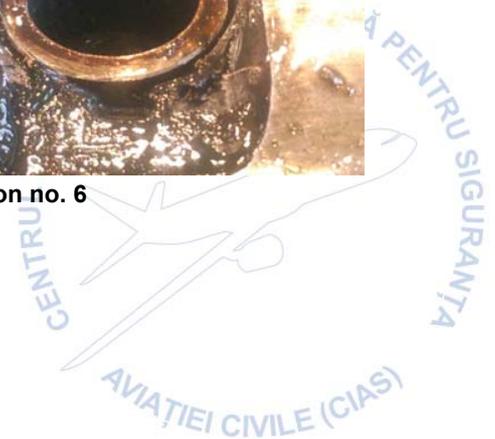
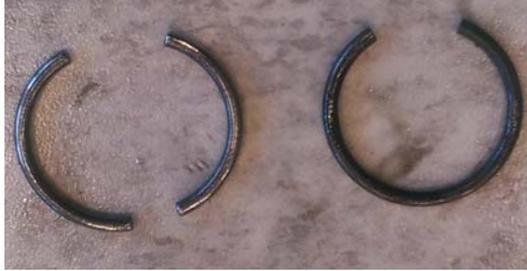
**Fig. 9 – Broken locking snap ring of piston no.6 bolt (left) and the whole locking snap ring of the piston no.6 bolt (right)**

The locking snap ring of the piston bolt that was incorrectly installed broke, when the axial play of the fixing bolt increased, this being also the moment when there appeared friction marks on the cylinder between the piston bolt and the cylinder.

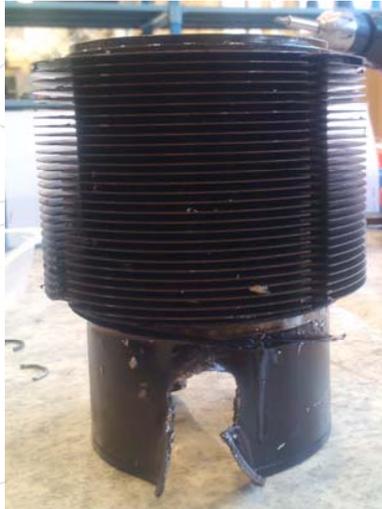
- The cylinder is sectioned at its base, and on the inner surface there are friction marks of the piston bolt.

**Fig. 10 – Cylinder sectioned at base**

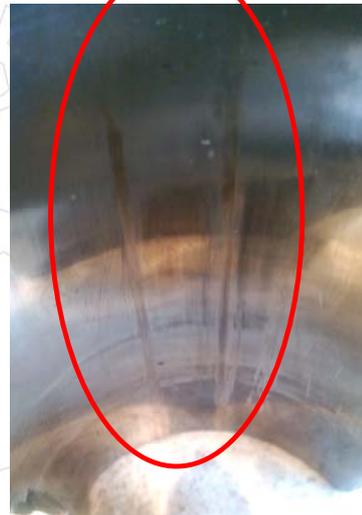
**Fig.11 – Friction marks of the piston bolt on the cylinder**

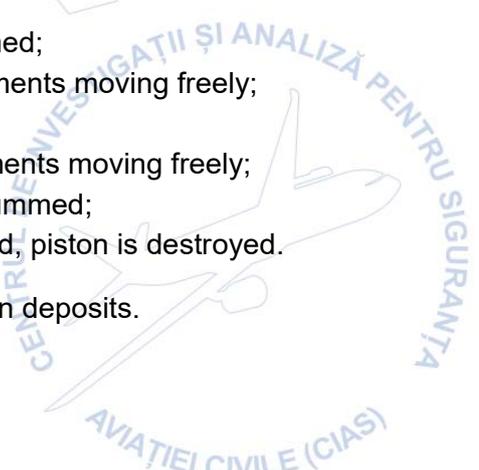
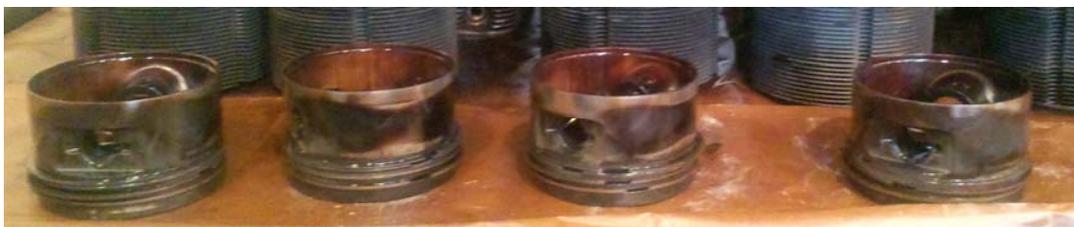
- Piston no. 1 – compression segments are gummed;
- Piston no. 2 – compression and lubricating segments moving freely;
- Piston no. 3 – lubricating segment is gummed;
- Piston no. 4 - compression and lubricating segments moving freely;
- Piston no. 5 – compression segments almost gummed;
- Piston no. 6 – segments are completely gummed, piston is destroyed.

On the lateral sides of the pistons there were carbon deposits.

**Fig. 12 – Carbon deposits on the lateral sides of the pistons**

The segments gumming, but also the results of the engine visual inspection indicate that the engine was operated exciding the upper limit of the temperature recommended by the manufacturer. The segments gumming favors the transition of exhaust gases to engine crankcase, thus contaminating the engine oil. Also, the large amount of ash found in the oil after the lab analysis indicates the same thing.

1. It is recommended for the operator the Romanian Air Club to inform the pilots that operates the aircraft type ZLIN 142 about the content of the Informative Bulletin LOM-IB-04b/2009 highlighting the necessity of monitoring the engines operation temperature and the effects of operations at temperatures above the limits recommended by the manufacturer.

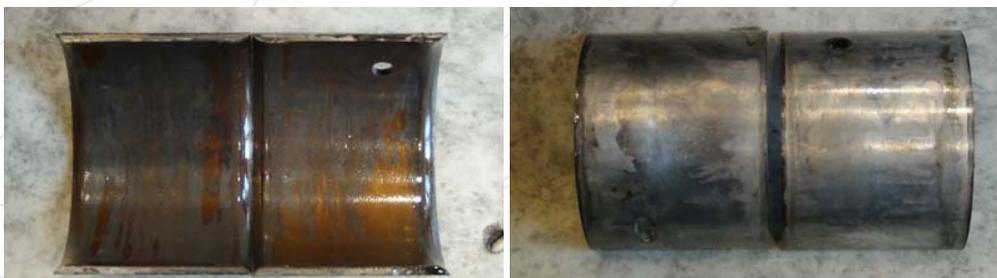
The rods from the crankshaft were demounted in order to inspect the bearings and it was noticed that they presented normal usage.

**Fig. 13 – Bearings usage**

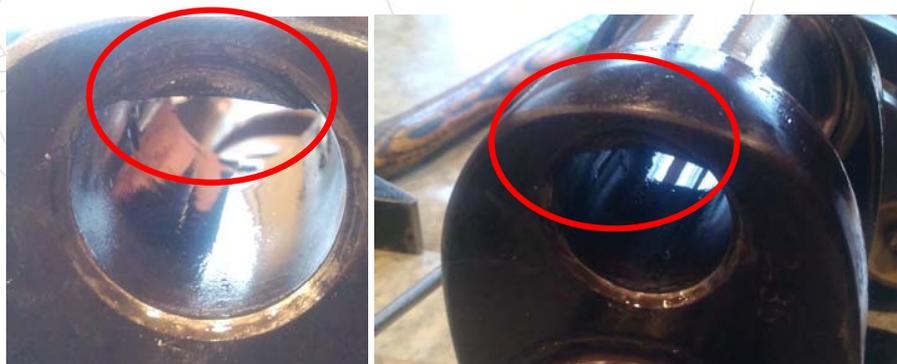
The engine crankshaft was demounted to check if the lubricating holes were blocked with ash deposits. There were inspected the crankshaft lubricating holes for pistons 1 and 6, there were found ash deposits in the normal limit, and the lubricating holes were free, unblocked, without ash deposits.

**Fig.14 – Ash deposits on the crankshaft lubricating holes**

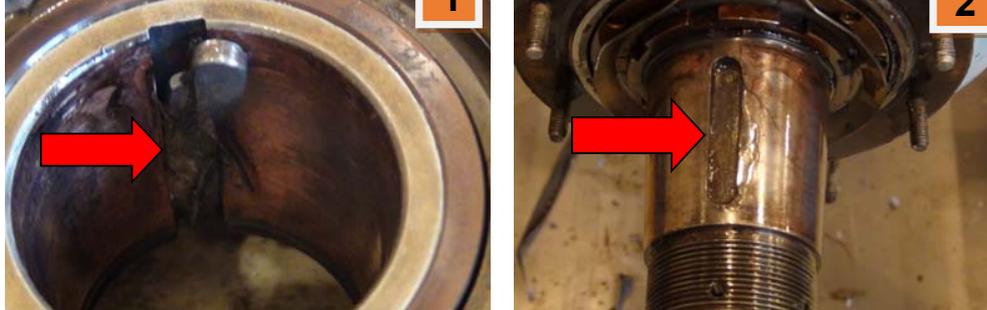
While demounting the propeller flange it was noticed that it was incorrectly mounted on the conical surface of the crankshaft. The latch key was improperly installed.

Fig. 15 – Latch key incorrectly mounted between the propeller flange (1) and the crankshaft (2)

the propeller flange when positioning it on the conical surface of the engine crankshaft. Most likely, the installation procedure recommended by the manufacturer was not followed by the maintenance organization of the operator when the engine was installed on YR-ZCC aircraft.

6. The engine operation was made at a temperature above the limits recommended by the manufacturer.
7. The latch key between the propeller flange and the conical surface of the crankshaft was found deformed.

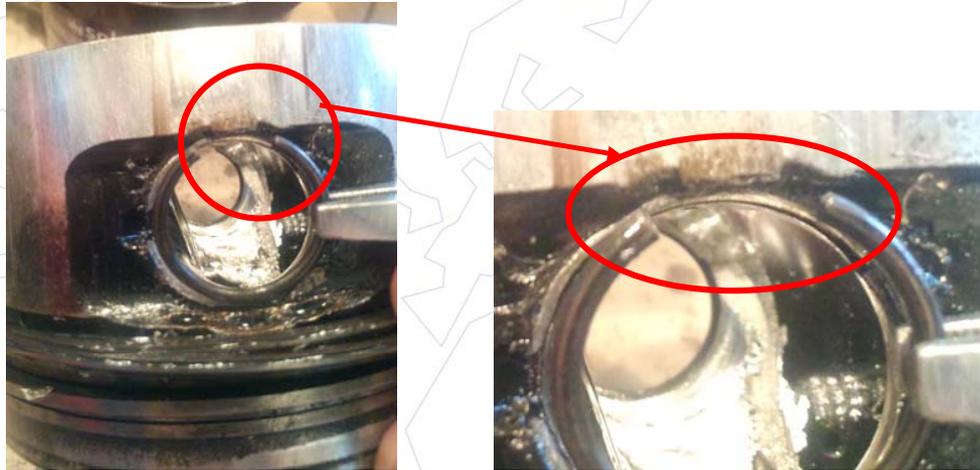
The process that led to the breakage of piston no. 6 rod was triggered by the breakage of one of the two locking snap rings of the piston bolt, the most likely cause being its incorrect installation after the last major engine repair. Thus, when installing the locking snap rings of piston no. 6 bolt, one of the rings was not properly fixed in the slot of the piston shoulder, resulting in an increased longitudinal axial play of the piston bolt.

**Fig. 17 – Marks of the incorrect installation of the locking snap ring of piston no.6 bolt**

8. One of The locking snap rings of piston no. 6 bolt was incorrectly mounted during the last major engine repair.
9. Volume I of the engine journal in Czech language is not available.

The main cause of the accident occurrence is the breakage of piston no. 6 rod as a consequence of wrong installation of one of the two locking snap rings of the piston bolt during the last major engine repair.

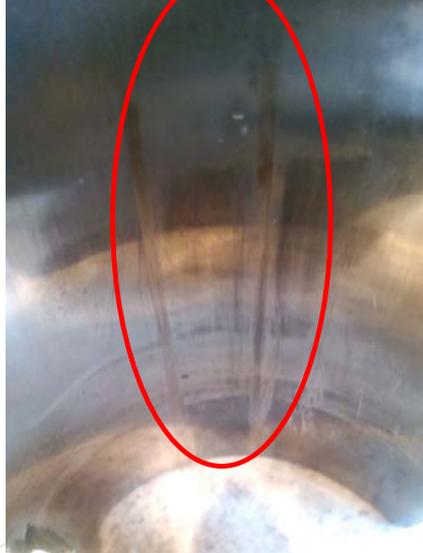
**Fig. 18 – Friction marks of piston no. 6 bolt on the cylinder**

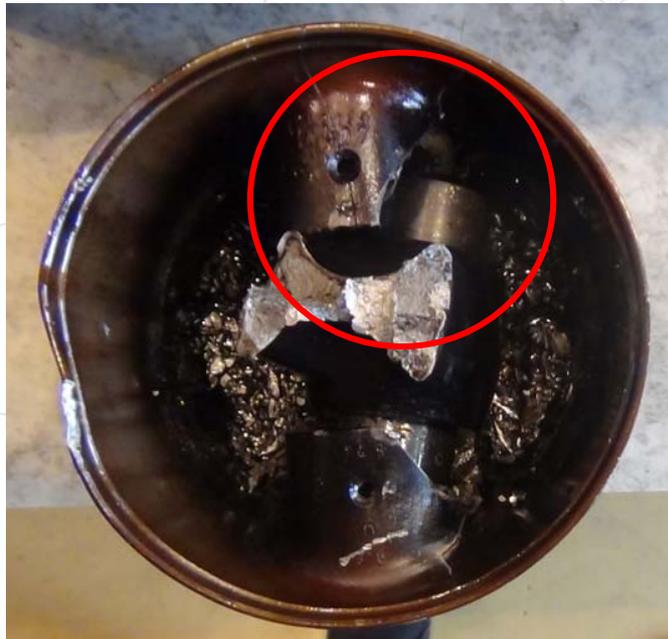
The influence of these negative factors lead in the end to the breakage of piston no.6 shoulder, to the displacement of the piston bolt that along with the increased mechanical forces resulted in rod breakage and cylinder no. 6 sectioning. In the end, the broken rod penetrated and sectioned the engine block.

**Fig. 19 – Broken shoulder of piston no. 6**
