No. CZ -13 - 459

FINAL REPORT

**Investigation into the Serious Incident of aircraft type Boeing B737-800,
registration mark OK-TVG, at LKPD aerodrome
on 25th August 2013**

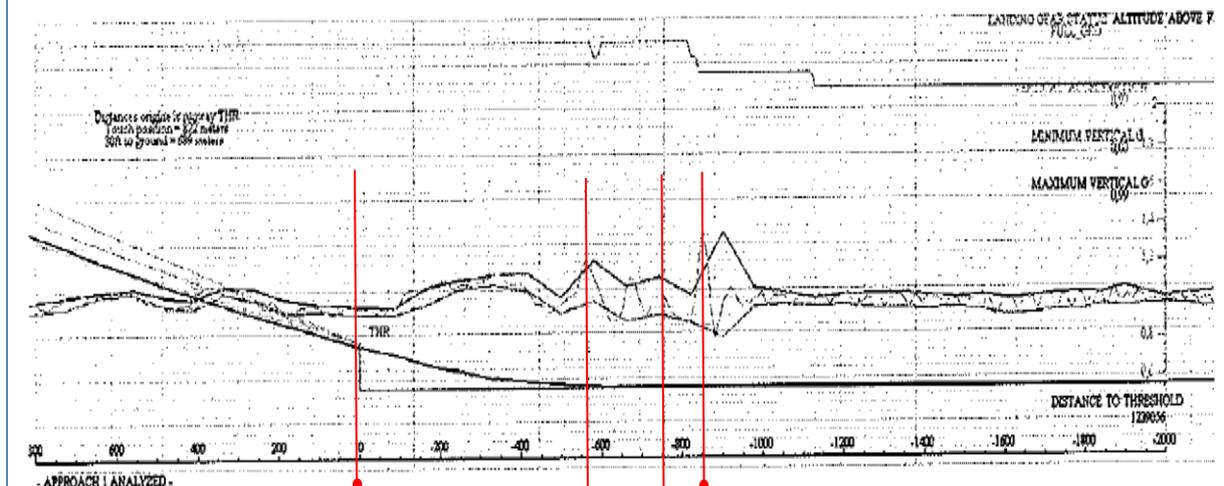
14:47:29 – TD 821 m after THR 27

H 0 ft, IAS 143,3 kt, GS 155,5 kt, N1 IDLE, MLG-on, AB2 from TD 6 sec to 14:47:35;

The graphical chart landing procedure by DFDAU

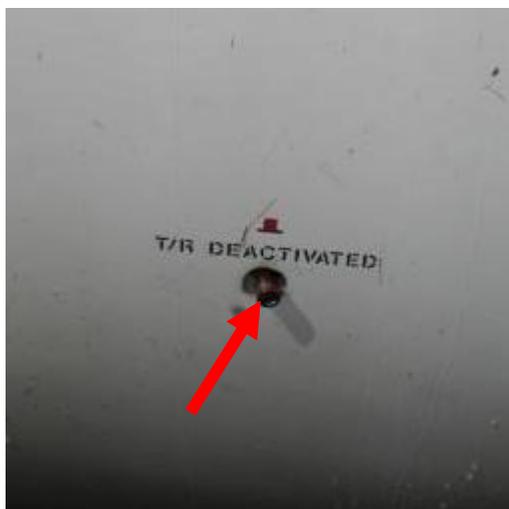
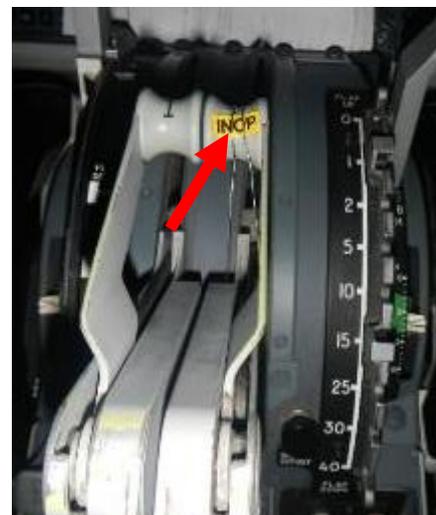
On 22 August 2013 an entry into the failure log under the serial No. 029480 was made about the deactivating of the reverse thrust system on the engine (hereinafter the "reverse") The operation of the aircraft was technically limited in accordance with MEL 78-7, category "C" and the deadline for the postponed defect elimination was set for 1 September 2013 inclusive. There were no technical and operational failure entries in the TLB on 25 August.

Pulled-out pin indicating that the reverse of the engine had been deactivated. The control lever of the reverse of engine No. 2 with the deactivated mode marked by a yellow "INOP" sticker.

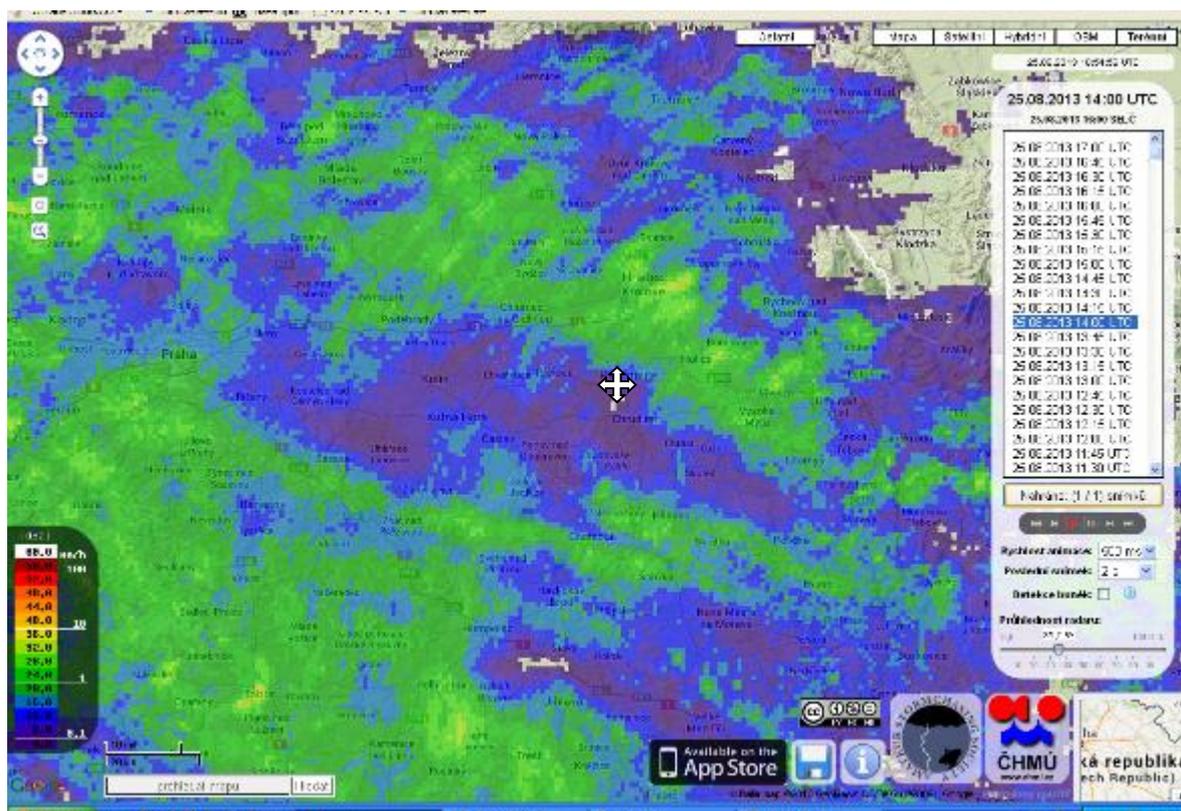
The precipitation started falling between 12:00 and 13:00UTC, hourly precipitation amounts between 14:00 and 15:00UTC reached for instance at two meteorological stations at Hradec Králové 1.3 to 1.7 mm/hour.

Meteorological situation – METRAD, white point shows LKPD aerodrome

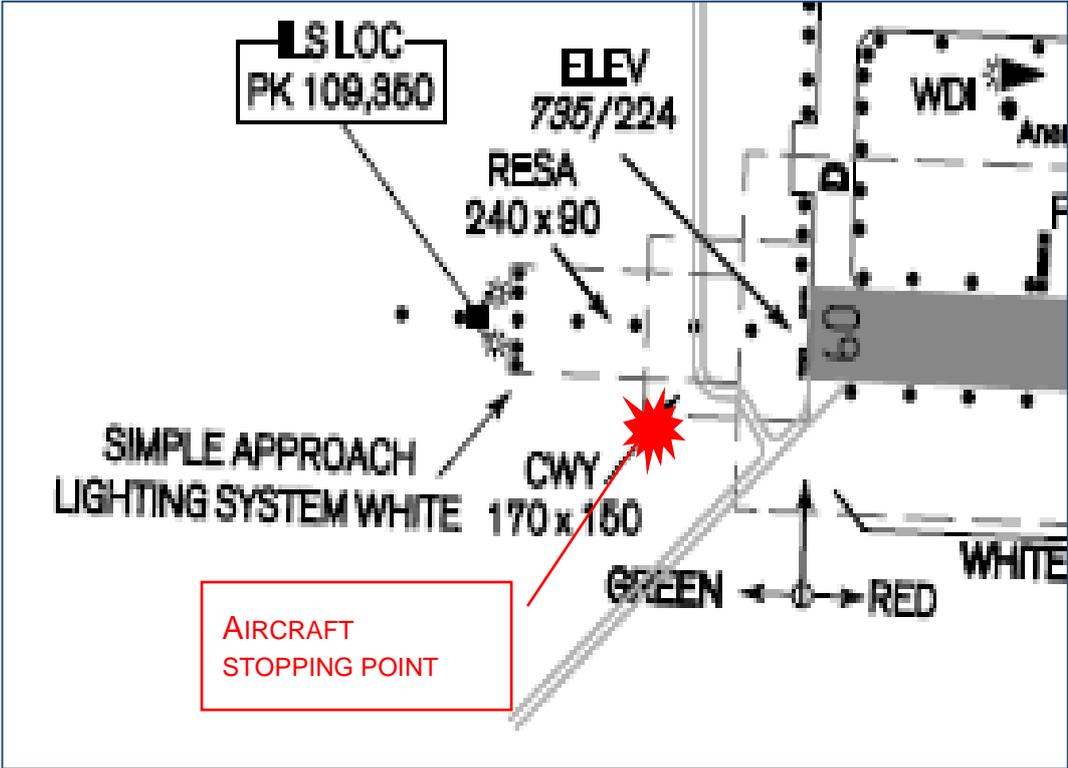
The surface of the coating of the lower fuselage parts, engine covers and landing gear wheels was stained with remains of grass and mud. In no place there were noticeable leakages of aircraft fluids or damage by impact and other deformations to the fuselage and wing structures.

Full stop position on end RWY 27

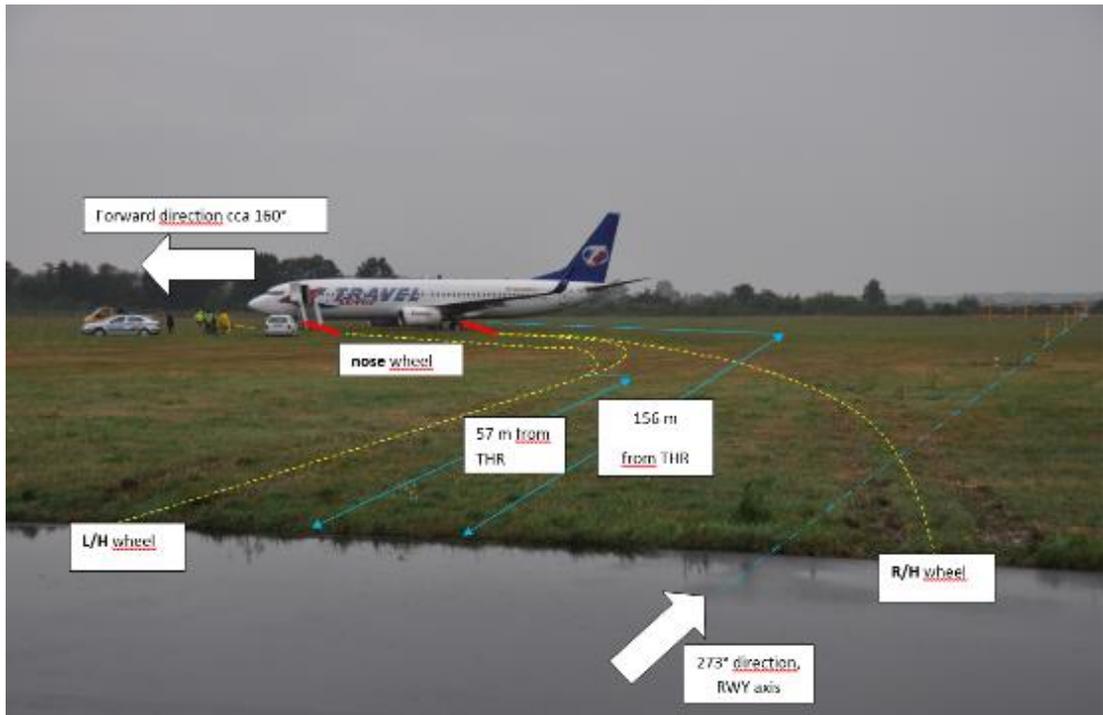
all landing gears. There were no foreign objects or parts of the aircraft and aerodrome equipment found in the tracks.

Overrun tracking

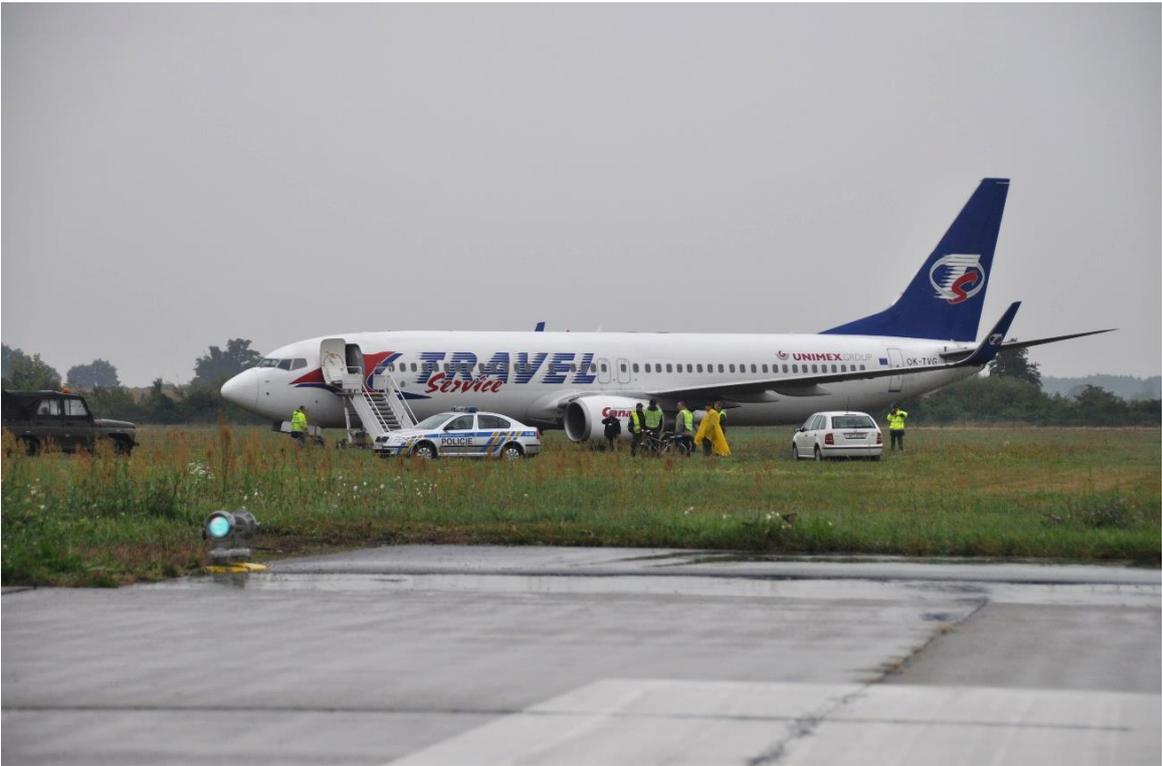
Pic.1 General situation

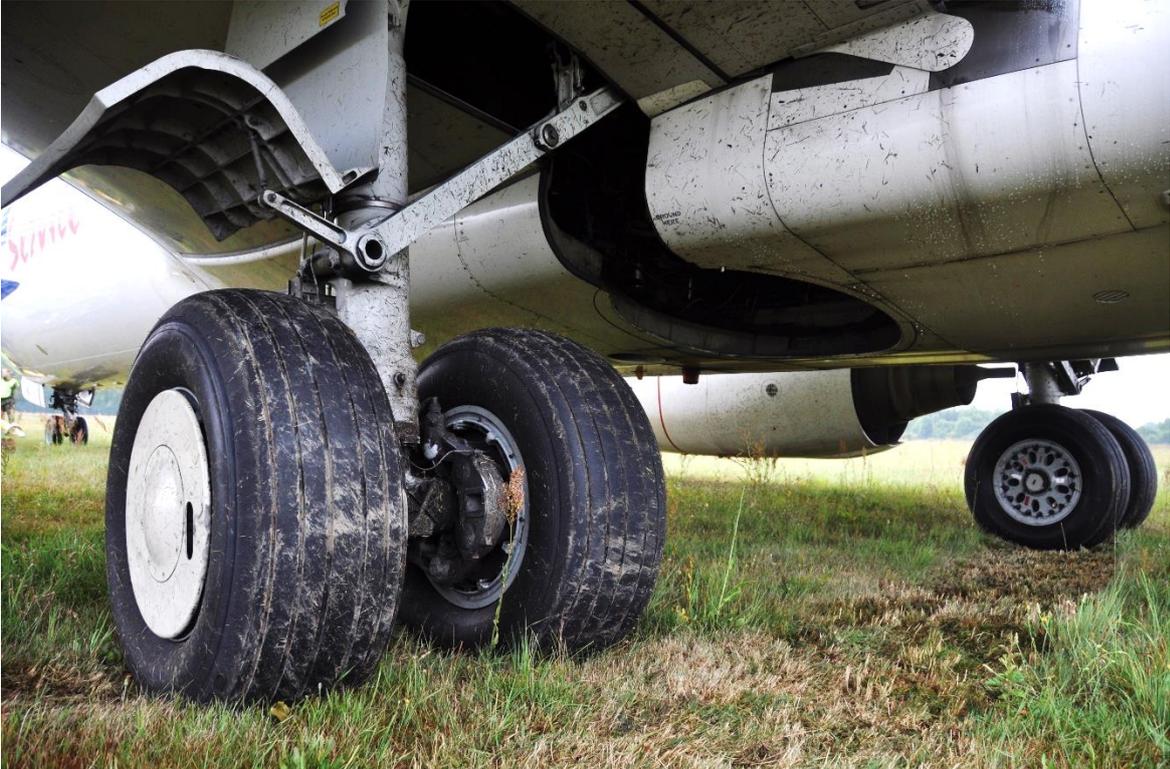
Pic. 2 Landing gear (LH) after full stop

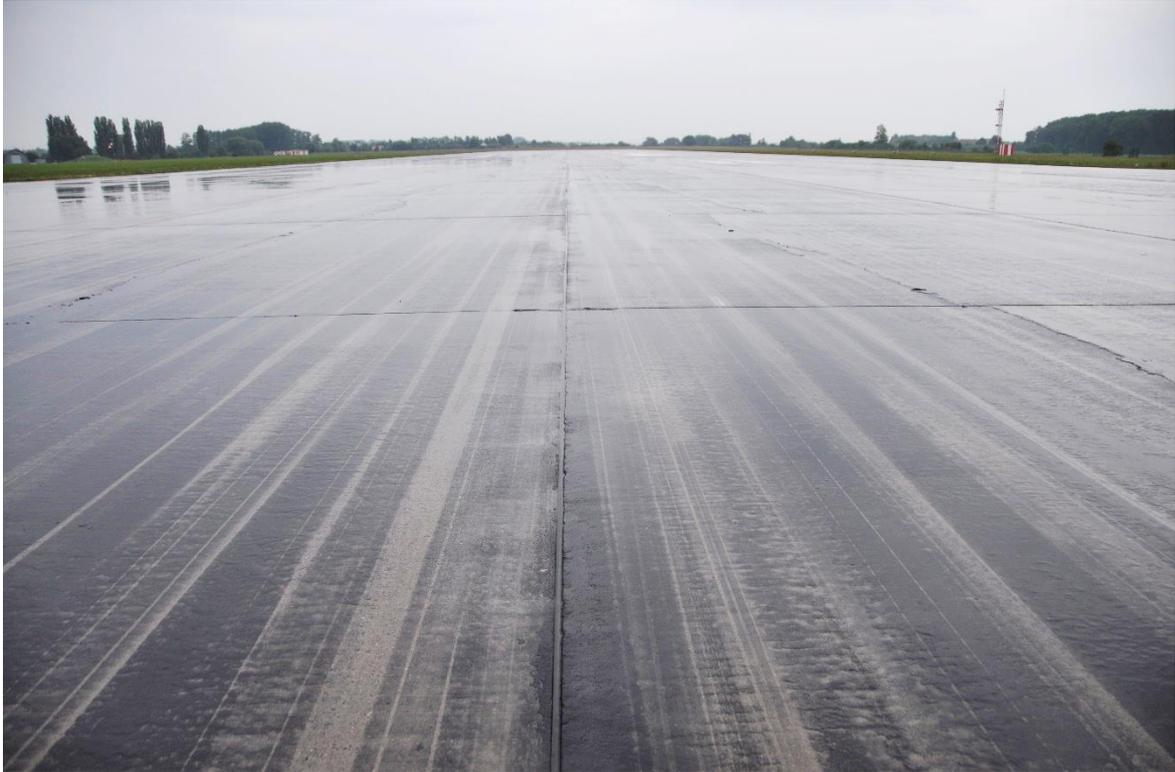
The subjective feeling of FO that he touched down before the junction of RWY 27 and TWY B, which is 750 m from THR 27, could have been correct as he very likely sensed the touchdown of the right hand side wheel, recorded approx. 581 m beyond THR 27 (therefore before the junction RWY 27 and TWY B). According to the recording, the full touchdown took place in 3 seconds, and at the same moment all of the required conditions for activating the automatic braking system and extracting of the "speed brake".

Pic. 3 Touchdown point (crossing RWY 27 and TWY B)

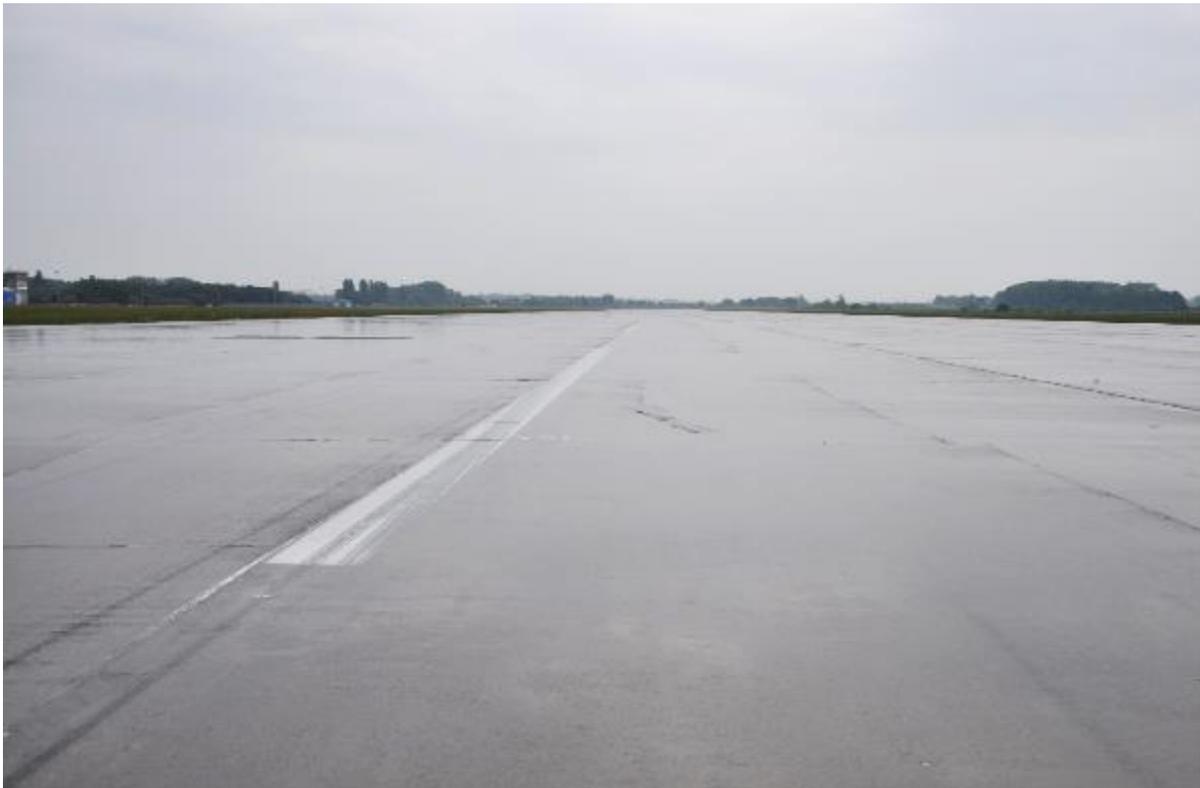
Pic. 4 RWY direction to THR 27 (crossing RWY 27 and TWY C)
