Final Report No. 2325

by the Swiss Transportation Safety Investigation Board STSB

Concerning the serious incident (near-collision)
involving the commercial aircraft Fokker 50, OO-VLF,
operated by Vlaamse Luchttransportmaatschappij N.V.
(VLM) under the flight plan call sign VLM 22TX
and the Piper PA-28RT-201T aircraft, OK-ELL,
on 21 April 2016
approximately 10 NM north-east of
Friedrichshafen airport (EDNY), Germany

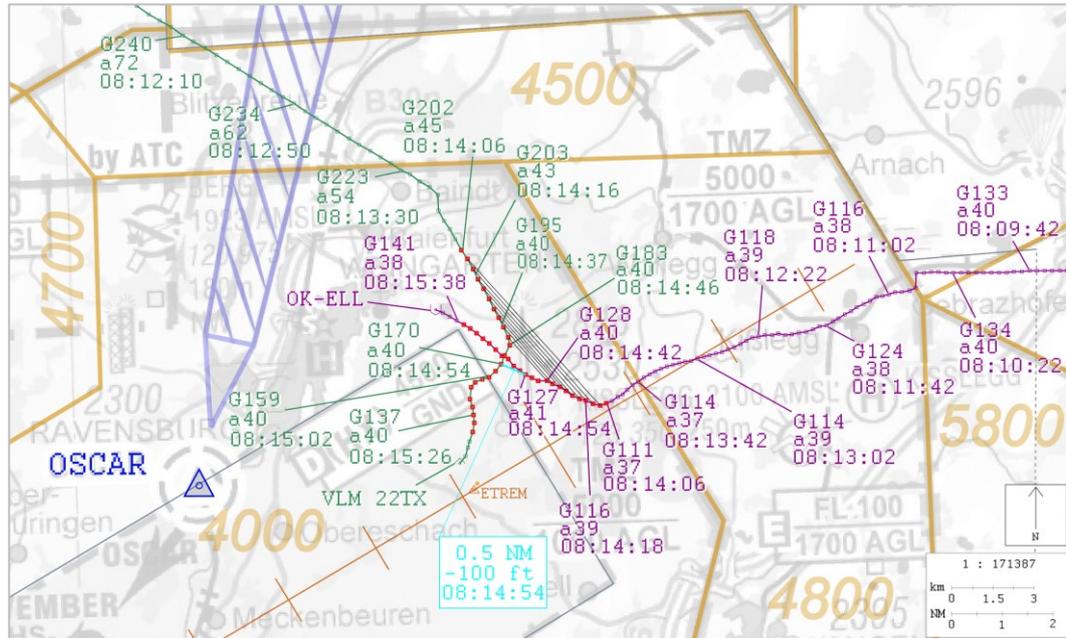
Figure 1: Flight paths of VLM 22TX (green) and OK-ELL (magenta) during the dangerous convergence according to the recorded radar data, with information of speed (G) relative to the ground in knots, altitudes (a) in hundreds of feet QNH and time in UTC. All positions during the STCA from 08:14:06 UTC until 08:15:34 UTC are illustrated in red, the closest point of approach having taken place at 08:14:54 UTC (cyan). In the period of time between 08:14:18 UTC and 08:15:38 UTC, the altitude readings of OK-ELL increased from 3900 ft to 4100 ft and then decreased again to 3800 ft. The following superimposed information are shown: the areas with the respective minimum vectoring altitudes (MVA) (orange), the VFR approach corridor to the reporting point OSCAR (blue) and the connecting lines (black) between the positions of the two aircraft with a constant angle (constant bearing).

At 08:14:42 UTC, the radar plot indicated a first change of course of VLM 22TX to the right. At the same time, OK-ELL changed his own course to the left, followed by another change of course to the right four seconds later. The RE air traffic controller later declared that he had been surprised by the left turn of the VFR traffic, because the speed vector had pointed shortly and unexpectedly towards VLM 22TX. Based on the observed altitude and heading fluctuations of the VFR traffic involved (cf. figure 1), the RE air traffic controller determined that neither a reliable heading instruction nor a descent clearance were possible, as the aircraft was already flying at the minimum vectoring altitude (MVA) of 4000 ft AMSL.

Adding to the unfavourable visual conditions for all pilots, both aircraft were approaching each other with a constant angle (constant bearing) between 08:14:10 UTC and 08:14:42 UTC, meaning that the respective position of the other aircraft remained unchanged from the perspective of the pilots, as shown by the black narrow parallel connecting lines in Figure 1. It is, therefore, not surprising that the pilot of OK-ELL saw the large silhouette of the Fokker 50 only late as he initiated a right turn, thereby altering the constant convergence bearing. This indicates that the traffic information given by the PL Main aerodrome controller at 08:14:50 UTC, only four seconds before the closest point of approach, came too late.

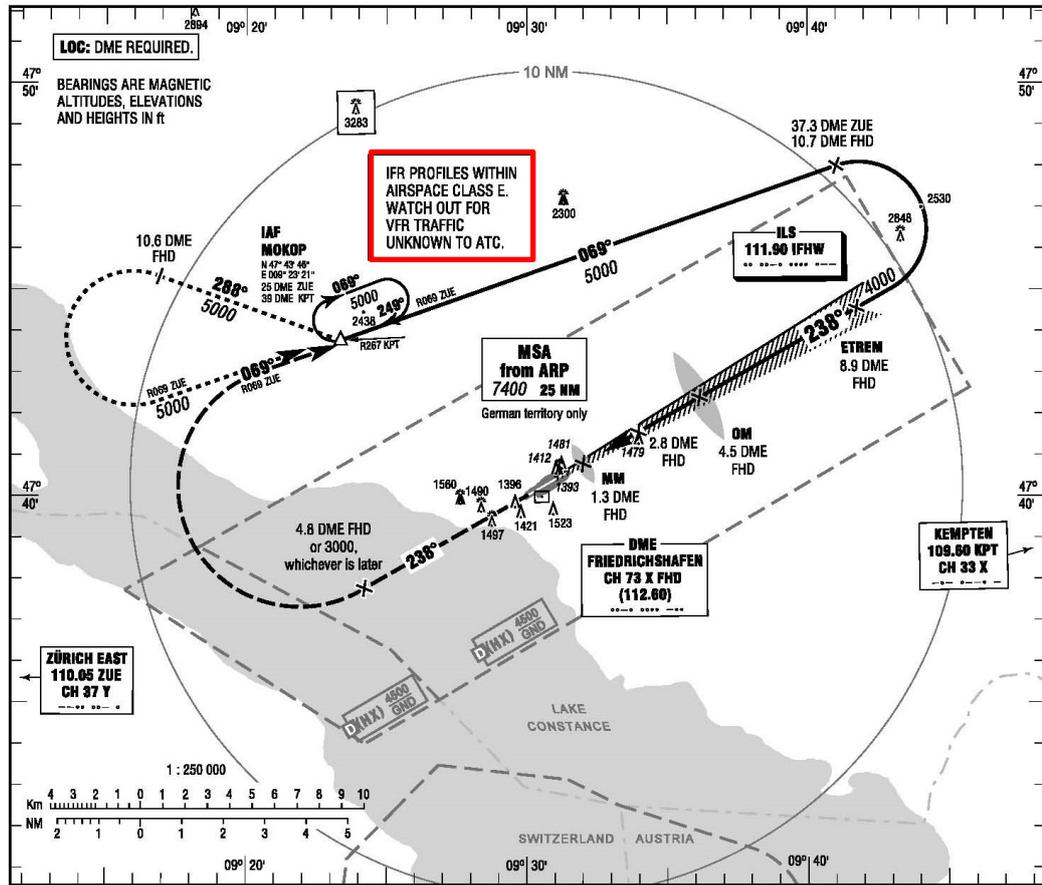
Figure 5: ILS approach to runway 24 in Friedrichshafen according to the German AIP with a note (red frame), stating that the approach leads partly through airspace E and therefore unknown VFR traffic is to be expected.

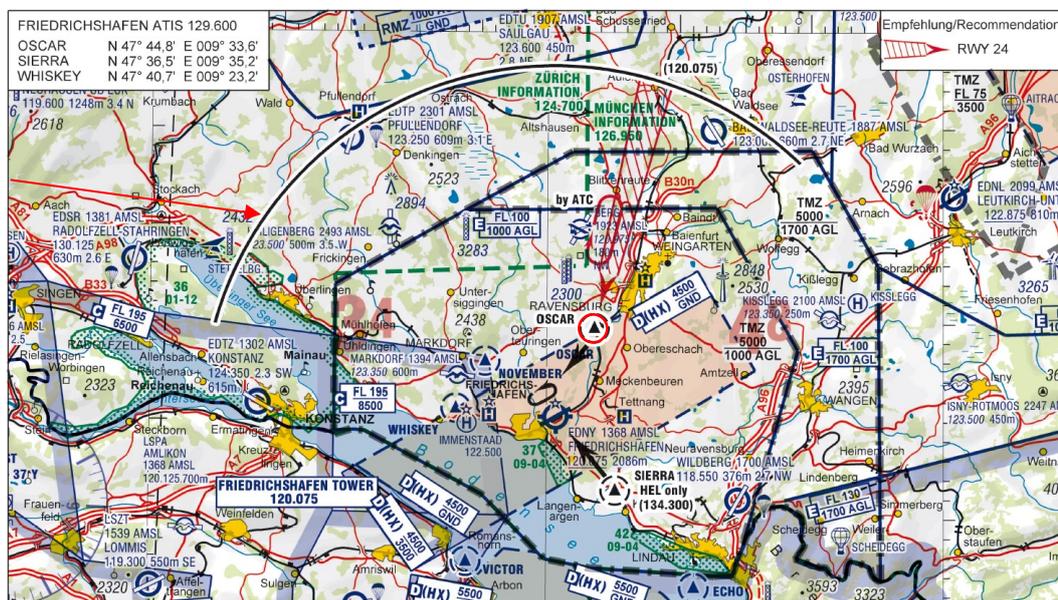
Figure 7: VFR chart pursuant to the publication AIP SUP VFR 07/16 of 14 April 2016, valid from 18 April to 24 April 2016, with the circular arc plotted at 18 NM around EDNY (red arrow) and the VFR arrival corridor to the compulsory reporting point OSCAR (red circle highlighted by the STSB)

According to the visual approach chart published on the occasion of the aviation exhibition, the flights on approach for the concrete runway 24 must proceed over the compulsory reporting point OSCAR, whereby the recommended approach corridor, crosshatched in red, must be followed (cf. figure 7). As a consequence, the VFR traffic is indeed channeled on an arrival route that must, however, cross the approach axis when approaching from the south. The approach altitude of not more than 4000 ft AMSL when flying to the compulsory reporting points constitutes a recommendation and corresponds to the MVA in this sector (cf. figure 1). In view of the lack of a flight altitude limit in the arrival corridor, as well as outside the CTR, an increased concentration of mixed traffic can be expected, especially in the right hand base leg for runway 24 when conducting IFR approaches, representing a systemic safety deficit.

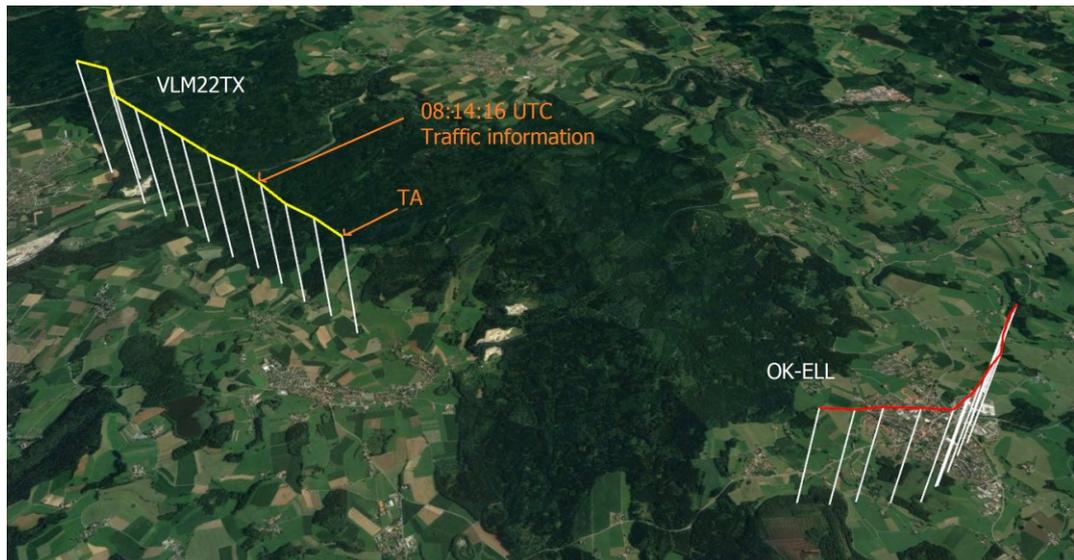
Figure 8: Convergence of the two aircraft based on the recordings of the MRT every 4 seconds and activation of a traffic advisory (TA) at approximately 08:14:27 UTC (orange), featured in Google-Earth

- Consequently, in terms of prediction time to CPA, the conditions on board VLM 22TX were satisfied for the activation of a TA between 08:14:27 UTC and 08:14:55 UTC, respectively for a RA between 08:14:41 UTC and 08:14:54 UTC.

- The CPA occurred at 08:14:54 UTC, as both aircraft were already on divergent trajectories. The separation was 0.5 NM horizontally and 100 ft vertically.

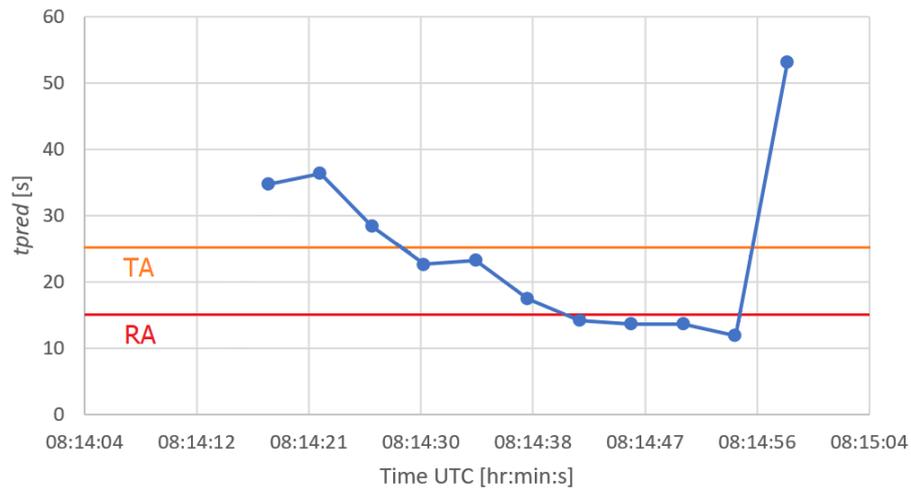
Figure 9: Prediction time (t_{pred}) to the CPA in the horizontal dimension during the convergence between the two aircraft with the two threshold values (TAU) for a traffic advisory (TA) (orange horizontal line), respectively for a resolution advisory (RA) (red horizontal line)

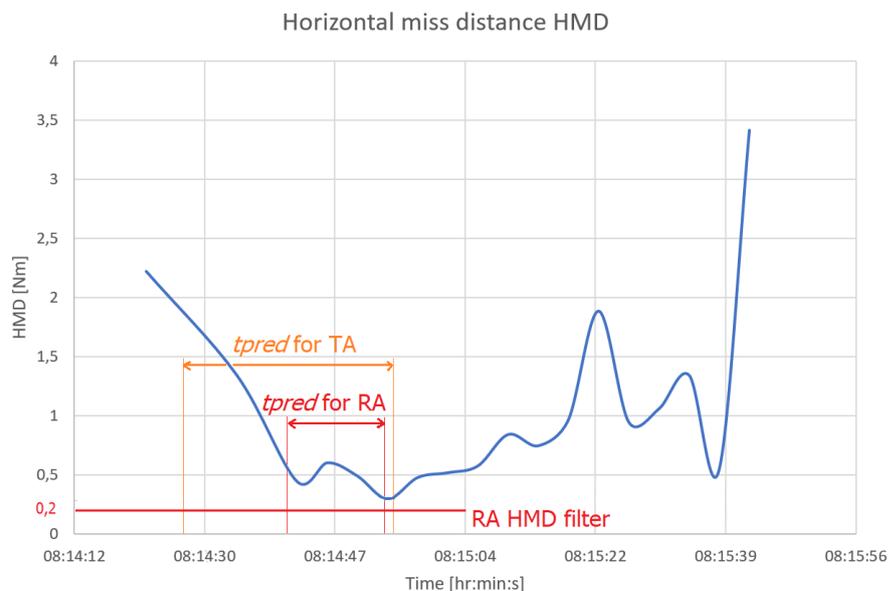
Figure 10: Horizontal miss distance (HMD) during the convergence between the two aircraft with the threshold value for a resolution advisory (RA) (red horizontal line) of 0.2 NM as well as the period of time during which the conditions were satisfied for the activation of a TA (t_{pred} for TA), respectively for a RA (t_{pred} for RA).
