**ACCIDENT**

<b>Aircraft Type and Registration:</b>	HPH Glasflugel 304 eS, G-GSGS	
<b>No &amp; Type of Engines:</b>	1 LZ Design D.O.O FES-HPH-M100 brushless electric motor	
<b>Year of Manufacture:</b>	2016 (Serial no: 059-MS)	
<b>Date &amp; Time (UTC):</b>	10 August 2017 at 1121 hrs	
<b>Location:</b>	Parham Airfield, West Sussex	
<b>Type of Flight:</b>	Private	
<b>Persons on Board:</b>	Crew - 1	Passengers - None
<b>Injuries:</b>	Crew - None	Passengers - N/A
<b>Nature of Damage:</b>	Fire damage to FES <sup>1</sup> batteries and FES battery compartment	
<b>Commander's Licence:</b>	British Gliding Association Gliding Certificate	
<b>Commander's Age:</b>	55 years	
<b>Commander's Flying Experience:</b>	314 hours (of which 25 were on type) Last 90 days - 9 hours Last 28 days - 7 hours	
<b>Information Source:</b>	AAIB Field Investigation

**Synopsis**

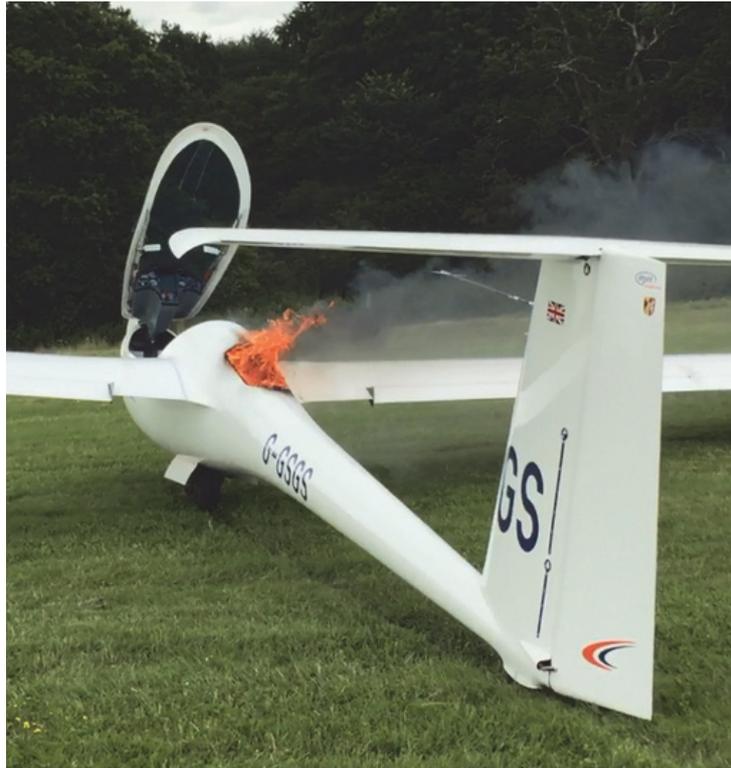
**Figure 1**

As the glider slowed during the ground run, the pilot smelled burning and the cockpit filled with smoke that was moving forward from behind his head. The pilot did not report observing any warning messages or illuminated LEDs on the FCU, although his attention was drawn outside the cockpit during landing. He vacated the cockpit normally, without injury, and observed that the FES battery compartment cover was missing and that smoke, followed shortly by flames, was coming from the battery compartment (Figure 1). The airfield fire truck arrived promptly and an initial attempt was made to extinguish the fire using a CO<sub>2</sub> gaseous extinguisher, but this proved unsuccessful. Aqueous film-forming foam (AFFF) retardant was then sprayed into the FES battery compartment and the fire was extinguished.

Fire in the FES battery compartment following the landing roll

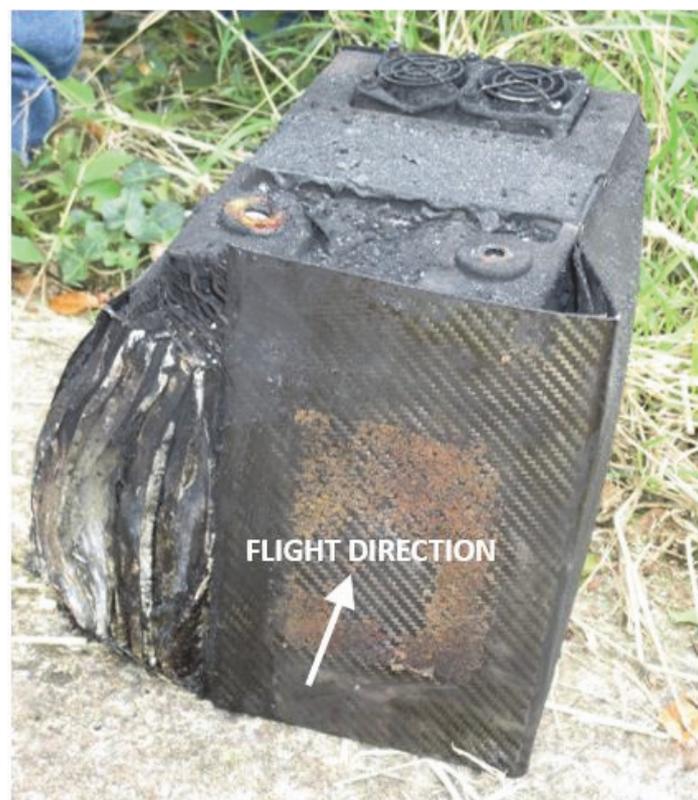
**Figure 5**

The origin of the fire was the forward FES battery; its battery box was ruptured along the rear left corner and the battery assembly was heavily fire damaged (Figure 5). The rear battery box suffered from external fire damage although the internal components were only slightly damaged and the cells remained charged.

Fire damage to the forward FES battery

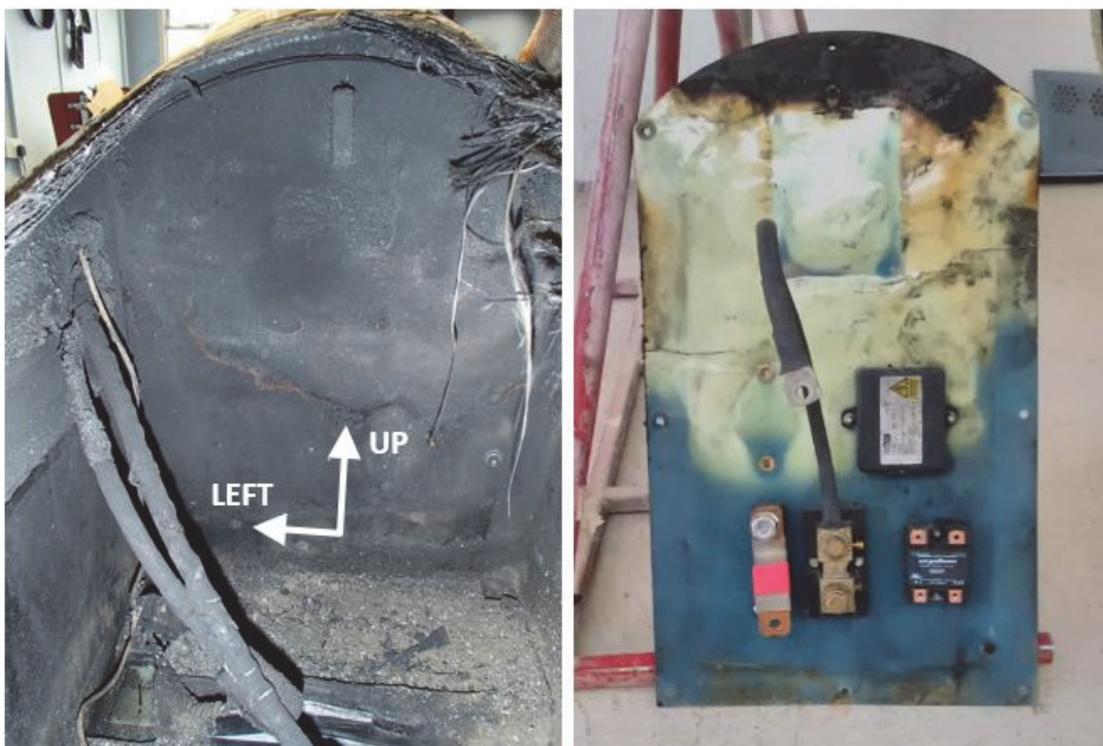
**Figure 6**

The FES battery compartment was heavily fire damaged with burning of the composite material's resin on the internal faces of the battery compartment and around the external cut-out in the upper fuselage skin. The top edge of the removable access panel that forms the front panel of the battery compartment (Figure 6) was also burned on its forward face and the FES electrical components in the equipment bay between the cockpit and the battery compartment were covered in soot deposits, demonstrating that the battery compartment had not contained all of the smoke and fumes released by the FES battery fire.

Fire damage to the FES battery compartment front access panel (left image, looking forwards), and to the forward face of the front access panel (right image, looking aft)

In the accident to G-GSGS, the smoke and fumes generated by the battery fire were not contained within the battery compartment, and entered the cockpit due to fire damage of the forward battery compartment bulkhead. This bulkhead was constructed of composite materials which ignited once the battery had begun to burn. Apart from this failure, the remainder of the battery compartment structure remained intact and prevented the fire from spreading further within the fuselage.

The HPH 304 eS sailplane manufacturer has replaced the composite battery compartment forward bulkhead with a stainless steel bulkhead to improve the fire-resistance of the bulkhead in the event of a battery compartment fire. The internal surfaces of the battery compartment are now painted in an intumescent fireproof paint finish.

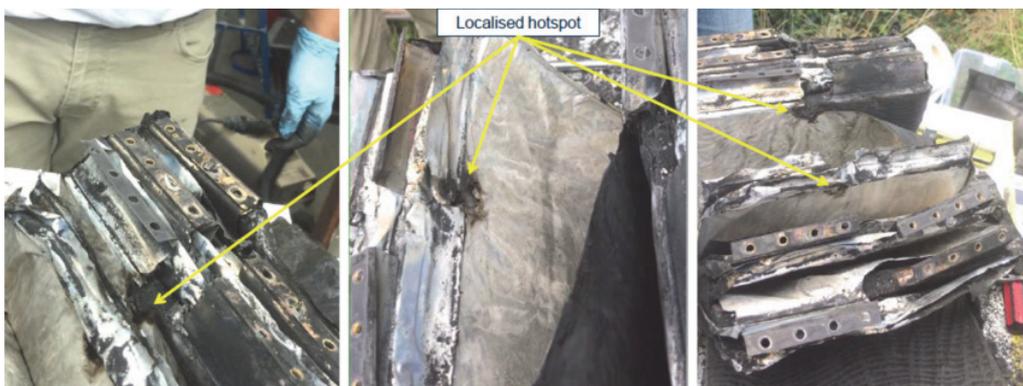
**Figure 7**

A localised hot-spot was observed between cells 5 and 6 on the upper edge of the cells in between the electrode tabs (Figures 7 and 8). The hot-spot was observed on the cell pouches and a number of the internal sheet electrodes were also exposed. The hot-spot did not appear to penetrate the whole cell pack thickness.

Localised hot-spot between cells 5 and 6 apparent during initial disassembly of the battery (courtesy British Gliding Association)

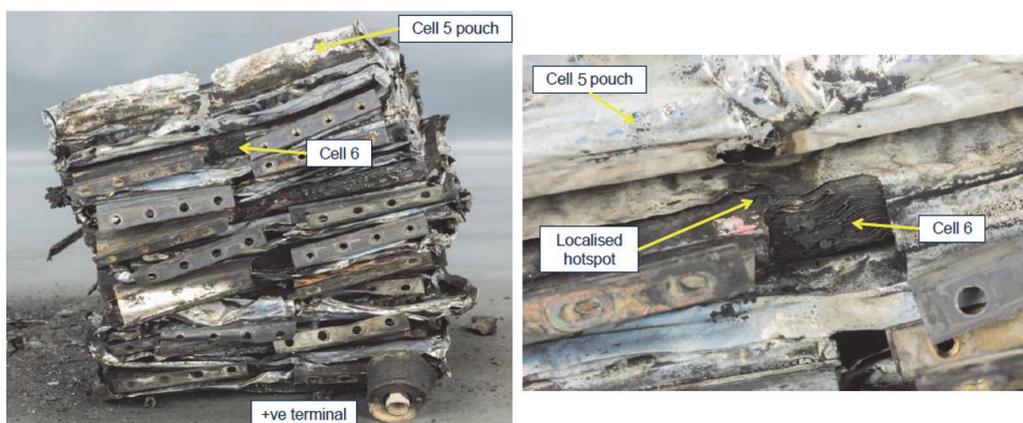
**Figure 8**

Localised hot-spot between cells 5 and 6 (courtesy QinetiQ)

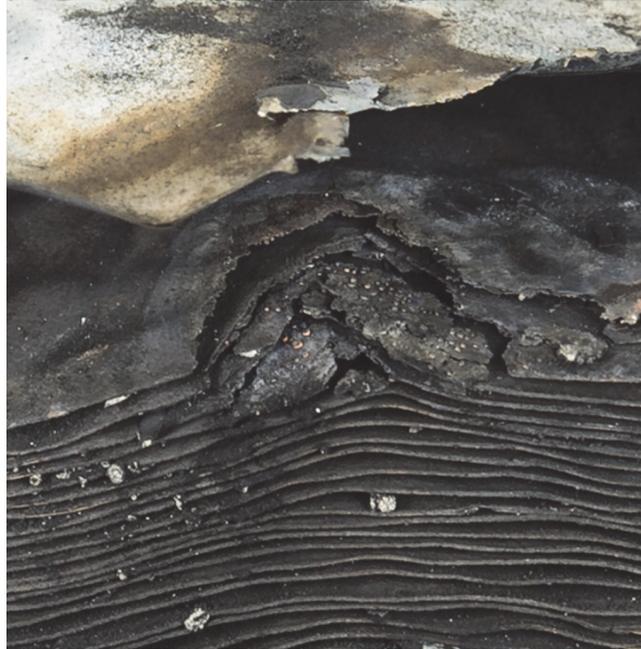
**Figure 9**

Examination of the hot-spot at cell 6 revealed localised melting of both the aluminium cathode and copper anode electrode sheets (Figure 9) indicating that the temperature at the hot-spot had exceeded 1,085°C, the melting point of copper. The presence of solidified molten copper was further confirmed by examination of the hot-spot location using a scanning electron microscope, and energy dispersive X-ray analysis of the molten copper deposits.

Localised hot-spot at cell 6, with solidified molten copper present  
(courtesy QinetiQ)

The G-GSGS battery fire started in the forward FES battery due to an electrical arcing event that occurred at the top of cells 5 and 6, as evidenced by melted copper and aluminium cell electrodes. The available evidence suggests that the electrical arcing began when the glider touched down during a normal landing. The temperature reached in the electrical arcing event exceeded 1,085°C and probably exceeded 1,400°C, based on the results of AAIB tests. The release of pressurised combustible gas from the forward battery caused over-pressurisation of the glider's battery compartment, leading to the detachment of the battery compartment cover. Once the battery's gel electrolyte had ignited, the fire continued to burn and consumed all of the electrolyte and also ignited the glider's composite structure, until the fire was extinguished by the application of AFFF foam retardant.

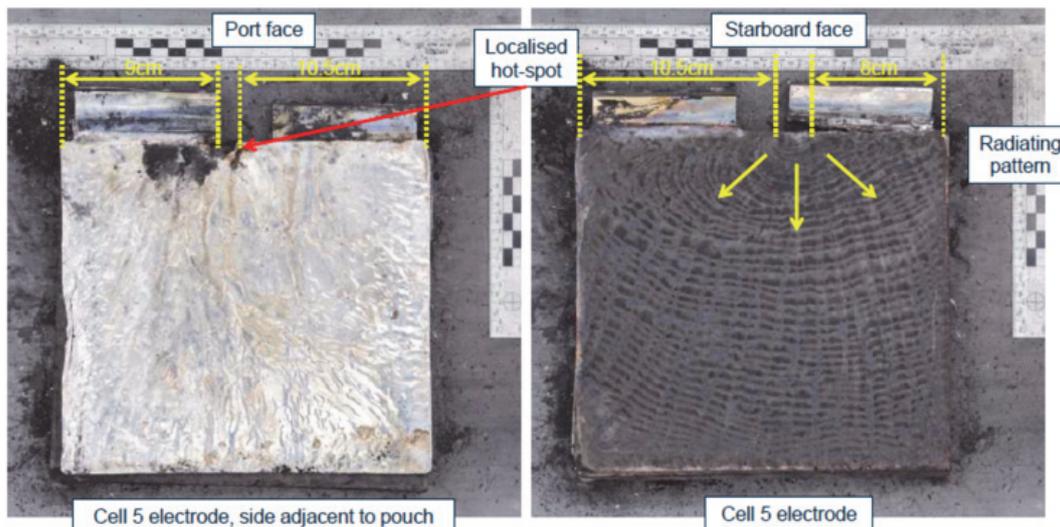
**Figure 10**

When cell 5 was disassembled, a radiating pattern of combustion-deposit ‘beachmarks’ was apparent, originating at the hot-spot (Figure 10). This indicated that ignition of the cell’s gel polymer electrolyte had begun at the hot-spot location before burning downwards through the cell. Detailed examination of the hot-spot sites did not reveal the presence of any foreign objects at these locations. There was no evidence of ‘welding’ of the individual cell electrodes; the cell packs appeared to be fused together with combustion products, most likely the gel electrolyte residues.

Combustion front 'beachmarks' evident on cell 5 electrodes (courtesy QinetiQ)

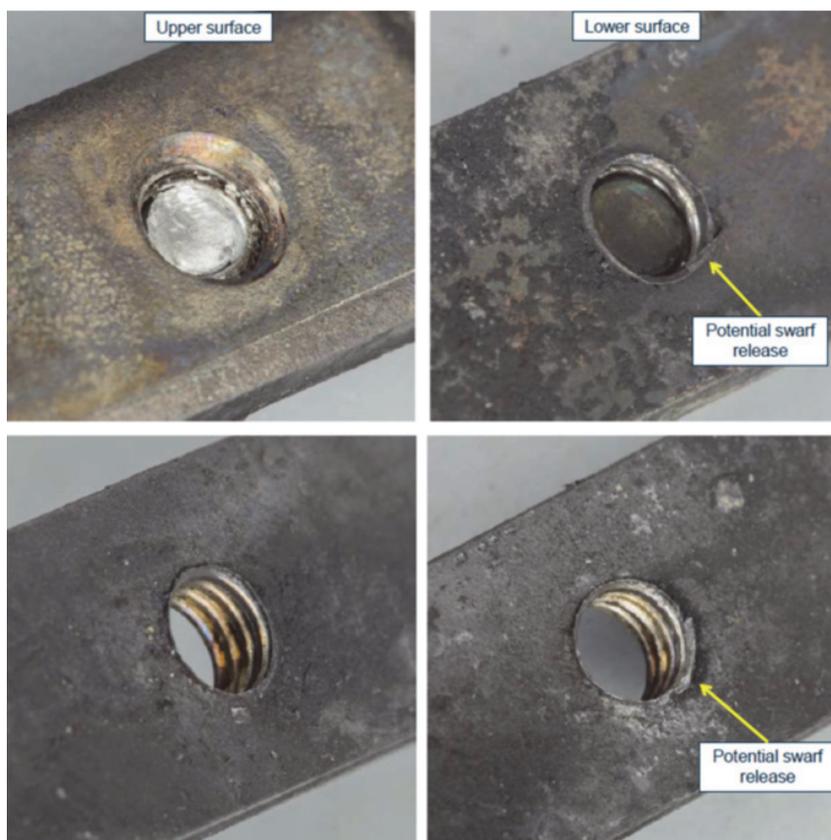
**Figure 11**

Examination of the lower stainless steel cell connector plates showed a burr present on a number of the drilled and threaded holes, on the lower surface of the plates (Figure 11). The visual examination also showed the potential formation of swarf from these burrs.

Thread-cutting swarf present on the lower surface of the connector bars (courtesy QinetiQ)

The new FES battery features additional nomex-mylar insulation between the cells and an increased quantity of silicone encapsulation of the battery cells to prevent foreign objects from falling between the cells. The edges of the battery cells pouches are covered in an electrically-insulating tape to prevent electrical discharge of the cell should the cell pouch seal fail. The stainless steel battery cell connector plates have been replaced with anodized aluminium plates which have been demonstrated not to eject machining swarf from screw threads when the connector screws are inserted during assembly.

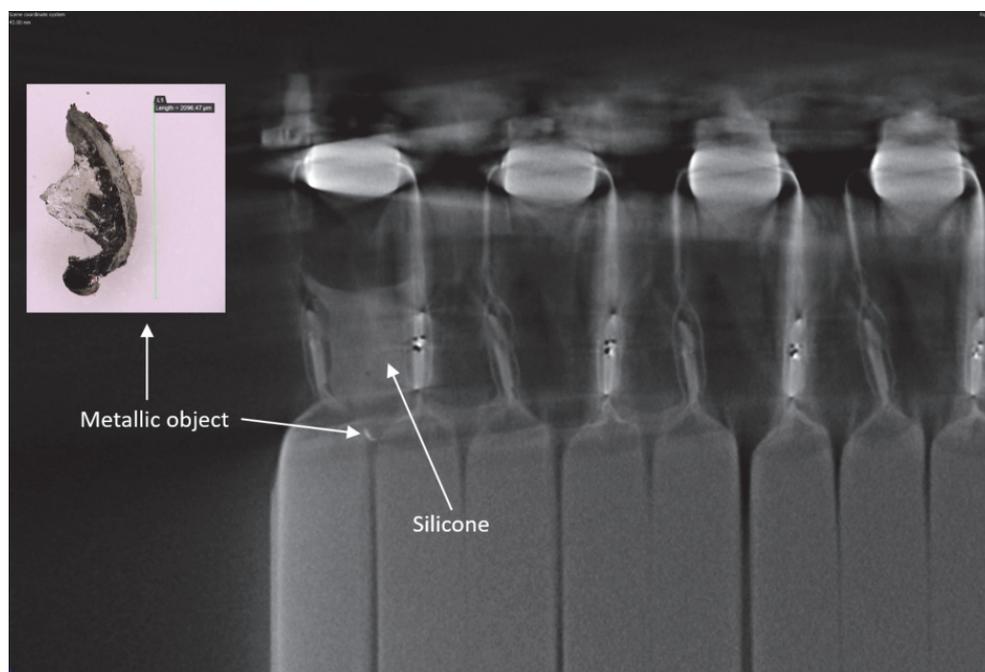
**Figure 14**

The CT scan of battery pack 080-B, the rear battery pack from G-GSGS, contained one metallic object lying between two cells at the top of the pack (Figure 14). This object was beneath the silicone layer indicating that the foreign object has been present when the battery pack was assembled.

The battery pack was disassembled and the metallic object was recovered. The object was a piece of metal swarf, 2 mm in length, with a distinctive curved shape consistent with the swarf generated during the thread-cutting process of the connector plates.

Metallic swarf debris within battery pack 080-B (courtesy QinetiQ)

Investigation of intact FES batteries revealed the presence of metallic foreign objects within the battery assemblies on 7 of the 11 battery packs investigated. Most of these metallic objects were less than 1.0 mm in length, although metallic objects up to 4.0 mm in length were detected. One battery pack was disassembled as part of the investigation which revealed that a 2.0 mm long metallic object was a piece of metal swarf, probably produced as part of the thread-forming operation on one of the battery's stainless steel lower connector plates. The location of this metal swarf, which was beneath a silicone layer, showed that it was present during the battery manufacturing process.

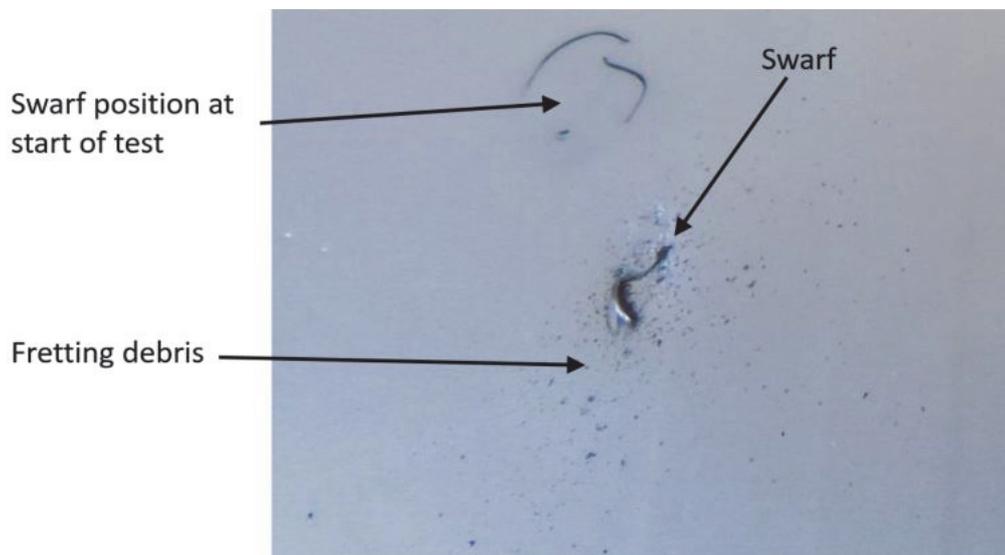
**Figure 16**

A second test was conducted with 3.0 mm lengths of steel swarf inserted between the cells (Figure 16). The cells were vibrated in the horizontal axis for 30 minutes at a resonant frequency of 20 Hz, during which there were no signs of fire, smoke or unusual odours. Following this test, the cell fixture was disassembled and it was noted that there had been migration of the swarf within the cell fixture and some fretting of the cell pouch material due to contact with the swarf, but the fretting depth had not exceeded the pouch thickness and no electrolyte had been released.

Cell pouch fretting during vibration testing with metal swarf present

The vibration testing conducted by the AAIB showed that whilst cell pouch fretting did occur due to the presence of swarf within a battery assembly, the fretting was not severe enough to cause the swarf to penetrate the cell pouch and cause an internal short circuit within a cell.
