Ref. No: CZ-15-110

FINAL REPORT

**Investigation on the serious incident
to Shorts SC7 Skyvan aircraft, OE – FDN
on 8 April 2015**

**Prague
December 2017**

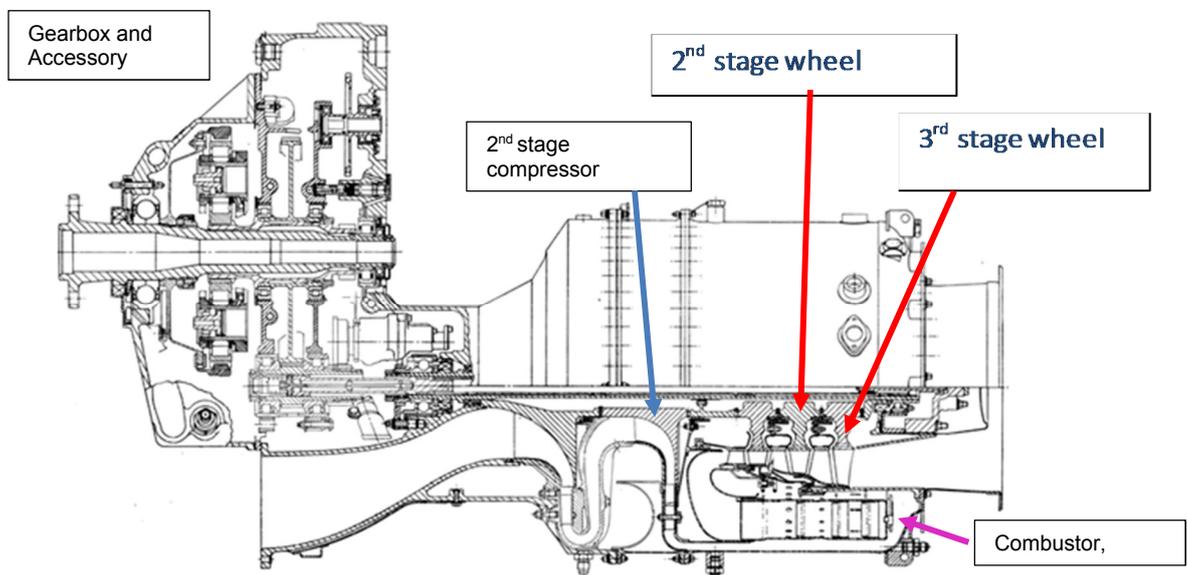
Upon landing the technical inspection revealed perforation in the lower part of the engine casing. A rupture of the rotor wheel of the second and third stages of the gas turbine occurred in the engine. The largest fragments from the turbine perforated the combustion chamber and the engine casing in the area of the rotor of the third stage of the gas turbine, and left the aircraft through the engine casing. Smaller fragments caused multiple perforation of the fuselage casing on the right side and perforation of the rubber bladder of the fuel tank. The fragments did not strike the load-bearing structure elements of the fuselage. Due to the fuel leakage the passenger compartment of the cockpit was contaminated as well as the space under the floor.

Fig. 1 Layout of the damage to the parts of the engine (source Honeywell)

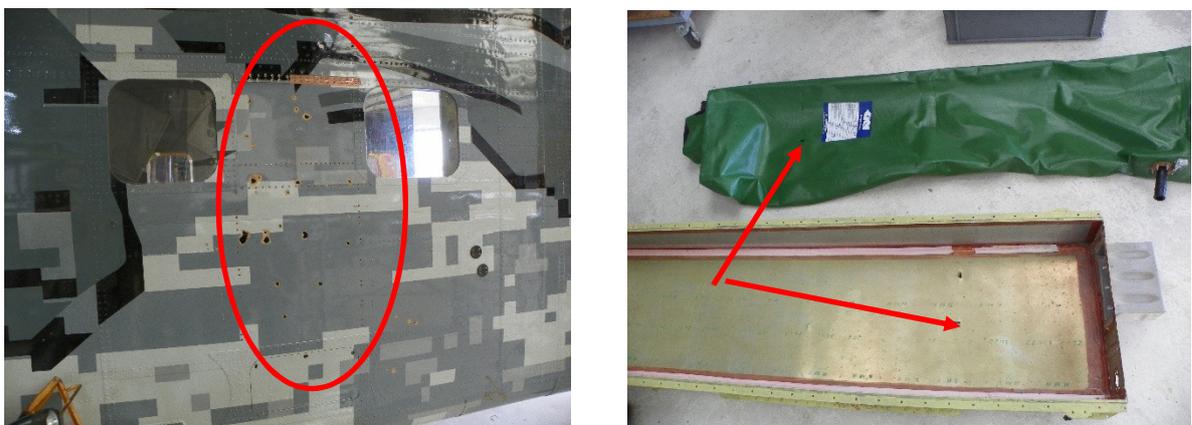
Fig. 2 Damage to the aircraft fuselage and fuel tank.

When bursting of the 2nd and the 3rd stage turbine, the fragments of the largest size penetrated the combustion chamber and engine casing and left the engine through the engine cover. At the same time, the smaller sized fragments caused multiple breakage of the fuselage wall on the right side and puncture of the fuel tank of the fuel tank.

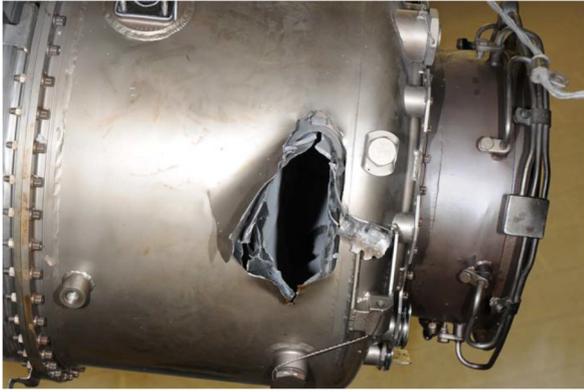
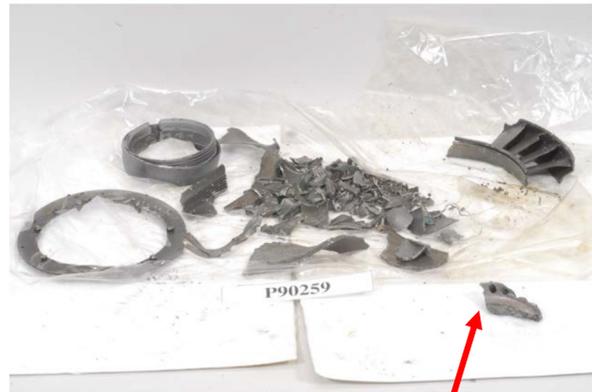
Fig. 3 Hole in Combustor Plenum Housing at 7:00 O'clock and debris - Fragment of a Turbine Rotor (source Honeywell).

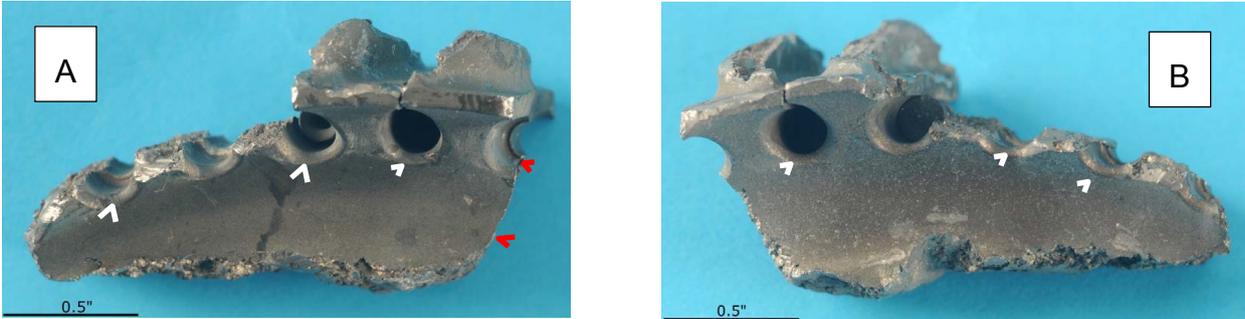
The examined fragment contained the web and airfoil regions of 5 fractured blades (Figure 5 and Figure 6).

Figure 5. Views showing the front (A) and rear (B) side of the 3rd stage turbine wheel fragment. (Honeywell)

Fractures occurred through two airfoils and three blade posts. Radial separations occurred through the rivet holes on each side of the fragment.

Red arrows in Figure 5 identify the primary fracture surface emanating from the aft corner of the rivet hole. White arrows (Figure 5 and Figure 6) identify cracks in the rivet holes.

Visual inspection of the rivet hole regions revealed cracks at the axial centres (small diameter) of at least 2 holes. Rivets were still installed in the two intact holes. Cracks were also observed in 3 of the 4 aft and forward corner radii.

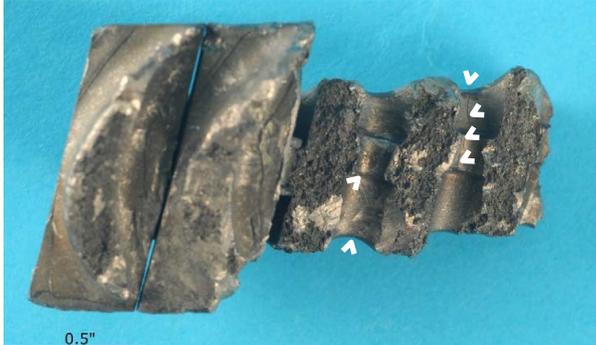
Figure 6. Views showing the airfoil and identify cracks in the rivet holes. (Honeywell)

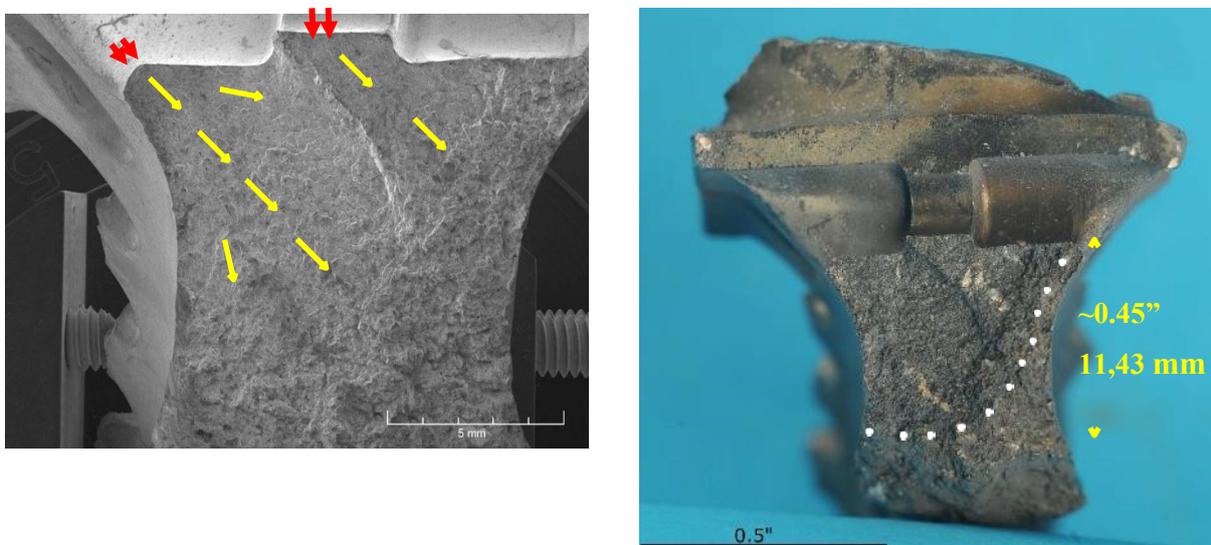
The fracture features on the airfoil and post separations were indicative of overload. The fracture features were characteristic of fatigue.

Scanning electron microscope (SEM) examination of the web separation confirmed the fatigue fracture mode. The primary fracture emanated from the aft corner of the rivet hole at 3rd stage turbine wheel (Figure 7) and a second fatigue origin emanated from the smallest diameter surface at the base of the rivet hole. The two crack fronts converged and propagated inboard cca 11,43 mm in fatigue before the final overload separation of the web segment occurred.

Figure 7. View showing the wheel fragment fatigue fracture of 3rd stage turbine wheel. The primary and secondary origin regions are identified by red arrows. Yellow arrows identify the direction of fatigue crack growth. (Honeywell).

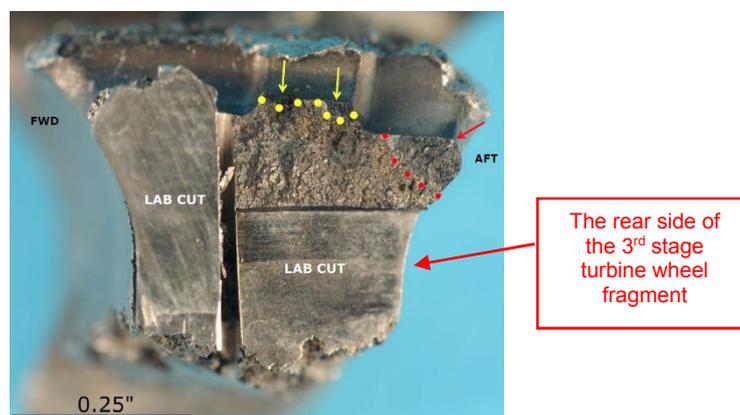
SEM evaluation of the aft surface of the segment confirmed the rivet hole cracks. The cracks didn't appear to have been associated with surface imperfections/machining marks. The fracture surface of one crack was exposed in the laboratory after cut in rivet hole (Figure 8). The exposed fracture surface revealed one discolored fatigue thumbnail emanating from the aft corner radius of the rivet hole propagated to a maximum depth of cca 1,778 mm from the aft corner of the rivet hole.

Figure 8. View showing the exposed fracture surface of the crack in the rivet hole of 3rd stage turbine wheel. Fatigue thumbnail patterns emanating from the aft corner of the rivet hole (red arrow) and smallest diameter surface at the base of the rivet hole (yellow arrows). Red and yellow dots outline the extent of fatigue propagation.

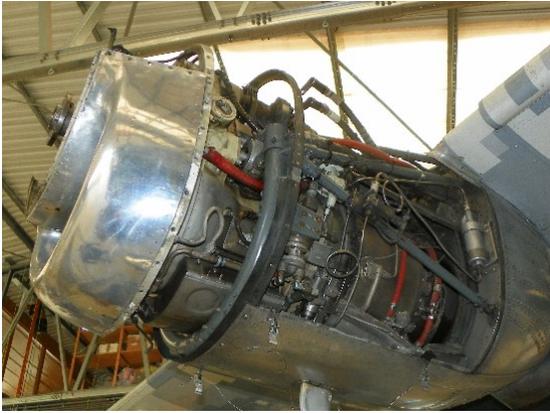
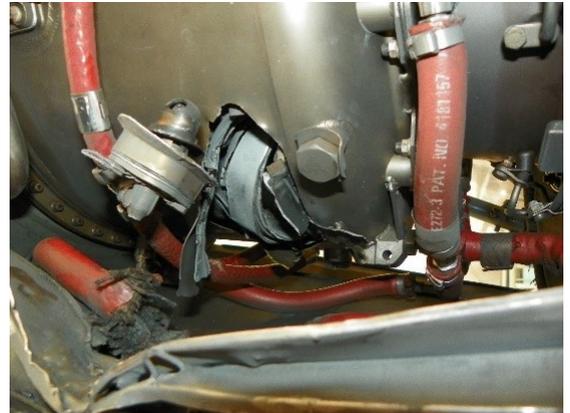
Fig. 1 - Engine No. 2 and the detail of the combustor plenum penetration.

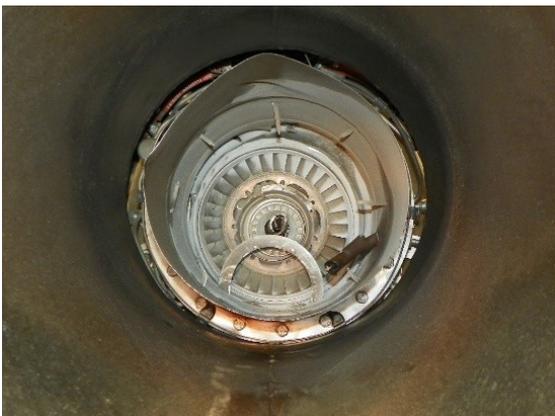
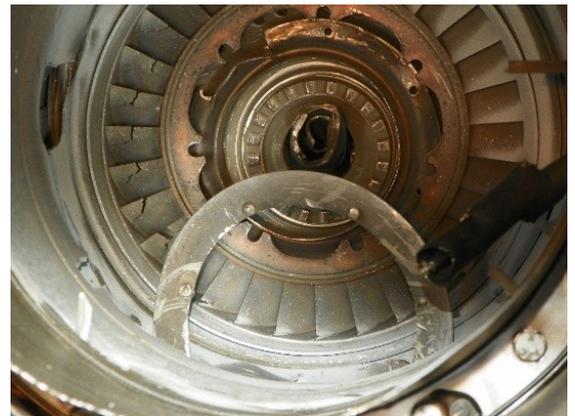
Fig. 2 - Rear view of engine No. 2 and detail of damage.

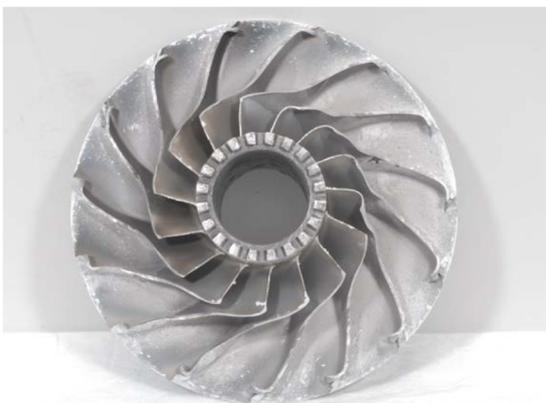
Fig. 3 – Damage of 2nd Stage Impeller.

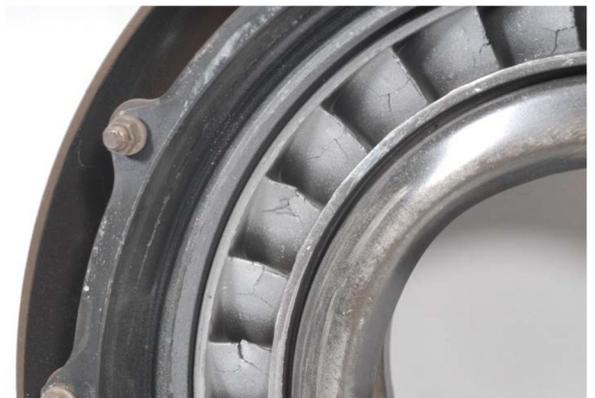
The 1st stage nozzle was intact, however the leading edges and trailing edges of approximately 2/3 of the vanes were cracked near the midspan. The 1st stage turbine wheel was intact however leading edges of all the blades were dented. The curvic teeth of the forward and aft coupling were intact but moderately deformed.

Fig. 4 – 1st Stage Nozzle - Cracks on Trailing Edges

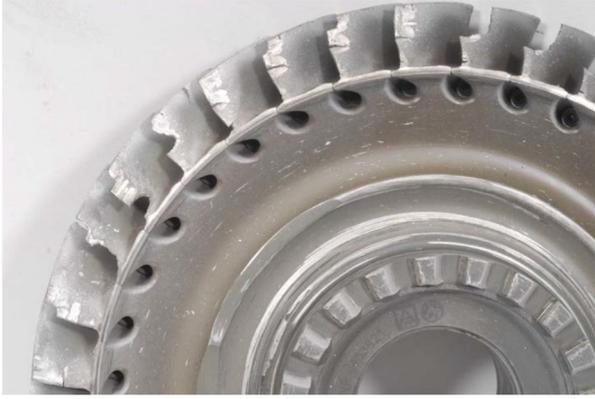
Fig. 5 – 1st Stage Turbine Wheel - Aft View.

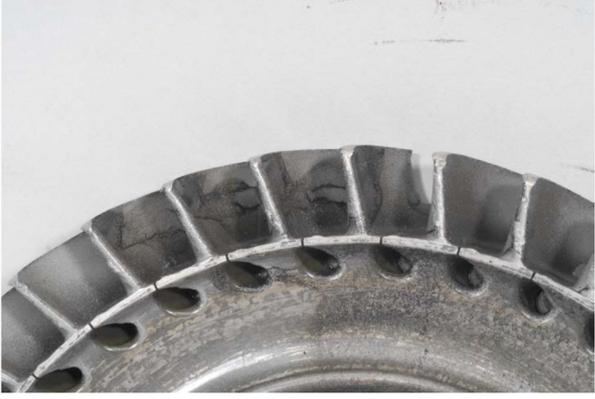
Fig. 6 – 1st Stage Turbine Wheel – Leading Edge.

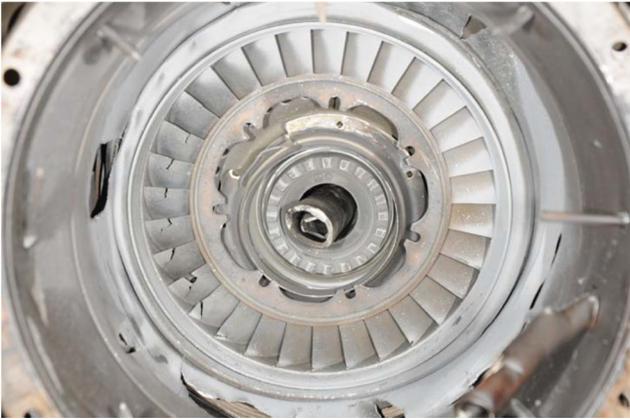
The 2nd stage nozzle was intact however the leading edges of approximately 1/3 of the vanes were rotationally scored, consistent with contact against the 1st stage rotor. The trailing edges of all the vanes were battered and approximately 1/3 of the vanes were fractured.

Fig. 7 – 2nd Stage Nozzle – Aft View.

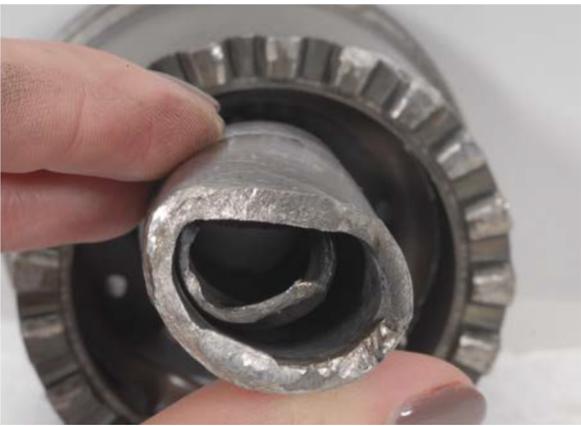
The main shaft was fractured in two locations: just aft of the 2nd stage impeller and just aft of the second stage disk.

Fig. 8 – Fractured Main Shaft and Torsion Shaft
