# FINAL REPORT

**Investigation of causes of an air accident  
of the Cessna 421B aircraft, ID mark OK-TKF,  
on 26 September 2017 approx. 1.5 km NE of Noviny pod Ralskem**

Prague  
January 2019

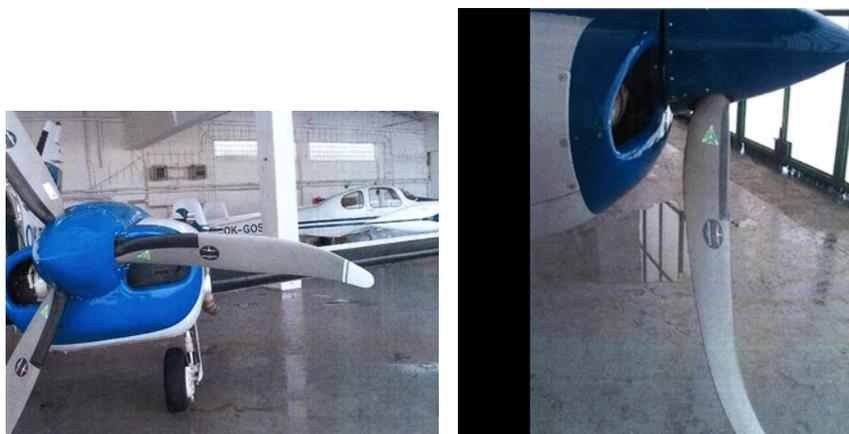
Fig. 7: Damaged propeller

The pilot, involved in this accident, stated that on 3 March 2004, the left main gear wheel of the aircraft concerned had got caught up in a patch of snow during a left-hand turn at LKMT. The left wheel was decelerated. The aircraft ran into deep snow. Having switched off engines, the pilot detected a bent propeller blade on the left engine upon visual inspection.

An authorised servicing centre repaired the propeller and the engine subjected to forced engine shutdown. The costs of repair work amounted to EUR 40,457.32.

The Logbook, namely the specific Section 1.6.3 lacks any record of work done or engine and/or propeller inspected following this event.

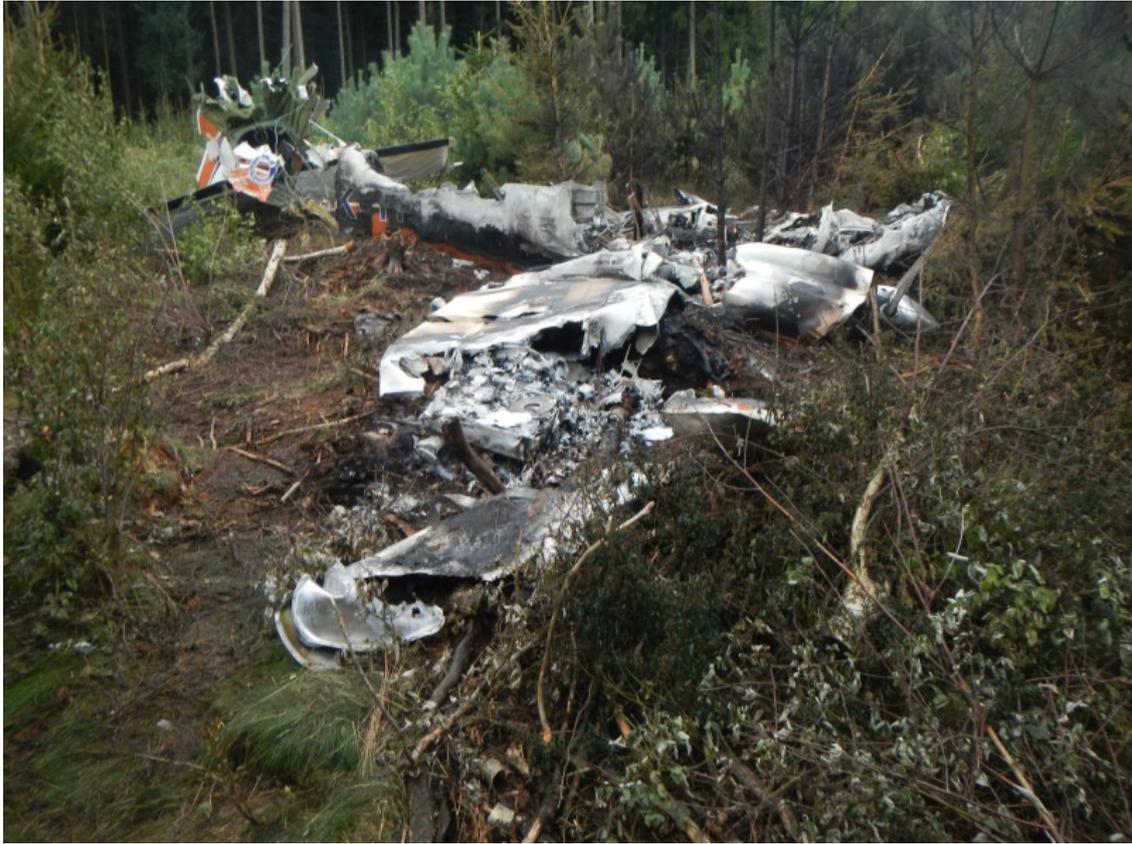
Fig. 11: Air accident location

The aircraft fell down at an angle of approx. 45° in the course of approx. 300°. It was damaged by the crash against forest trees, ground and subsequent fire. The wing with engines, the front part of the fuselage and the torn-off rear part of the fuselage with tail surfaces have been scattered in the area not exceeding the geometric dimensions of the aircraft by more than 2 m. Smaller parts of aircraft wreckage and its equipment were scattered up to 5 m away from the place of fall. Greater dispersion has been prevented by the dense forest.

The right half of the wing was broken at the wing root. The flaps were retracted. The damage to metal nose cones protecting propeller hubs corresponded to the crash at the above-mentioned angle. The angle setting of both propellers was compliant with the flight mode. One blade of the right propeller was stuck nearly vertically in the soft forest soil. The remaining two blades have been neither bent nor considerably damaged. The left propeller had two of its blades stuck in the same soft soil. The third propeller blade, almost in vertical position, has been neither bent nor considerably damaged.

The bottom front part of the fuselage together with the wing centre section and the cockpit area have been heavily damaged due to the impact coming from the front bottom, and also by the subsequent fire. The cockpit was pierced by two pine trunks (approx. 10 cm in diameter) during the fall. The effect of flames and fire was devastating, namely in the front part of the cockpit and in the wing centre section. At the time of the AA site inspection, the top part of the cabin was non-existent. The interior equipment made of flammable materials was completely burnt. Parts made of light metals were melted down and together. The seat frames made of more fire-resistant material have been preserved. The mechanical and thermal damage to the wreckage considered, it was not feasible to ascertain and evaluate the functionality of controls and positions of controls of aircraft and engine systems. The fuselage rear part has been broken off together with the tailplanes at the point of contact of the vertical stabiliser leading edge with the fuselage. The control planes have been firmly attached and secured. The distance between both the fuselage parts from each other, up to 50 cm, was caused by the tilted position of back parts of the wreckage rearward. The tilt angle of the leading edge of the horizontal stabiliser was approx. + 60°. The longitudinal axis of the rear fuselage part wreckage was following through to the longitudinal axis of the front fuselage part wreckage. Except for the detached, broken off tailplanes the whole aircraft was affected by fire.

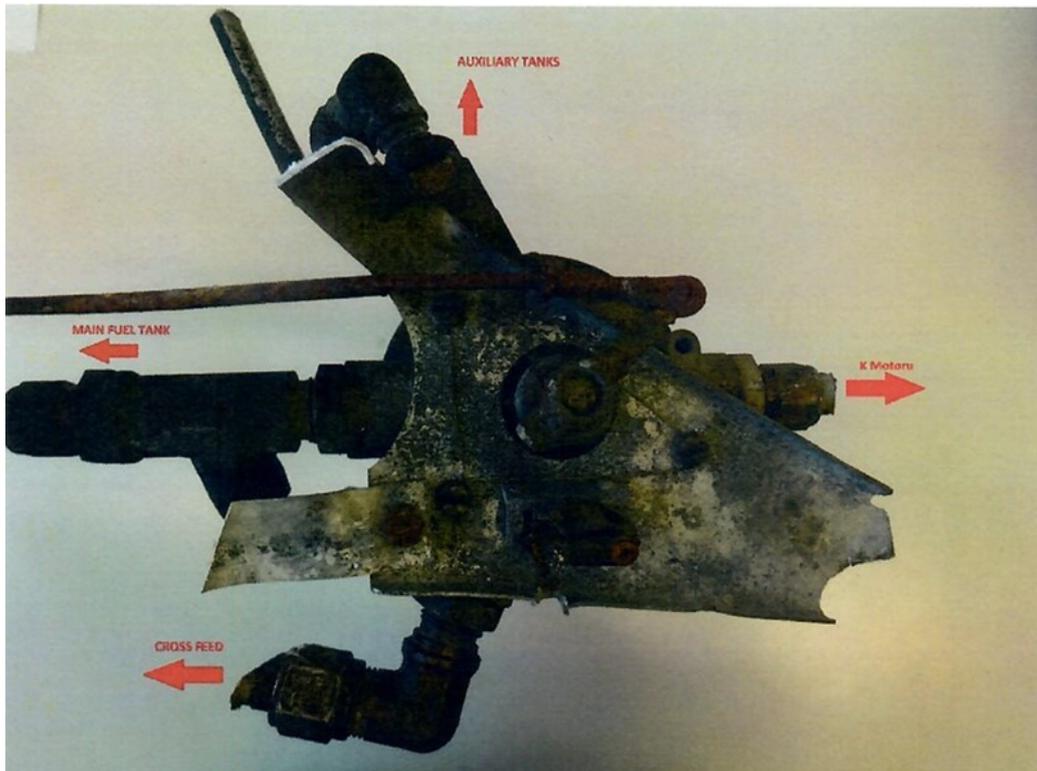
Fig. 12: Right fuel selector, outlets

In accordance with the Cessna 421B Maintenance Manual D817, the fuel selectors are located in the aircraft wings. See Appendix 2, page 2. The overall control of the selector is described in Appendix 2, page 3. In order to determine the position of the selector control lever, the inlet and outlet pipes have been identified first. By applying compressed air, the throughput test was performed confirming that the submitted fuel selector was switched to the "Auxiliary Tanks" position, see Appendix 3. The remaining output pipeline branches were closed, which indicates the switched position of the selector. Whether the selector was switched to the "Auxiliary Tanks" position due to the impact to the ground cannot be determined; considering, however, the construction features of the selector, this option appears to be improbable. For this reason, it can be stated that the selector had been switched to the "Auxiliary Tanks" position most probably by the pilot. Nonetheless, the possibility of the selector being switched to the "Auxiliary Tanks" position due to unskilled handling during selector disassembling from the aircraft wing by the rescue services personnel cannot be ruled out.

Note: The Commission members were present during the dismounting of the said fuel selector from the aircraft frame. During the stated disassembly, neither intentional nor unintentional change of the position of the fuel selector control took place. The complete Technical Report issued by the reviewer of the fuel selector forms one of the Appendices hereto.

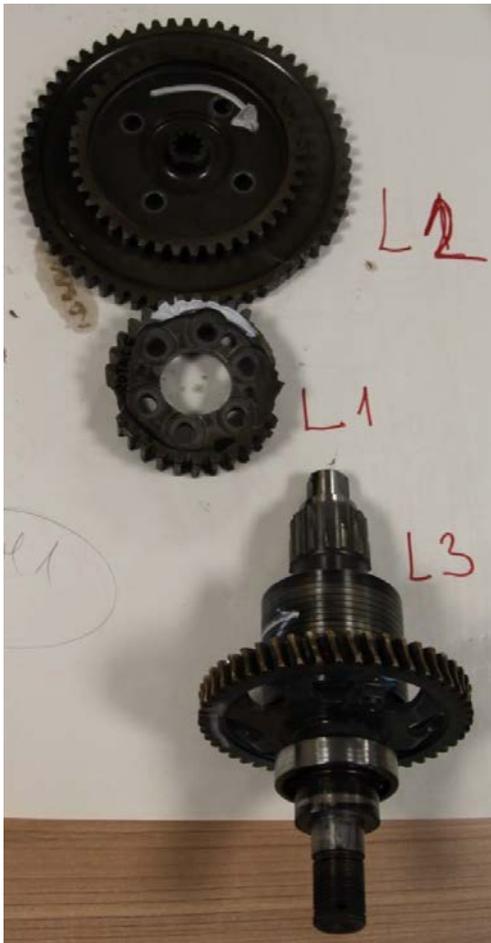
Fig. 3.2: Left engine teeth

The teeth of the left engine driven gear are damaged in one area only, see Fig. 3.6. L3 gear pinion teeth are completely damaged.

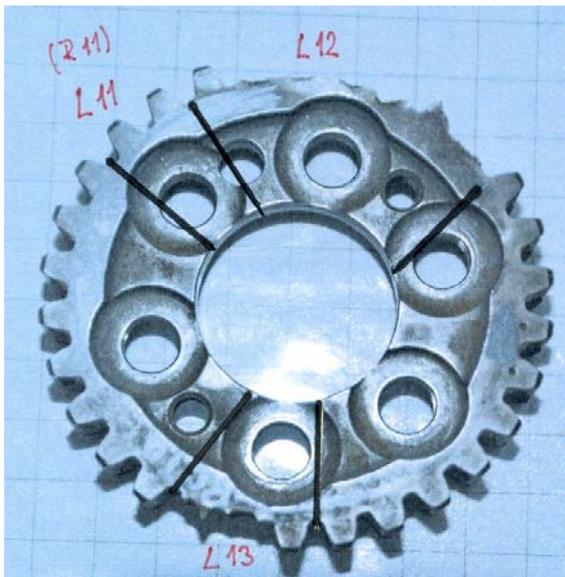
Fig. 3.4: L1 drive gear of the left engine

For the purposes of description and potential hypotheses of failure, the areas of failure on L1 drive gear were marked (see Fig. 3.4 and Fig. 3.5). As obvious from the photographs, L1 drive gear is damaged in two areas – L12 and L13 – corresponding in the angle to the gears in the engine. As evident from the submitted photodocumentation (see Fig. 3.5), there is indenting of teeth of L2 driven gear into the teeth of L1 drive gear. Given the engine rotation direction, these imprints are located in front of the location of the broken off teeth.

Furthermore, presence of a groove on L1 driving gear (see Fig. 3.4) ahead of the broken off teeth area (corresponding with the rotation direction) confirms a different mechanism of the defect origin.

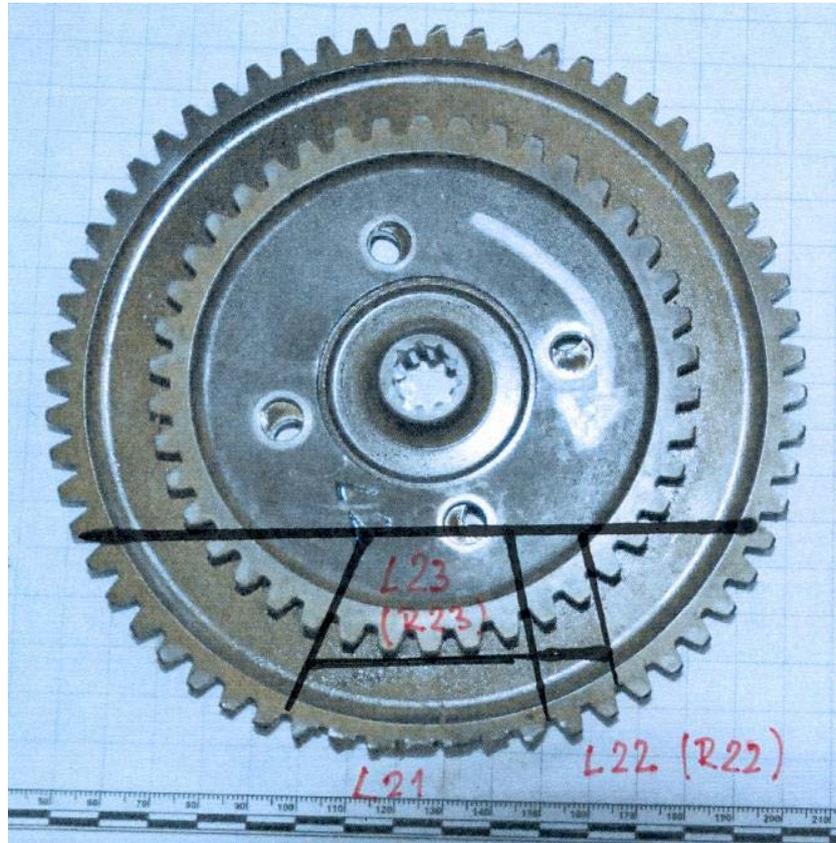
Fig. 3.6: L2 driven gear with the area of damage

Based on the state of the teeth, the possibility of wear damage can be admitted in case of the teeth of L2 driving gear; such condition, however, does not correspond with the damage occurred in the area in front of the broken off teeth location and thus cannot be considered as the primary cause of malfunction.

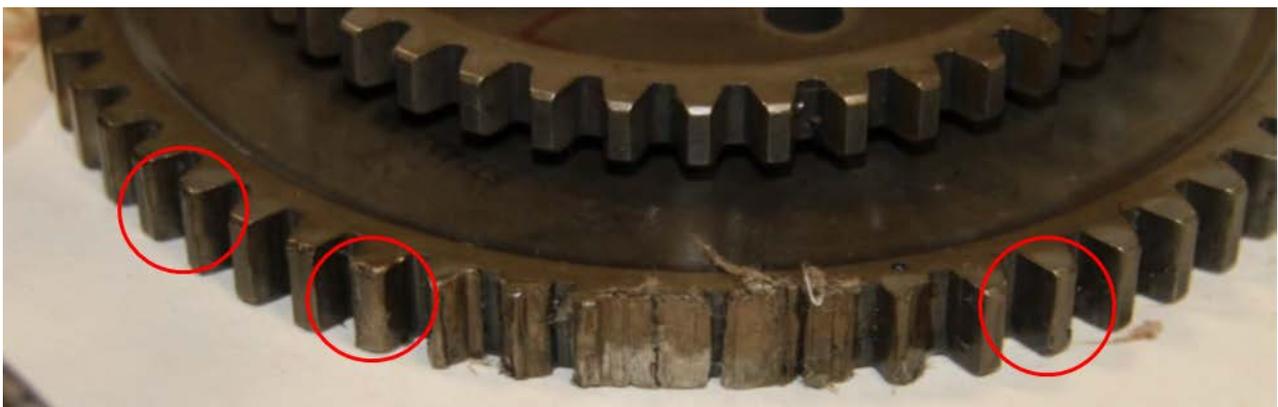
Fig. 6.1: Damaged faces of teeth on L2 gear

Based on the debate ensuing from inspection of L1 and L2 gears, traces of impressions as well as gradually disappearing damage of the apexes of L1 teeth, repeated on specific teeth, have been detected (see Fig. 6.1).

sufficiently long period of time in order to cause gradual damage to L1 driving gear (groove across several teeth) and pressing down of teeth on the driven gear. Once a certain degree of wear has been reached, substantial and major wear damage has occurred so that the teeth on L1 were broken off and pressed down and tore off teeth on L2 resulting in an immediate stall of the engine.

Resultant breaking off of two teeth on L1 driving gear and of all teeth on pinion L3 can be ascribed to the subsequent efforts of the pilot to start the engine up when the fixed worm gear was able to transmit the load onto the pinion which was thus damaged. The great strain on the starting mechanism is corroborated also by breaking off of the starter electromotor in the upward direction, i.e. the teeth of the worm and the gear were moved further apart from each other.
