CZ-17-1037

FINAL REPORT

Investigation of causes of an air accident
ULL EV97 EuroStar SL
reg. mark OK-UUU72
2 km E of Nížkov
on 24 October 2017

Prague,
November
2018

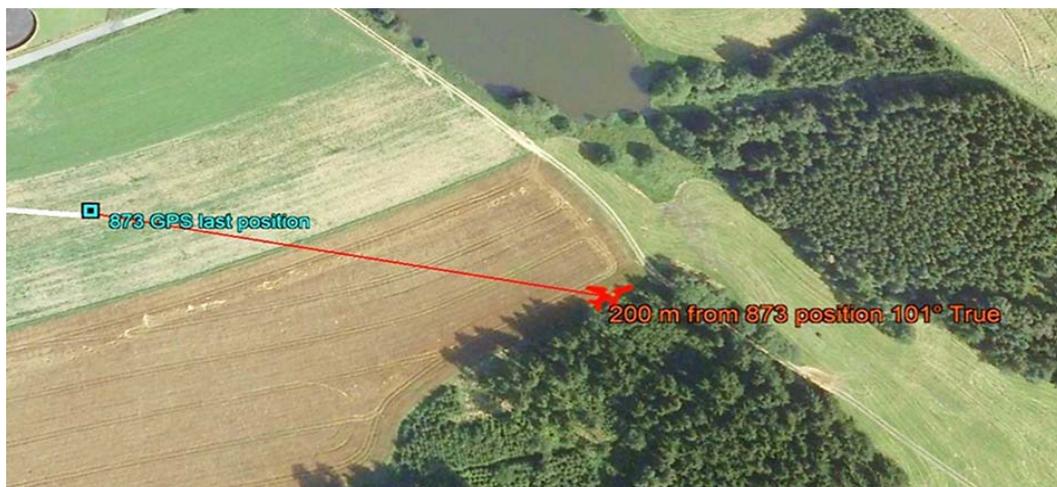
Fig. 2 Approach details from the last recorded point 873 by GPS Garmin 695

The pilot performed a turn over Nížkov and subsequently began to decrease the flight speed from 139 km/h GS-GPS all the way down to 98 km/h GS-GPS. At 10:38:27, the pilot overflew with the UL aeroplane at 2,035 ft ALT-GPS the power towers holding the high-voltage lines at 1,923 ft ASL.

During the overflight of this obstacle, the UL aircraft flight speed dropped from 105 km/h GS-GPS to 98 km/h GS-GPS. The UL aeroplane then continued in flight configuration without flaps down with backwind (310°/11 km/h) in the course 101° for about 200 m more. Upon retracting the backwind component of 8 km/h from the speed 98 km/h GS-GPS, the flight speed would be as follows:

The UL aeroplane was flying with a speed margin of approx. 12.7 km/h over the calculated stall speed 74.3 km/h IAS for the weight of 510 kg. The g-load factor of the UL aeroplane with a low speed margin above the stall speed, and very likely due to the low engine power output, led to – according to the factory test pilot – typical manifestation in wing rolling. This statement corresponds with the statements of the witnesses who observed the wing rocking phenomenon in the UL aircraft shortly before the AA. It was not feasible to objectively assess any further circumstances of the flight course and the engine mode. From the weather conditions on the AA site, low visibility was ascertained manifesting itself also in the treetops being covered by low clouds. The pilot lost the visual reference to the true horizon. Significant wing rocking of the overloaded UL aeroplane was a manifestation of low speed margin during flight above the stall speed. The UL aeroplane probably hit trees with the right half of the wing and subsequently the aircraft fell down from a height of more than 10 meters onto the field.

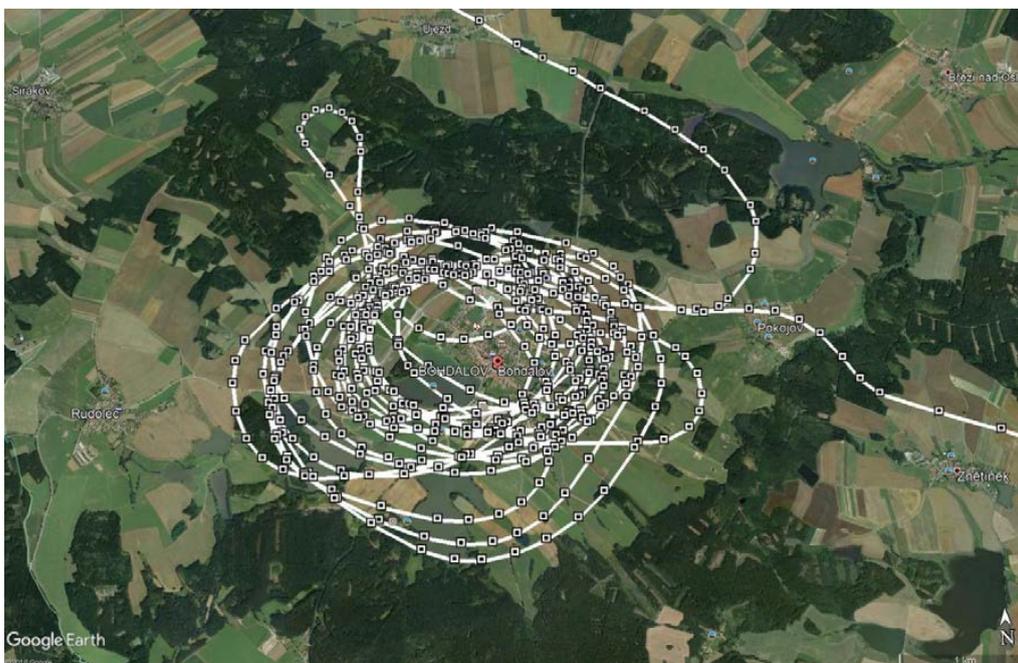
Fig. 3 Trajectory of the flight over Bohdalov

At 09:35:40, the pilot started a series of left-hand turns due to deteriorating weather in Bohdalov. After 55 minutes of flying in circles over Bohdalov, the pilot evaluated the weather conditions and opted for precautionary landing. At 10:31:28, the UL aeroplane departed from Bohdalov and continued flying towards Nížkov. While flying towards Nížkov, the UL aeroplane crew noticed a man driving a tractor in a field and decided for precautionary landing close to him. The landing took place in fog, in flight configuration without flaps down and with a greater weight than authorised. The course of the flight was recorded by the GPS Garmin 695 navigation device. Flight parameters were used for a graphical representation of significant flight phases during AA investigation. All ALT-GPS and GS-GPS were read from the data recorded by Garmin 695. The recorded ALT-GPS was compared with the LKKU AMSL. While the UL aeroplane was taxiing on RWY02C before take-off, Garmin 695 recorded ALT-GPS, AMSL lower by 20 ft than the AMSL of measured and compared points on RWY02C.

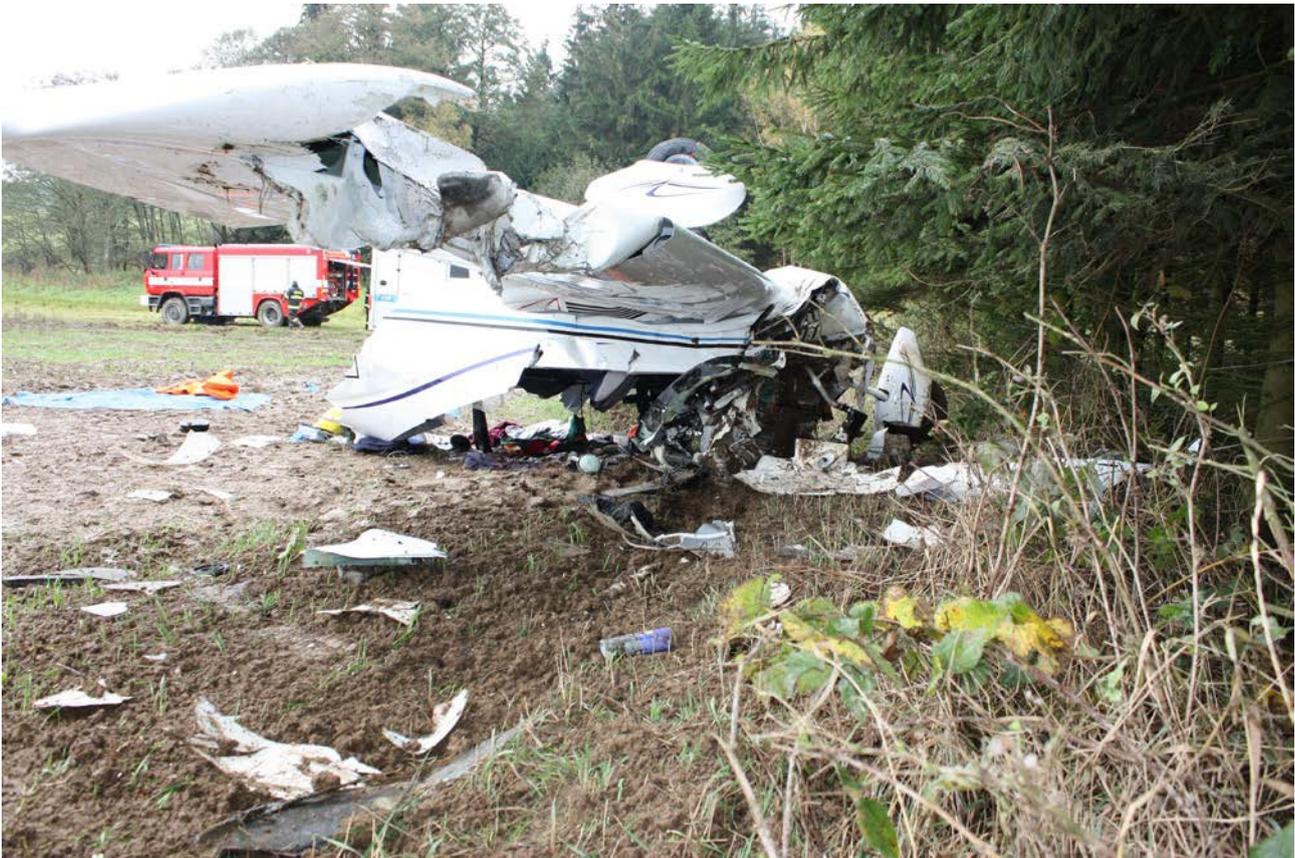
Fig. 5 Crash site location and UL aeroplane debris.

The UL aircraft was totally destroyed by the fall. The engine and engine cradle were torn away and wedged in under the deformed front part of the fuselage. The leading edges of both wing halves, the cockpit, HR and RUD were seriously damaged.

The UL aeroplane AA location is located at the borderline of a forest and a field approx. 35 m from Gigantský rybník (pond), in the vicinity of an access field road. The approach trajectory led across the high-voltage power line with steel towers with height of approx. 9 m above the ground; the line leads exactly between the recorded points No. 872 and No. 873 from the navigation device GPS Garmin 695. The first hit by the UL aeroplane was – considering the flight trajectory – very likely into the tree crowns with the leading edge of the right half of the wing. It was probably followed by rotation of the UL aeroplane to the right accompanied by the hit of the left half of the wing into the trees again. After the impact, the UL aeroplane turned over around the longitudinal axis and fell to the ground on its back from an altitude higher than 10 m on the engine part of the fuselage. The engine part of the fuselage was deformed symmetrically and the engine was forced out of its embedding and wedged into the cockpit. The leading edge of the right half of the wing bore significantly less noticeable traces of a direct hit into an obstacle than the left half which showed traces of a heavy damage to the leading edge following the impact into the trees. Both the wing halves had the flaps retracted and the lever controlling the flaps was in the retracted position. The control sticks were slightly bent. The foot controls were deformed by the impact and moved in the direction inwards into the cockpit. The values on the engine gauges were all 0. The altimeter was set to the value of 1,023 hPa. The altimeter was damaged due to the impact and the altitude indication did not correspond with the actual AA altitude. The power unit control lever was in the fore position. The carburettor preheating was on. The circuit breakers on the panel in the cockpit were forced out of their slots, some were missing. Avionic Master Switch was in the OFF position. The propeller blades were broken off at the cap. The HR and RUD tailplanes were seriously damaged. After the AA, only approx. 26 l of fuel was pumped out from the aeroplane tank.
