AIR ACCIDENTS
INVESTIGATION INSTITUTE
Beranových 130
199 01 PRAGUE 99

CZ-18-0679

FINAL REPORT

**Investigation of causes of a serious incident
of Boeing B737-800 aircraft,
identification mark N624XA
at LKPD
on 1 August 2018**

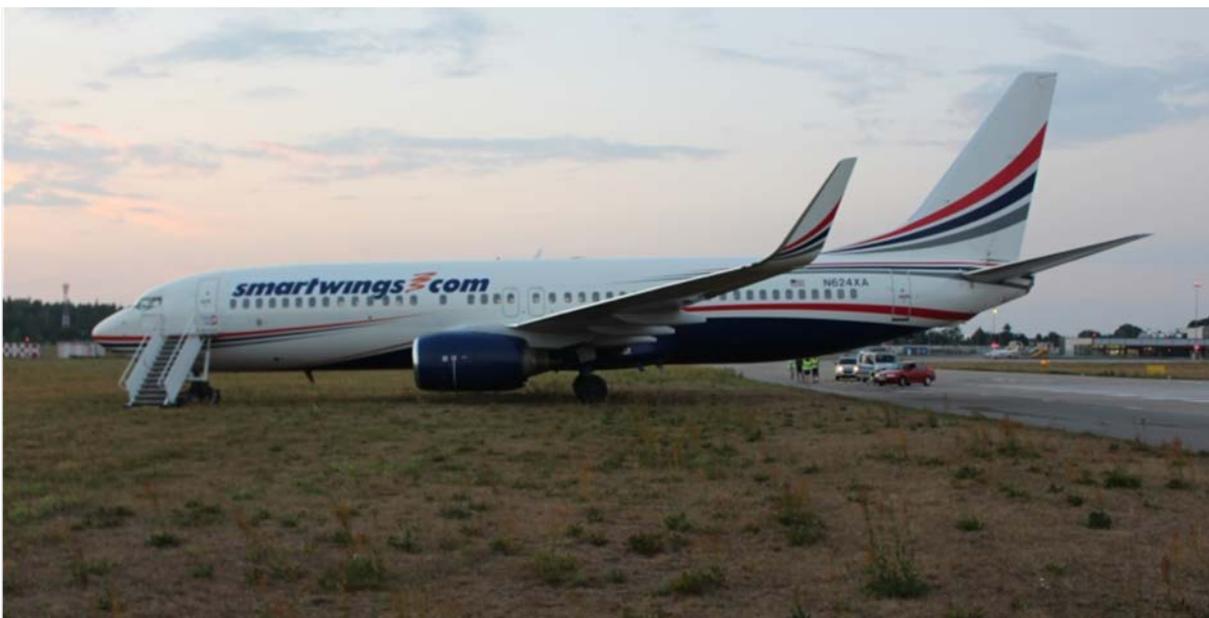
On 1 August 2018, the AAI was notified of overrunning off the western end of RWY 27 during landing at LKPD by Boeing 737-800, identification mark N624XA, flying from Iraklion / Nikos Kazantzakis to the planned destination airport Pardubice – flight No. TVS1903. The crew performed ILS approach to RWY 27 after a shower of rain. The final approach segment under 1000 ft AGL was carried out by manual landing. The aircraft overflew the threshold at higher altitude and landed approx. 600 m beyond the touchdown zone. The crew failed to correctly apply the brakes during landing run in the remaining segment of landing distance available on RWY 27 and the aircraft main landing gear overran into the unpaved clearway by approx. 12 m.

Figure 1 B 737 after overrunning the runway.

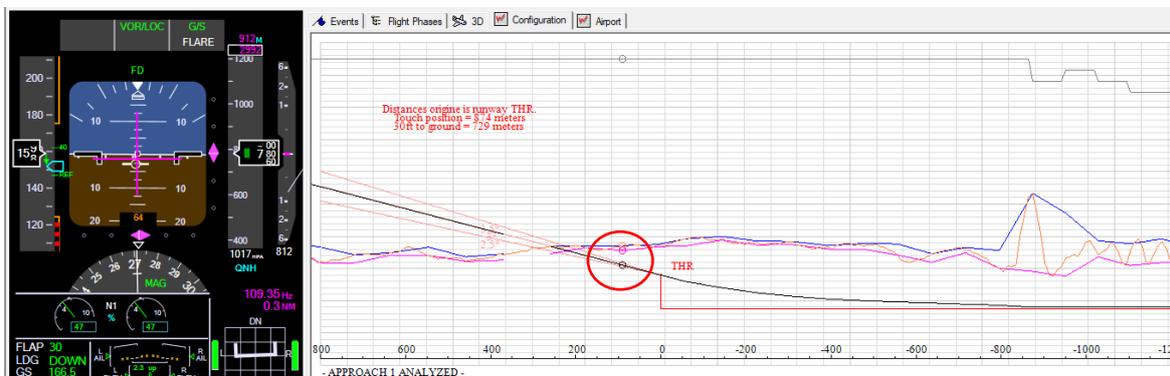
The aircraft had the full landing configuration with the approach reference speed $V_{REF} + 12$ kt at 4.7 NM from the airport. At 2 NM the aircraft was already on the required $V_{REF} + 5$ kt. The crew overflew THR RWY 27 at approx. 64 ft and performed touchdown outside TDZ at the distance of 965 m. THR is not shown in the correct position in the chart. The correct THR position is shown at 50 ft RA (by recalculating the position of the aircraft arrest) and is highlighted in Fig. 5 by red circle. Pass over THR at 64 ft, braking pressure and the GS deviation are recorded by the plotter due to the FAP inaccuracy.

Figure 5 PFD and graphics parameters with calculated THR inside red circle

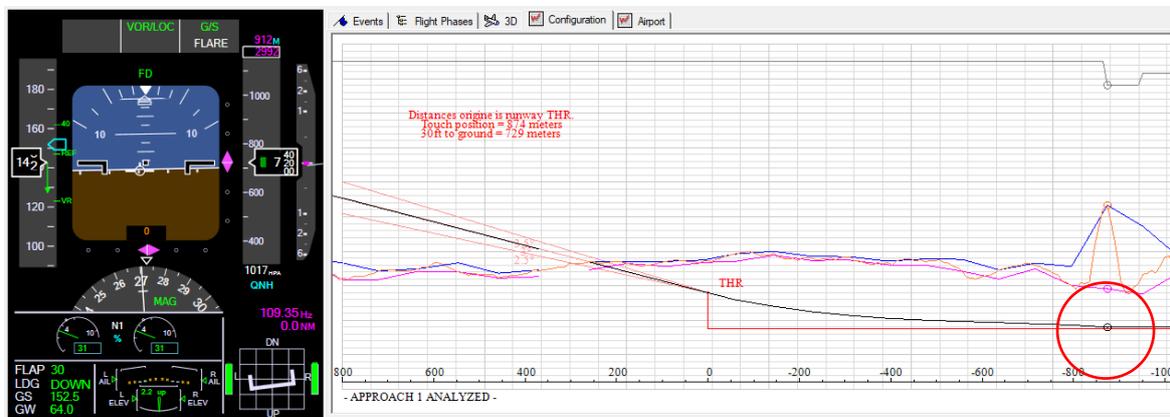
Figure 6 Touchdown at $V_{REF} - 4$ kt and Ground Speed 152.2 kt

PIC further stated that the visible glare had made it impossible to well recognise the runway markings which assist pilots in finding directions and identifying TDZ. At approx. 1000 ft, FO/PF turned off the automatic control and was carrying out landing by hand. Although PIC/PM could not see runway markings on TDZ well, he failed to employ *back up by instruments* so that FO/PF had relevant and correct flight trajectory information. FO/PF thus had to land the aircraft only based on his own estimate. The footage from the camera placed at the Pardubice airport shows prolonged “soaring” of the aircraft with touchdown beyond TDZ at approx. 965 m away from RWY 27 THR. The crew also failed to determine the Go-around point. After touchdown on RWY 27, DFDR captured unloading of the right main gear wheels for some 1 sec. Such unloading occurred at the time of retracting of ground spoilers. The crew was advised by TEC/TWR to vacate RWY 27 via TWY D. Data downloaded from DFDR confirmed that the reverse thrust of both engines had been used immediately after retracting of ground spoilers after touchdown on RWY 27. Except for a single moment when FO/PF was suggesting the use of AB 3 (due to possible rain), the flight crew was not realising that in case of use of full reverse of both the engines and AB 2, they were in any case far beyond LDA of 2,500 m. They should have also taken the sudden tailwind with a threat of possible long flare into consideration. The videofootage shows the use of reverse engine thrust also in immediate vicinity of the aircraft crossing the runway marking. Nonetheless, the data from flight recorders and videofootage from the passenger cabin revealed no heavy braking of aircraft in the last third of RWY 27. No damage and no traces of heavy braking were observed on main gear wheels and tyres. The crew observed the visual markings indicating the approaching end of RWY only after the aircraft had decelerated to 80 kt. Until this decision-making point of PIC/PM, the crew were busy discussing topics not related to flight performance. Afterwards PIC/PM took over control too indifferently and commenced manual braking of aircraft. It was this “pace” of his decision-making which, together with all the previous mistakes, was the last error which resulted in PIC’s failure to brake aircraft home on RWY after taking control and the aircraft stopped with its main gear approx. 12 m beyond the end of RWY.

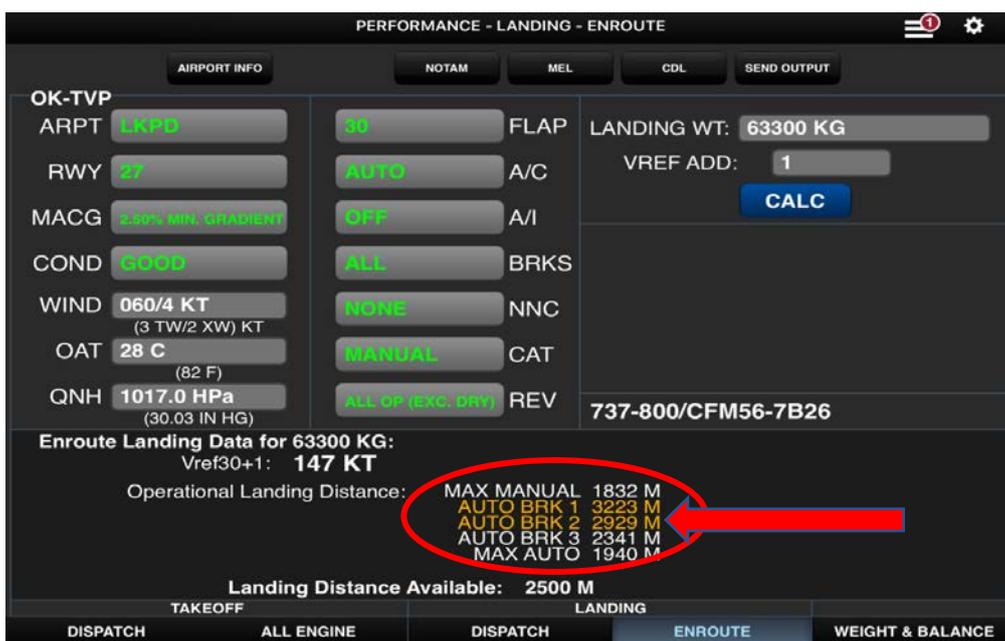
Reported conditions (at time)	Factored distance [m]	Unfactored distance [m]
Speci 240°/3kt (-13min)	2764	2403
ATC (-10min)	2823	2454
ATC (during landing approval)	2929	2546

Fig. 14 Simulation of calculation with correction 1 kt, Boeing OPT software

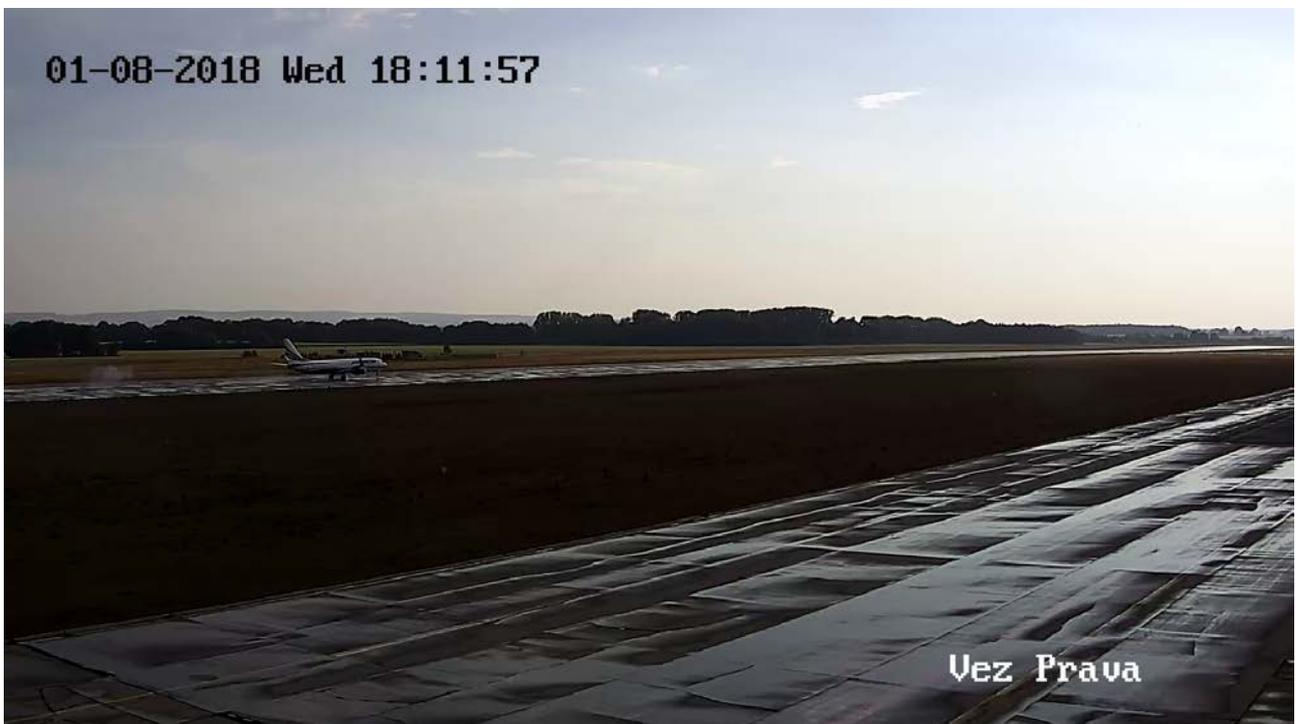
Figure 17 B 737 touchdown on RWY 27

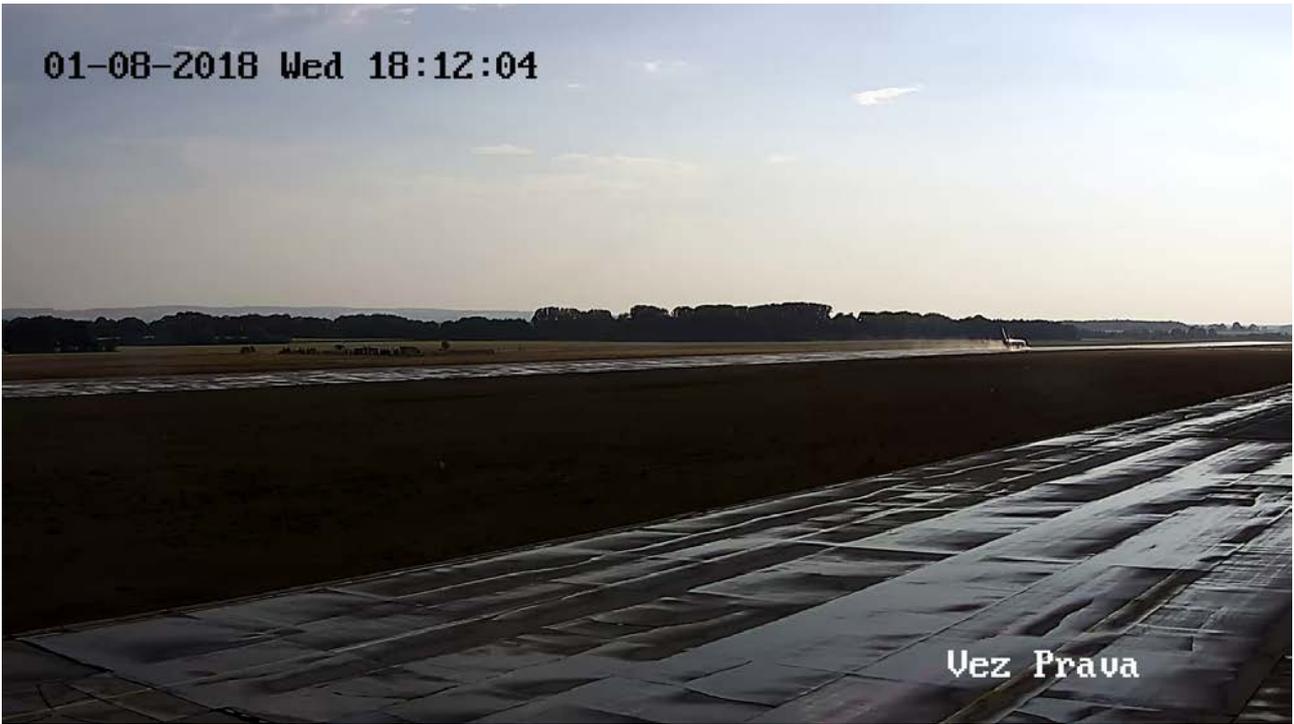
Figure 18 B 737 during decelerating – braking

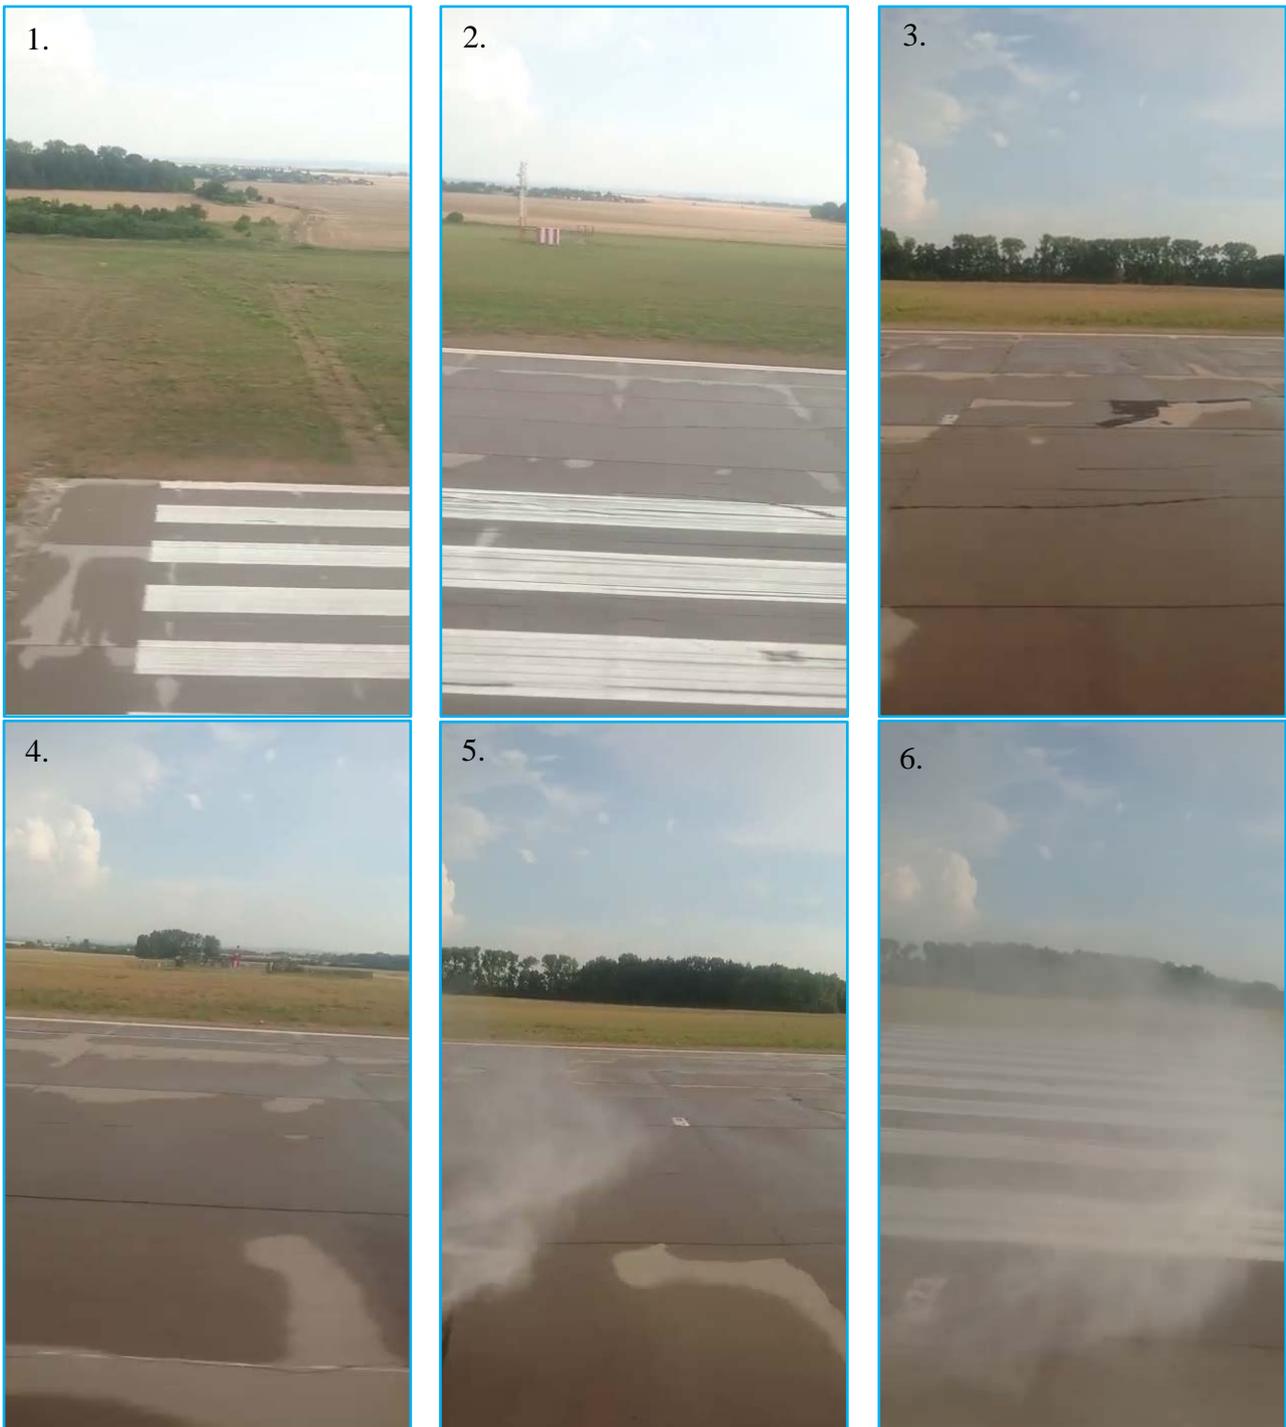
Figure 19 Videofootage sequences (1–6)

PIC/PM pinpointed the contamination of RWY with water as the possible cause of dynamic aquaplaning. Over a period of 24 h, and at the time of B 737 landing on RWY 27 at LKPD, the maximum of 0.9 mm/m² of precipitation was measured. Videofootage and photodocumentation show that the concrete panels on RWY 27 were wet at some places, but mostly only damp, and at many places even completely dry. Given the position of the sun and the temperature of 28°C, the wet and damp concrete panels could cause visible glare during approach and landing. Such glare made the PIC think that the RWY was contaminated with water. Nevertheless, given the measured amount of precipitation, it is possible that dynamic aquaplaning may not be experienced (2.4.1).

1. Altitude of RWY 27 THR flyover
2. The altitude above the runway markings, ILS in the background
3. RWY 27 contaminated with water – detail
4. Detail of RWY contaminated with water, PAR in the far background
(Precision Approach Radar)
5. Reverse thrust in operation
6. Reverse thrust in operation shortly before the overrunning of RWY 27 end markings
