AIR ACCIDENTS
INVESTIGATION INSTITUTE
Beranových 130
199 01 PRAGUE 99

CZ-19-0144

FINAL REPORT

**Investigation of causes of an accident
helicopter ENSTROM 480 B
registration mark OK-CLV
on the field near Blažkov,
on 22 March 2019**

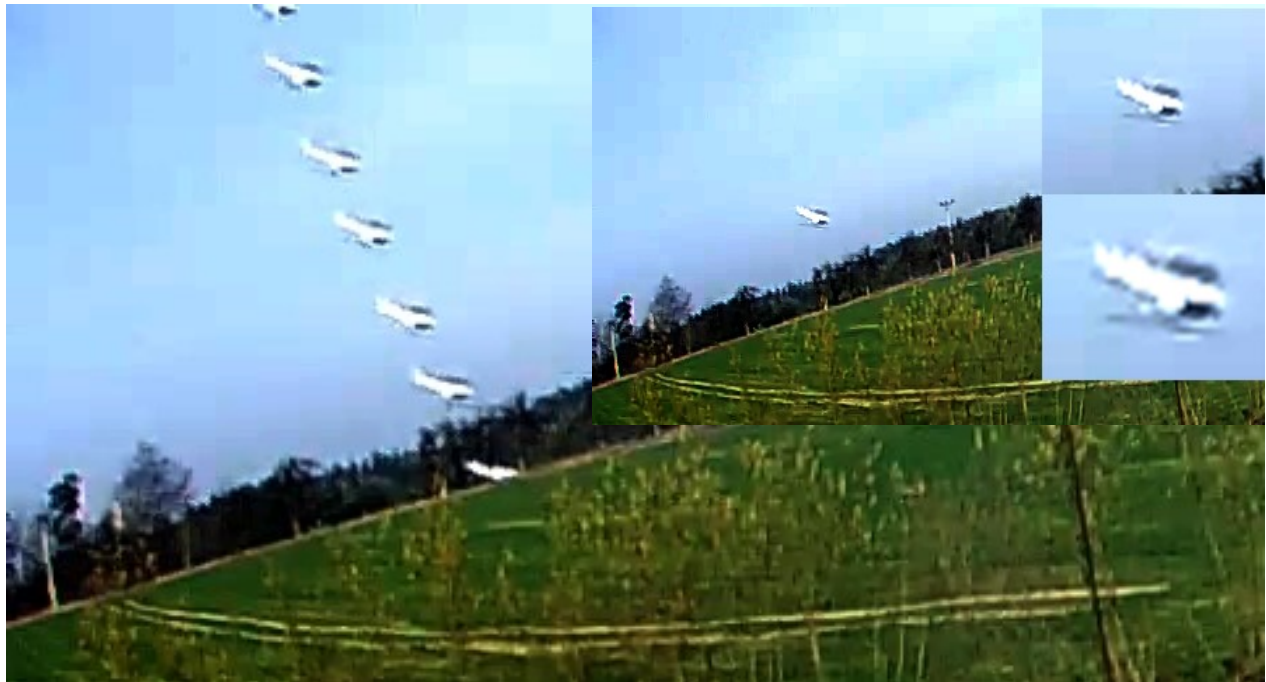
The Commission was able to obtain footage from an industrial camera located on the building of the agricultural firm ZBA Slavoňov. Last 1.2 s of the flight were recorded by an industrial camera located at a distance of approx. 300 m from the place of crash.

Fig. 2 – Individual footage images with an enlarged helicopter in the upside down position

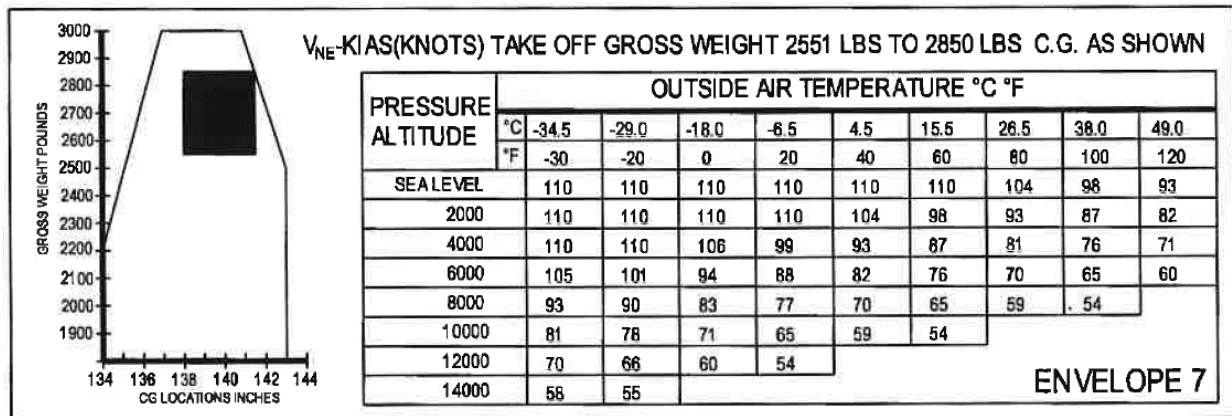
The set of relevant placards No. 1–11 is placed over the instrument panel in the pilot's visual field (Fig. 3). For the placards see the Flight Manual, p. 1-27 through 1-32. According to the chart on p. 1-20, we can determine the relevant placard for the centre of gravity within the range from 138.51 to 141.5 in. CG and ALT 4,500 ft – it is ENVELOPE 7. Under the conditions when ALT is 4500 ft, REG QNH 1,029 hPa, PA 4,068 ft, and air temperature is +5°C, the placard specifies V_{NE} 93 KIAS.

Fig. 5 – Placard No. 7 (the set of relevant placards No. 1–11 is placed over the instrument panel in the pilot's visual field)

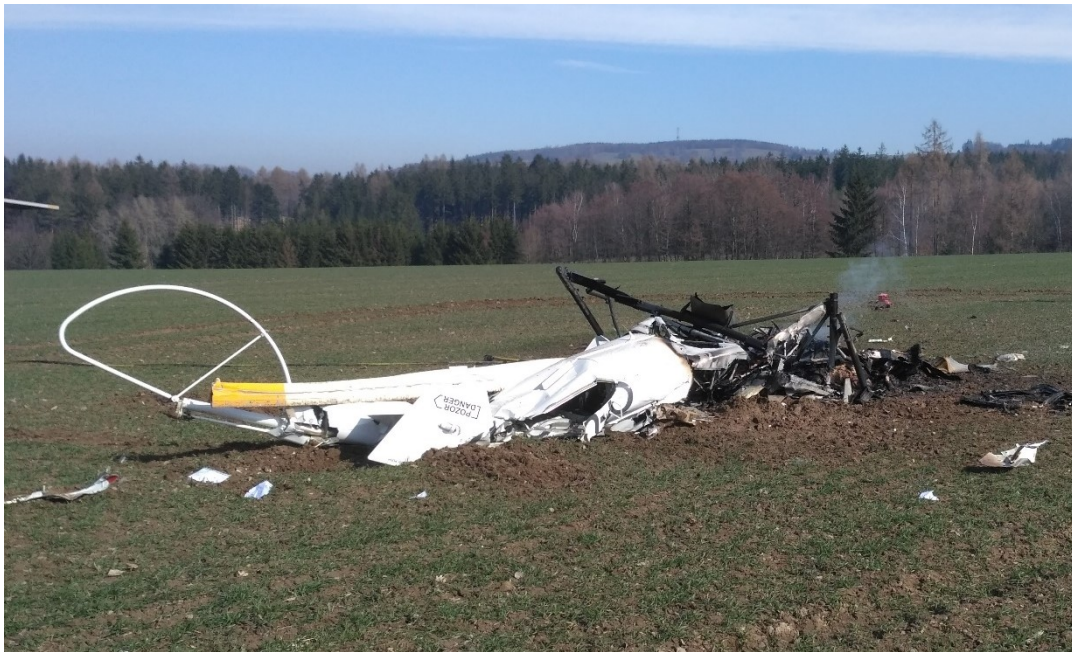
The considerably deformed and burnt helicopter fuselage was lying upside down with its nose pointing north-east. The helicopter frame was damaged by the forces generated by the helicopter impact at a sharp angle in the upside flying position with simultaneous forward movement. Subsequently, the fuselage was destroyed by fuel explosion and fire (JET A1 kerosene) which splashed out from fuel tanks upon the crash on the ground. Various significant construction elements disintegrated from the helicopter fuselage upon the crash on the ground were located both in the close proximity and in the surrounding area of the wreckage. Upon the first contact of the main rotor, one of the three blades (T2) was separated and found approx. 48 m north of the wreckage. The left stabiliser was found north

of the wreckage at a distance of approx. 20 m. The fragmented accumulator was found north-east of the wreckage at a distance of approx. 25 m.

South of the wreckage, at a distance of approx. 300 m, a number of paper documents were scattered over the field. A bag with documents and a few pieces of the plexi-glass glazed overhead window were found in this area.

Fig. 8 – Helicopter wreckage at the place of crash

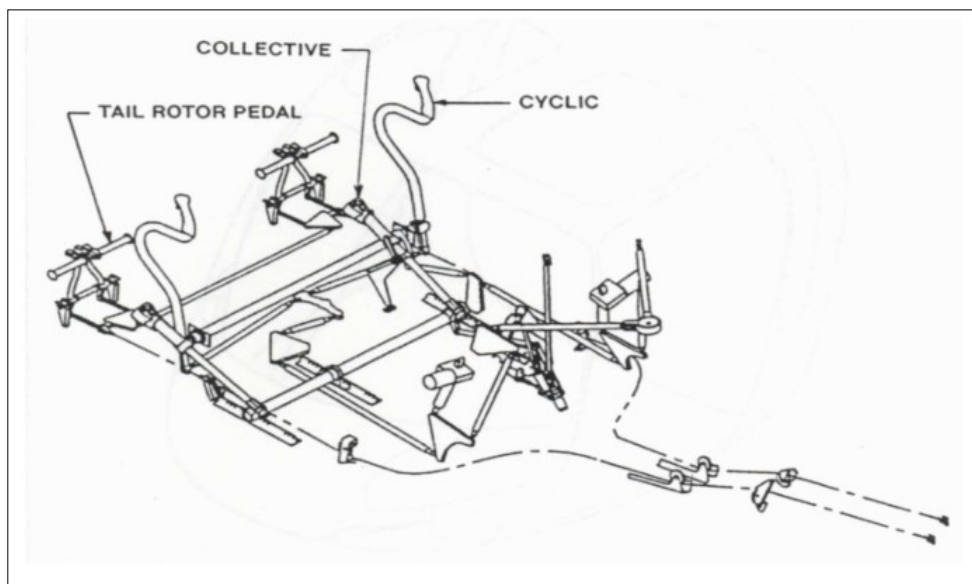
Fig. 9 – Diagram of the helicopter controls

All the controls in the pilot cabin were damaged due to the impact to the ground and subsequent fire. All the controls were disconnected from the rods, mostly broken at the attachment points of bellcranks. The control cables of the tail rotor were disconnected from the pedal control levers linkage as a consequence of fire and explosion. The cables were annealed in the area where the fire took place. All the pulleys were affected by the fire, but the cables laid in them were in secure positions. Further, the cables were torn apart in the vicinity of the tail rotor gearbox.

The left lever of the cyclic was bent due to breakage in approx. one third of its length. The plastic handle melted due to the fire. The collective lever was damaged by the fire. The end part connected to the linkage and the engine control cable outlets were melted by the fire. The left pedal was damaged by the fire. The left pedal was broken off from the main part of the foot control. Despite the damage caused by the fire all the parts were demountable and the arresting parts of the foot controls were secured by the securing parts. The connecting rod between the right and left foot controls was broken off from the transmitting elements and also damaged by the fire.

The right cyclic lever was bent and damaged by the fire. The lever of the collective was complete, slightly damaged by the fire in its upper part. Both the levers were melted off in their lower parts and partly broken off from the transmission linkages. The right foot control was damaged by the fire. The pedal rods were melted off in their bottom parts in the connection points with the pedals. The right pedal was deformed, with a great probability, by mechanical forces at the moment of impact. The left pedal was bent from the main part (a bracket of square cross section) in the upward-front direction.

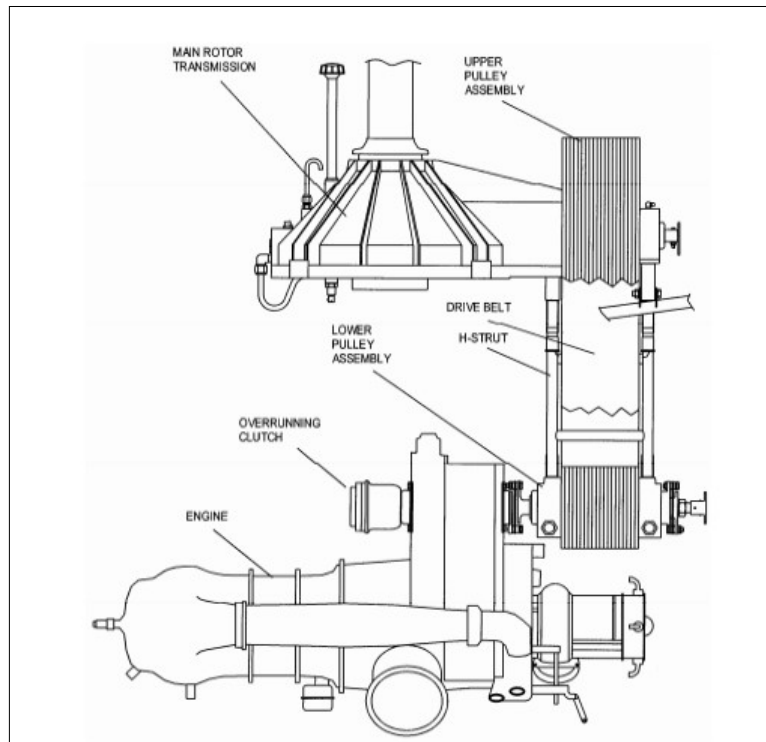
Fig. 10 – Transmission of power from the engine to the gearbox

During the inspection of the power plant (engine, drive box, transmission of power from to the main rotor) it was found that both belt pulleys were damaged by the fire. The multi-ribbed belt burnt completely thus it was not possible to inspect its condition prior to the accident.

The upper belt pulley driving the hypoid gears of the main rotor shaft were damaged both, mechanically by the forces working at the moment of impact and subsequently by the fire, or more precisely high temperature. The remains of the belt were melted onto its surface. The cogs of both parts of the hypoid transmission (the main rotor shaft cone drive gear and planetary cog) were free of mechanical damage.

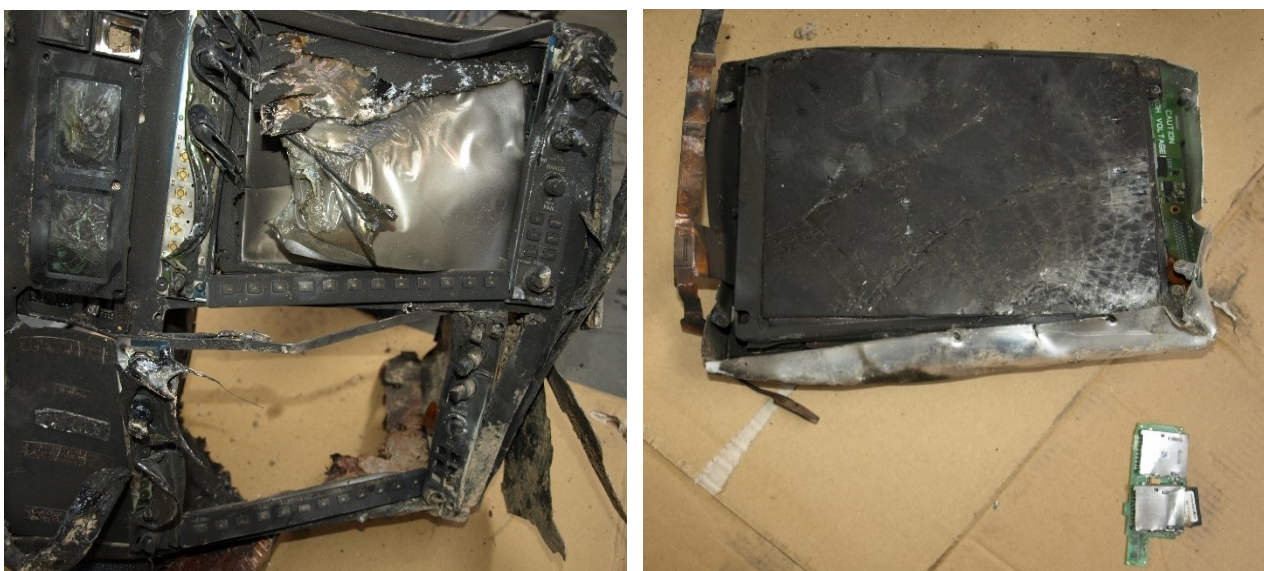
Fig. 12 – Both the MFDs destroyed by fire (left) and the MFD with the double data card slots (right)

At the place where the severely damaged GARMIN 1000 display units are located, two memory SD cards were found. The objective of examination was to find out what type of cards they were and if they were memory cards designed for recording of manufacturer-defined data, to download the data for their subsequent analysis in the specialised centre of the Army of the Czech Republic. The examination showed that neither card was designed for records of flight and technical parameters.
