CZ-19-0317

FINAL REPORT

**Investigation of a serious incident
a collision of two airplanes
Boeing B737-800 registration OK-TVW
and Boeing B737-8CX registration N277EA,
at Praha/Ruzyně airport, 17. 5. 2019**

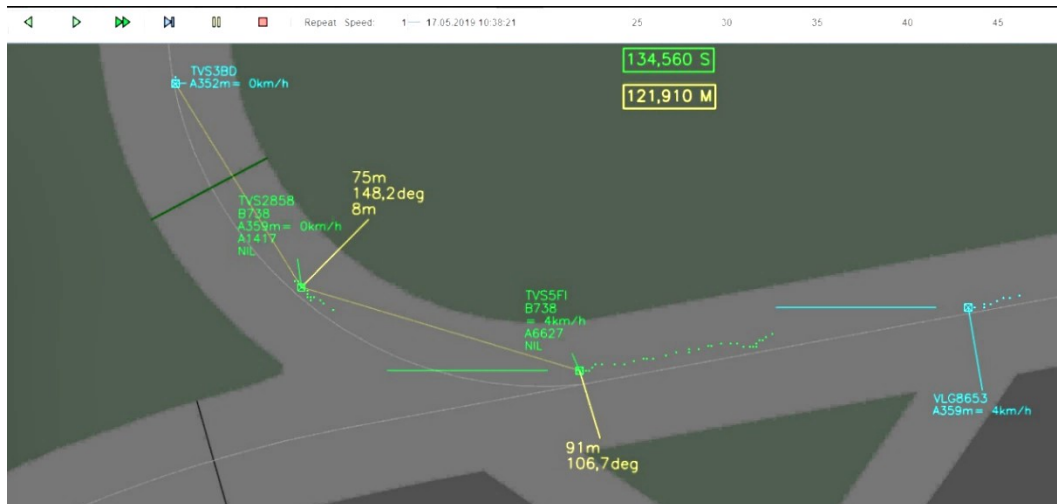
At 10:38:21, TWR-TEC issued clearance and instructed the crew to continue on TWY F to the holding position on RWY 06. The crew continued taxiing at low speed on TWY F towards RWY 06, slightly to the right of the TWY F axis – see the situation in Fig. 1.

Fig. 1 – Situation at 10:38:21 – OK-TVW cleared to continue on TWY F.

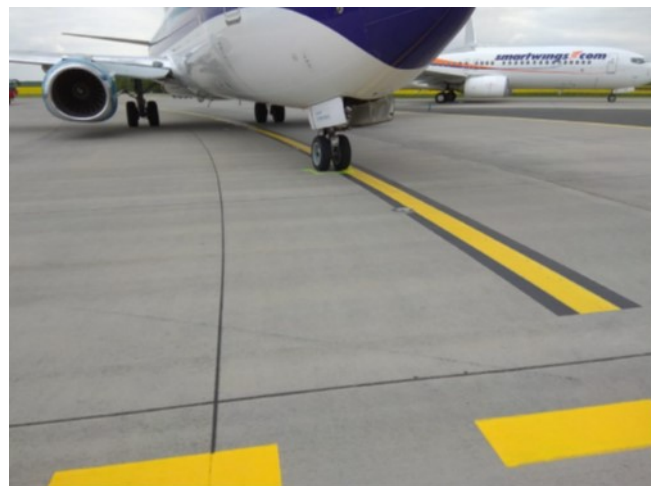
N277EA started taxiing from stand No. 14 for take-off from RWY 06 at 10:30. As instructed by TWR-GEC, it was gradually taxiing on TWY H, L, D, F and E. At 10:34:20, it switched to the TWR-TEC frequency. At 10:37:40, it turned to TWY E where it then stopped at 10:38:15 (approx. 75 m behind B737-800/TVS 3BD, which was holding the position HP CAT I, and reported readiness to enter RWY 06) – see the situation in Fig. 1. It was standing approx. 8 m in front of the horizontal marking of the intermediate holding position on TWY E – see Fig. 2.

Fig. 2 – Position of N277EA standing 8 m in front of the horizontal marking of the intermediate holding position on TWY E.

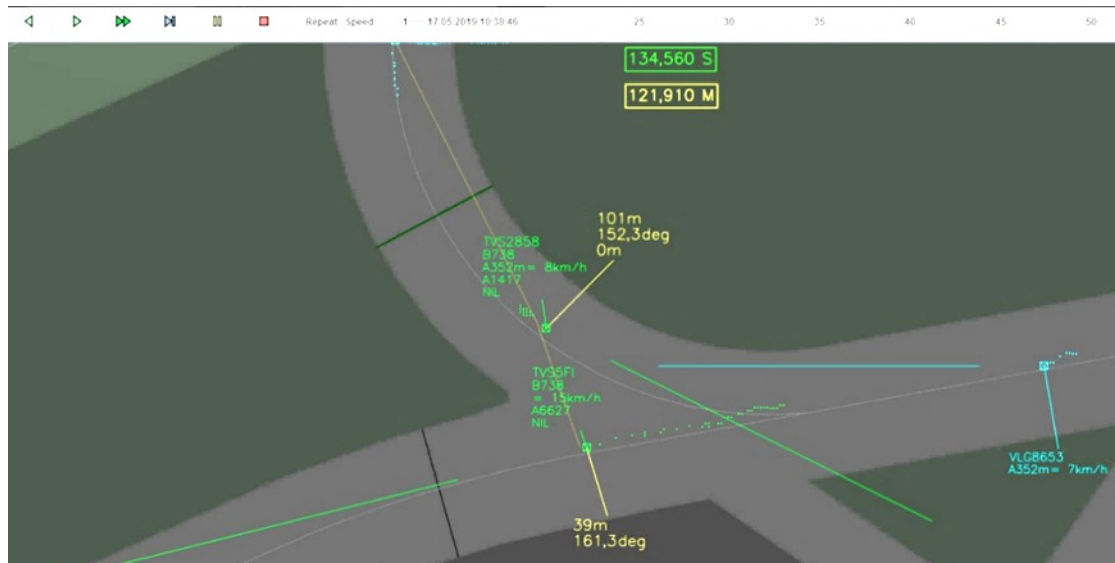
At 10:38:46, when OK-TVW was taxiing on TWY F, and passing by the tailplanes of N277EA, it crashed with its winglet leading edge of the right half of its wing to the stabiliser of N277EA. For the illustration of the aircraft positions see Fig. 3 and 4. OK-TVW flight crew stopped the aircraft after the collision.

Fig. 3 – Situation at 10:38:46 in aircraft collision.

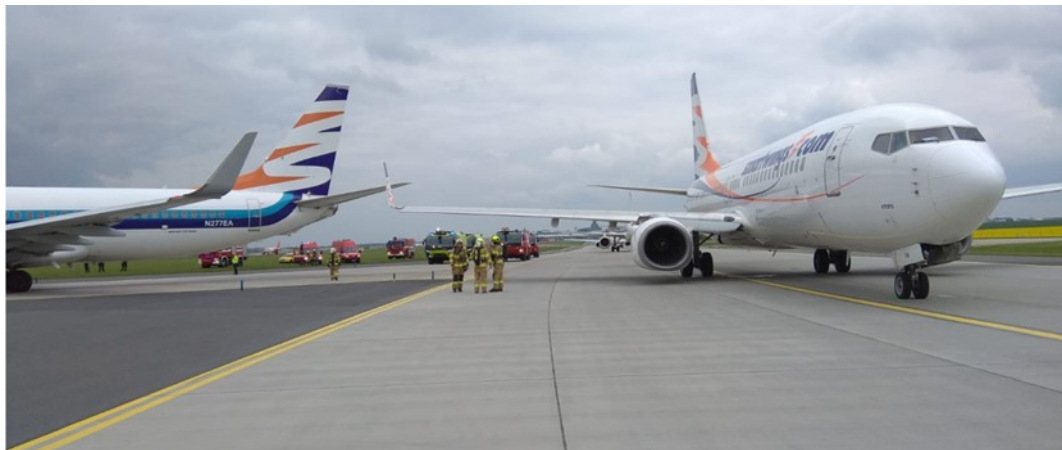
Fig. 4 – Situation after the collision and stopping of OK-TVW.

As a result of the collision, N277EA had a part of the end arch and the primary left stabiliser structure with dimensions of 120 x 120 mm chipped away – see Fig. 4. At the same time, the external electrostatic discharger at the trailing edge of the stabiliser was broken off – see Fig. 5.

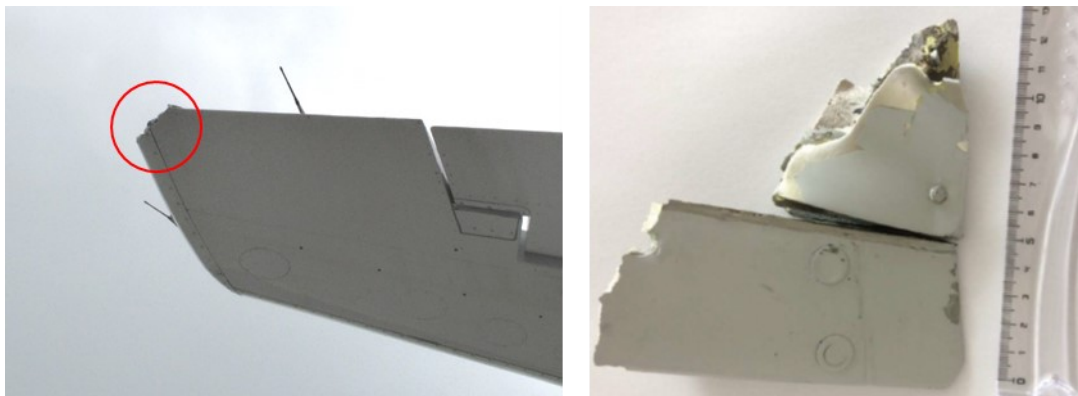
Fig. 5 – Damage to the N277EA stabiliser edge

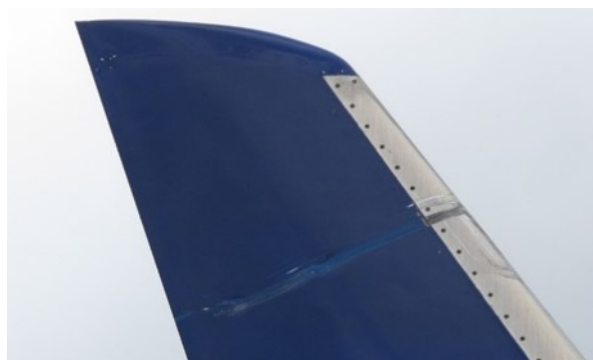
As a result of the collision, OK-TVW had a damaged winglet leading edge of the right half of its wing approx. 0.4 m from the upper edge. The surface on the outside of the winglet was scratched in a downward direction against the direction of aircraft motion, which was possibly caused by the structure spring back at the moment of the collision – see Fig. 6.

Fig. 6 – Damage to the OK-TVW winglet edge

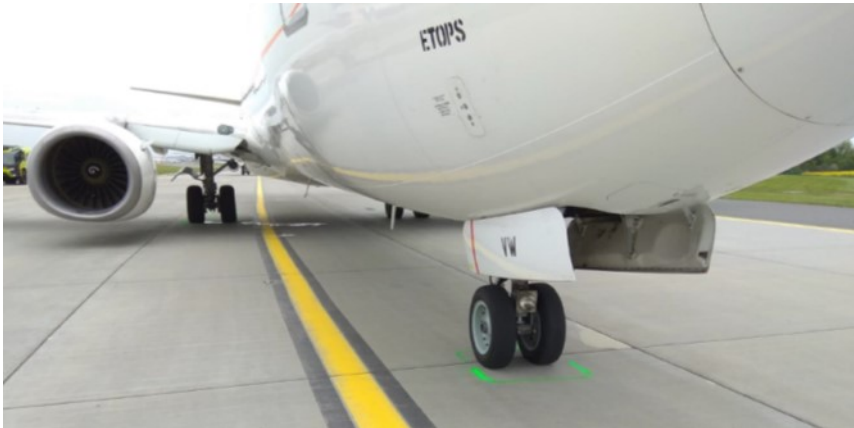
Fig. 8 – Position of OK-TVW after stopping on TWY F.

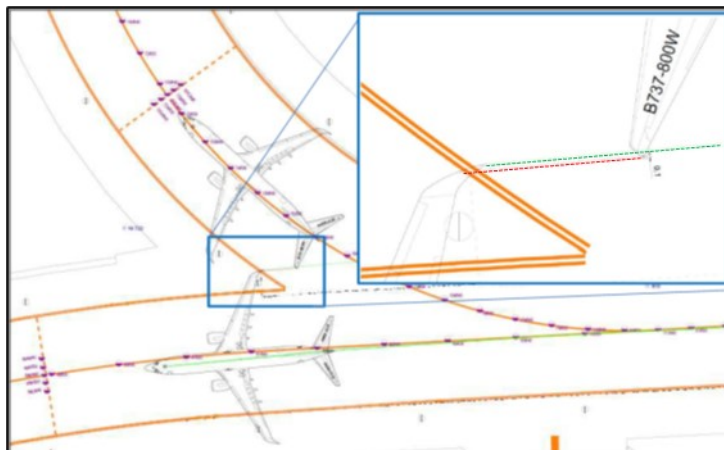
For the purpose of investigation, the trajectory of both aircraft movement prior to the collision was derived retroactively on the basis of measured final positions. The inserted detail in Fig. 9 marks in red the trajectory of the OK-TVW winglet edge at the level of the first contact with the N277EA stabiliser, which corresponds with the size of the identified damage to both the aircraft, i.e. approx. 0.1 x 0.1 m.

Fig. 9 – Derived movement trajectory of OK-TVW winglet edge in collision with N277EA stabiliser.

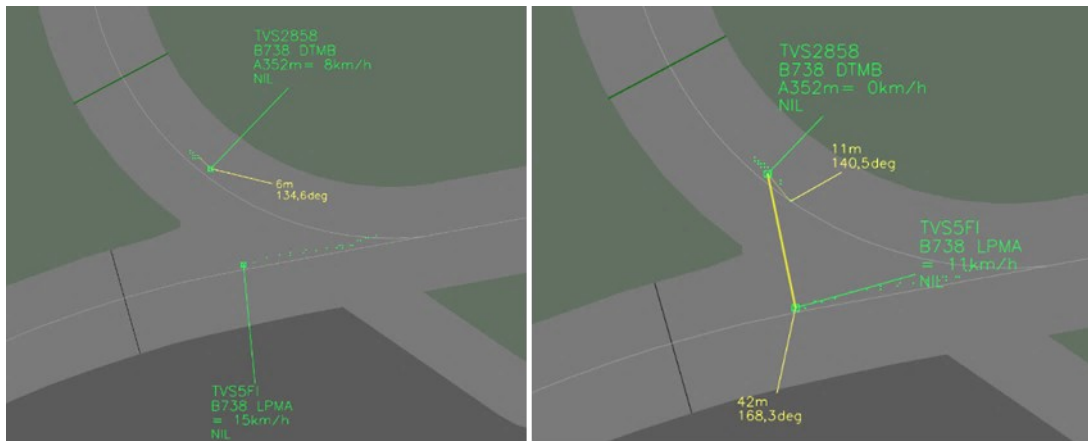
The A-SMGCS system records show that at 10:38:45–10:38:48, there was an obvious change in the N277EA symbol position (SSR transponder antenna) (from the position at stopping back by approx. 5–11 m) and also the shortened distance between the symbols of transponder antennas – see Fig. 10.

Fig. 10 – Position of the N277EA symbol (SSR transponder antenna) between 10:38:45 and 10:38:48.

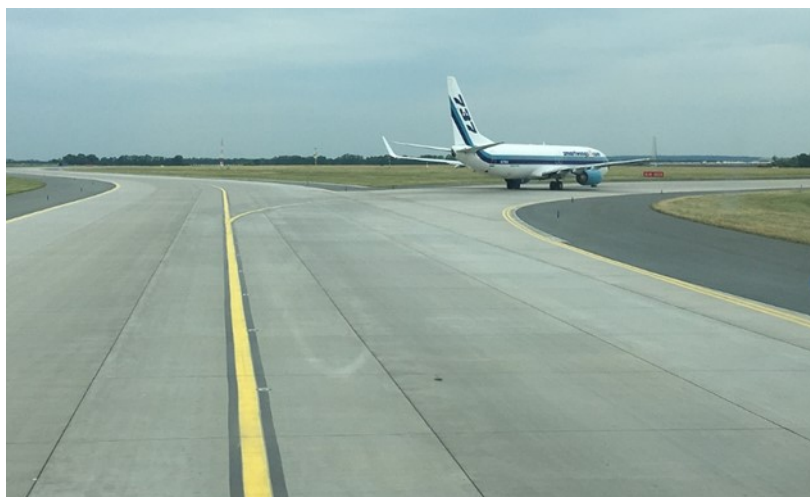
Fig. 11 – TWY E and TWY F intersection view with the same type and variant of B737-800 aircraft on the site of N277EA stopping observed from the same type and variant of B737-800 aircraft OK-TSO. Both the aircraft were positioned at approximately the same locations as prior to the collision.

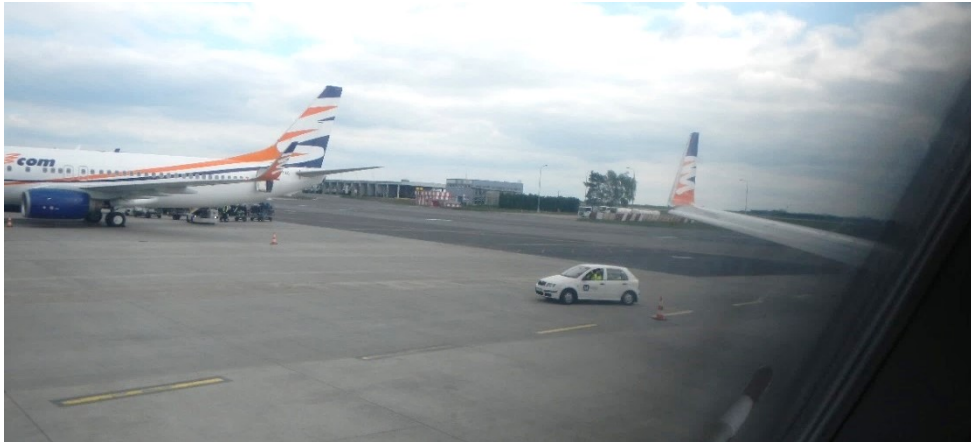
Fig. 12 – An example of view of the winglet from the FO's position through the right-side cockpit window.
