AIR ACCIDENTS
INVESTIGATION INSTITUTE
Beranových 130
199 01 PRAGUE 99

CZ-20-0752

FINAL REPORT

**Investigation of causes of a serious incident
of CESSNA 525 A aircraft, registration mark G-TOWP, on 18
November 2020**

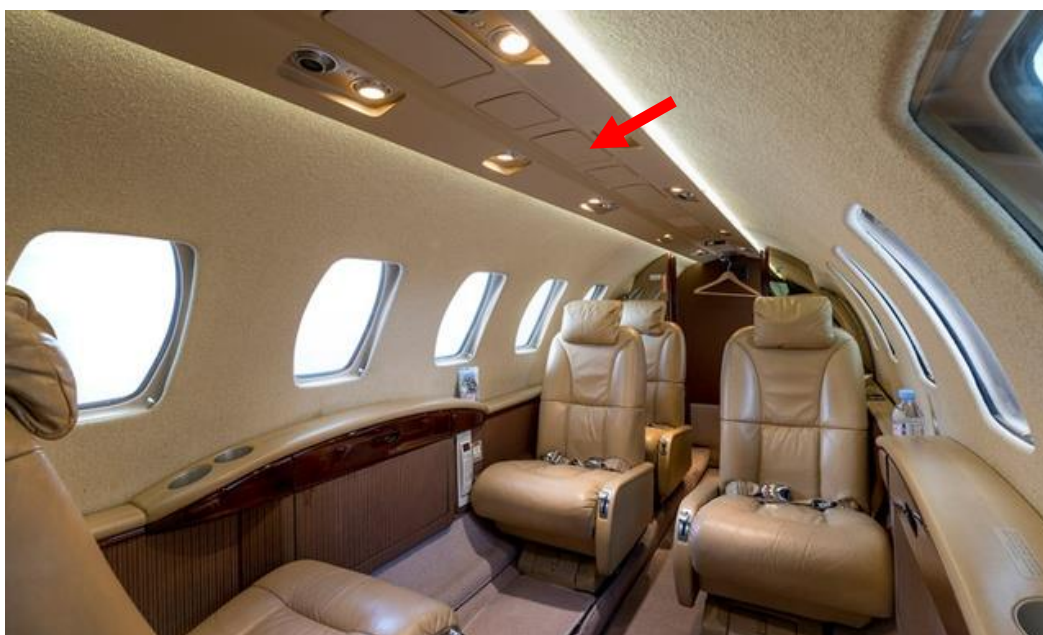
Fig. 2 – Cessna 525 A Citation CJ2+, drop-out boxes with passenger oxygen masks.

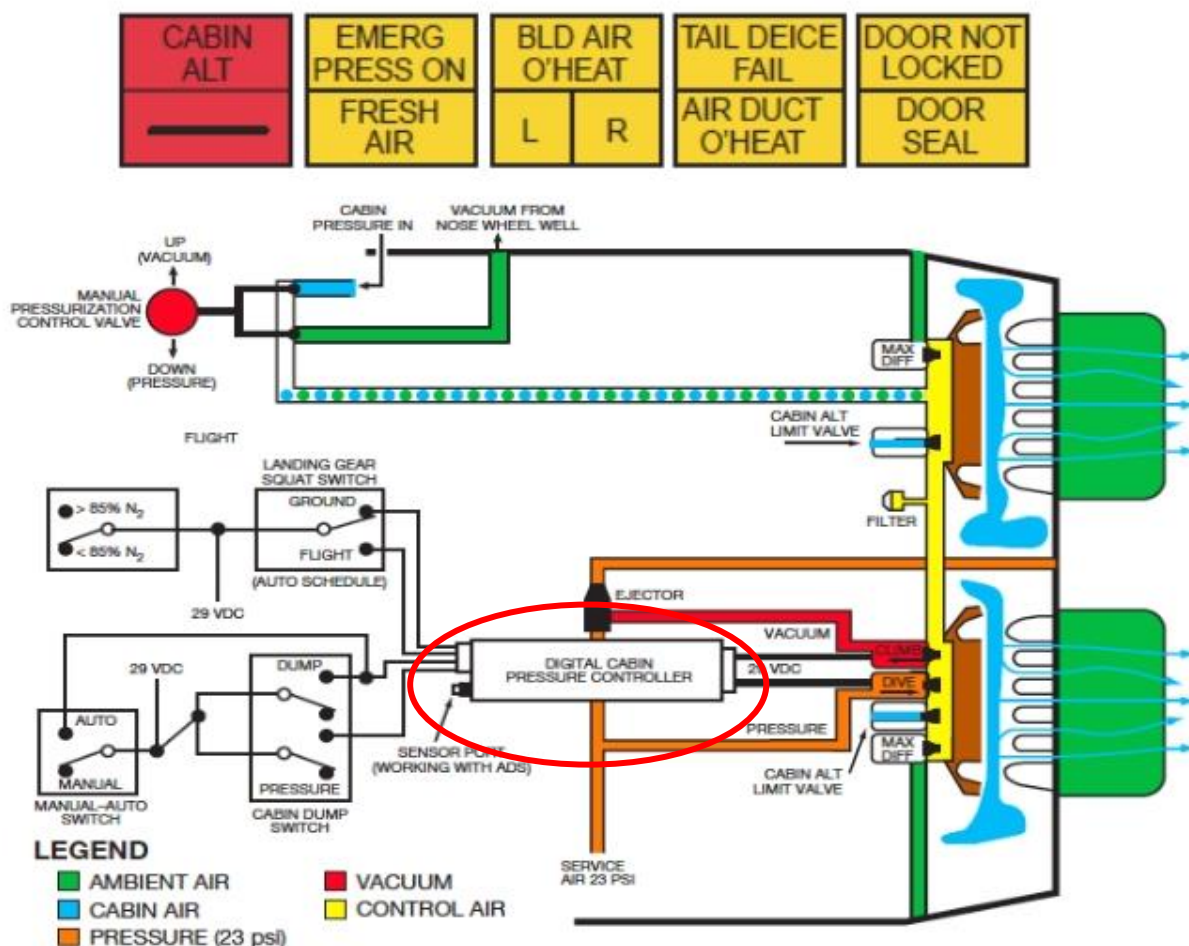
Fig. 3 – Diagram of the C 525's pressurisation system. The digital control unit of the pressurisation system that has malfunctioned is marked in red.

After the aircraft landed, the pressurisation system was inspected by a service organisation and a technical fault was found in the digital control unit of the system.

The increase in cabin altitude and the decrease in the pressure relief values were caused by a technical failure of the digital control unit of the pressurisation system.

The cause of the serious incident was a technical fault in the digital control unit of the pressurisation system which caused a pressure drop in the pressurised cabin with an increase in cabin altitude.
