AIR ACCIDENTS INVESTIGATION
INSTITUTE
Beranových 130
199 01 PRAHA 99

Ref. No. CZ-22-0885

FINAL REPORT

**Investigation on the accident
to Hawker Hurricane Mk IV, registration OO-HUR
1 km SW LKCB
on 14 August 2022**

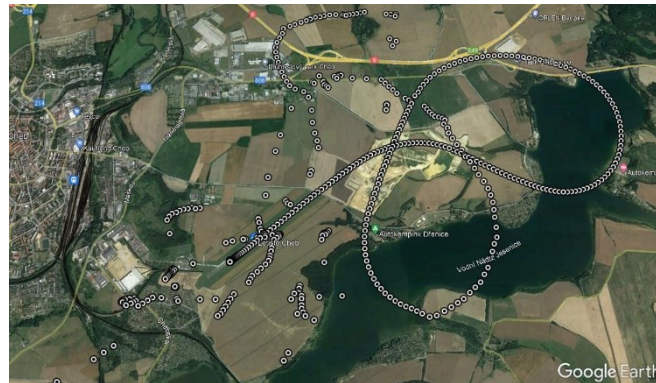
During the critical flight, the pilot had his Apple iPhone 13 with the SkyDemon application with him. The mobile phone was found damaged at the accident site. Data in the format of .blackbox file were extracted from the phone memory. AAIB UK specialists decoded the data to the CSV format at the request of AAII. The data file in the CSV format marked 2022814 (flight on 14 August 2022) contained location data recorded at an interval of 1 s. The start of the recording was marked with time (GPS Date) 13:22:29. Based on the changed position on RWY 05 and gradual rise in speed, the start of take-off could be determined at 13:23:20, and the change in the altitude data showed the time of aircraft lift-off at 13:23:43. At time marked as 13:29:23, data integrity was temporarily lost for approx. 26 s. Another temporary data loss for approx. 4 s occurred at time marked as 13:30:32. The reason for loss of GPS signal integrity could not be identified. The record of the flight trajectory during the aerobatic part of the performance was not continuous and individual trajectory points were recorded inaccurately compared to the flight trajectory on video footage. The end of the location data recording was marked with time at 13:32:11. The total length of the recording was about 9 min 42 s. In Fig. 1, there is a visualisation of the flight trajectory points on 14 August 2022 in the Google Earth application. When comparing the flight trajectory record on 13 August 2022, obtained from the data set marked as 2022813, a similar data integrity loss occurred during the aerobatic part of the performance.

Fig. 1 – Visualisation of the flight trajectory points of the Hurricane aircraft on 14 August 2022

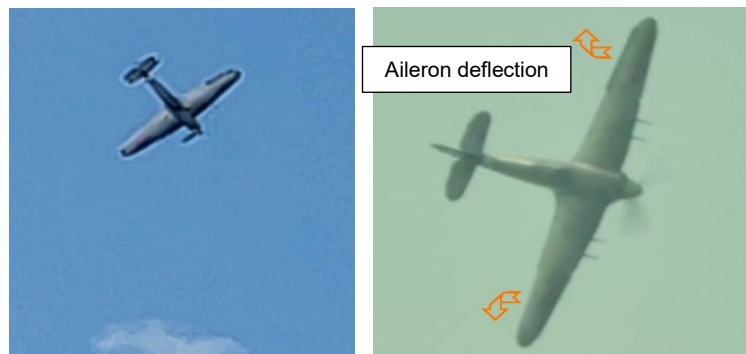
The public audience participating on the Flying Display provided the Commission directly or via the Police of the Czech Republic with various video footages and photographs. The Commission analysed the video footages and photographs showing the state of the aircraft and the course of the accident. Neither photographs nor video footages showed any evidence of any aircraft anomalies. Given the distances from which the videos were taken, the control surface deflections and their relation to the aircraft movement in the critical phase of the flight could be determined only as estimation. The video footage shows that 13–14 s after the start of an aerobatic manoeuvre, while turning by approx. 120 degrees to the left in a sharp descending turn, the left aileron was deflected upwards and the right aileron downwards (against the rolling movement). See the video footage images of this flight phase in Fig. 2. It is obvious from the detailed photographs of the aircraft that the pilot put the rudder trimmer tab for take-off – left-hand side. Appendix No. 1 shows the aircraft position during the descending phase of the critical manoeuvre according to the video footage.

Fig. 2 – Aileron deflection against the rolling movement in a descending turn.

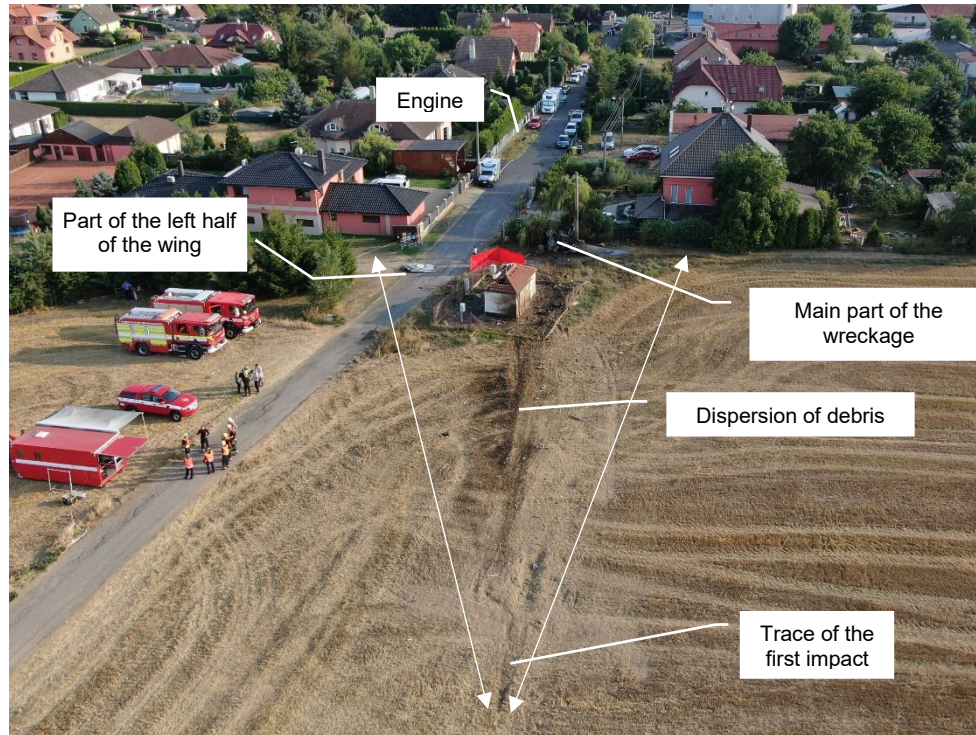
The air accident occurred in the field located between a built-up area of Cheb, the municipal district of Podhrad, K Letišti Street, and the premises of the Cheb airport. The surface of the stubble field after grain harvest was dry. The aircraft was destroyed by the forces of impact to the ground. The trace of the first impact of the aircraft crash against the ground was found about 22 m from the edge of the asphalt surface of K Letišti Street and some 61 m from the edge of the fence surrounding house No. 13. It corresponded to the impact of the aircraft at a slight angle in the heading of approx. 195 degrees. At the beginning of the debris trace,

there was a visible trench in the field, approx. 11.3 m long, as a result of the impact of the lower part of the aircraft fuselage to the ground. At the point of impact of the wing to the ground, the width of the wing imprint was about 12.4 m and there were visible traces of the impact of the dummy cannons in the leading edge of the wing.

Fig. 3 – View of the place of the air accident of the Hurricane aircraft

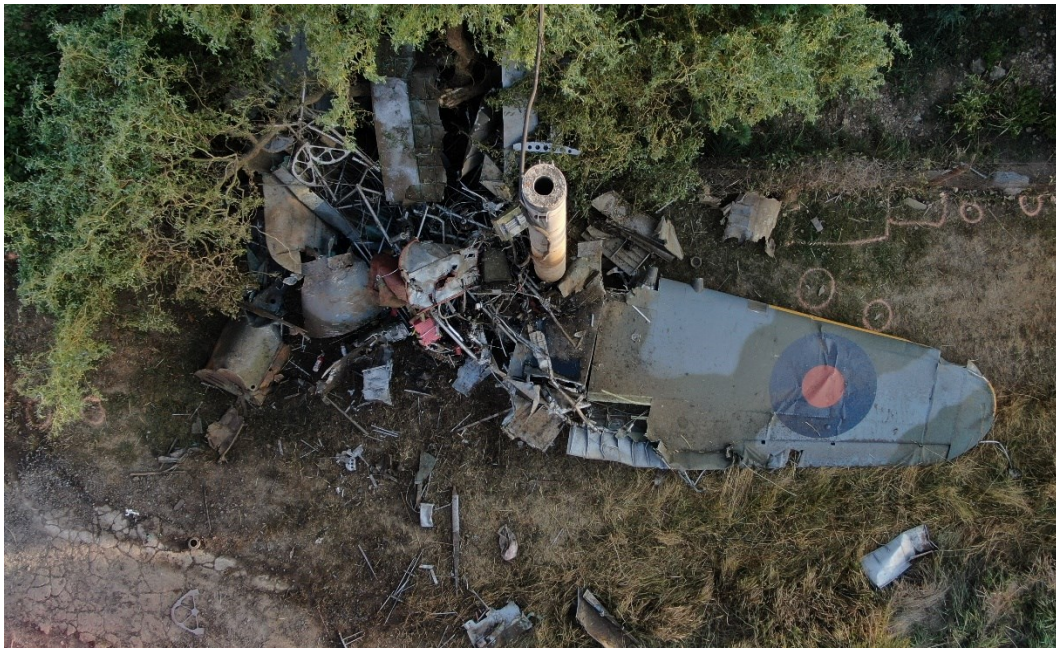
The debris was spread up to the fence surrounding the plot of family house No. 13 where the aircraft wreckage collided against the concrete column of power line standing at the edge of the plot. The fuselage structure with tailplanes was deformed round the column and stopped by the fence and the crown of a mature willow, which was behind the column and the fence. The right and left undercarriage legs with wheels remained in the centre-wing section. The right half of the wing was attached to the centre-wing section while it was torn at wing root at the leading edge and in the flap space and broken approximately at the point of internal aileron hinge. The root of the broken left half of the wing remained attached to the centre-wing section. The cockpit in the fuselage, a number of fragmented smaller pieces of the wooden aircraft structure, broken-off gearbox, centrifugal-flow compressor from the engine, and the propeller dome with blade fragments could be detected at the wreckage site.

Fig. 4 – The main part of the Hurricane wreckage

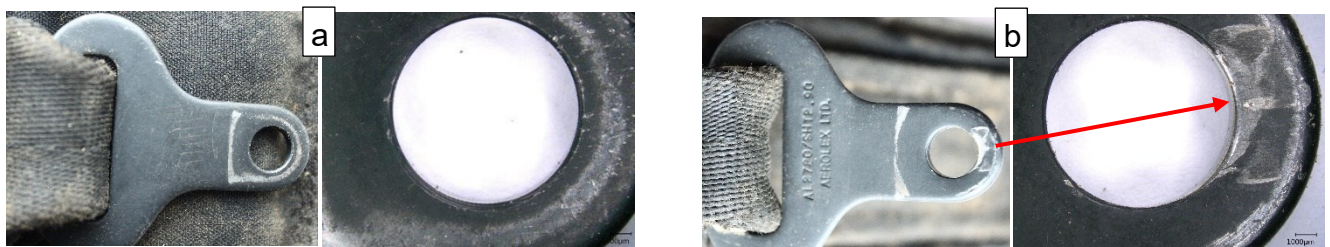
No significant variations in the regularity of the holes in lap safety seat belts were detected. The rear part of the clamp on the right lap seat belt shows hole bevelling in the direction of locking and several longitudinal surface grooves. See Fig. 5. These may be traces of pulling out of the central quick-release buckle. The rear part of the clamp on the left lap seat belt shows more prominent hole bevelling in the direction of locking. In comparison with the clamp on the right lap seat belt, the surface damage on the rear part of the clamp is not so significant. See Fig. 6.

Fig. 5 – The right clamp on the lap seat belt; (a) front part of the right clamp; (b) rear part of the right clamp.

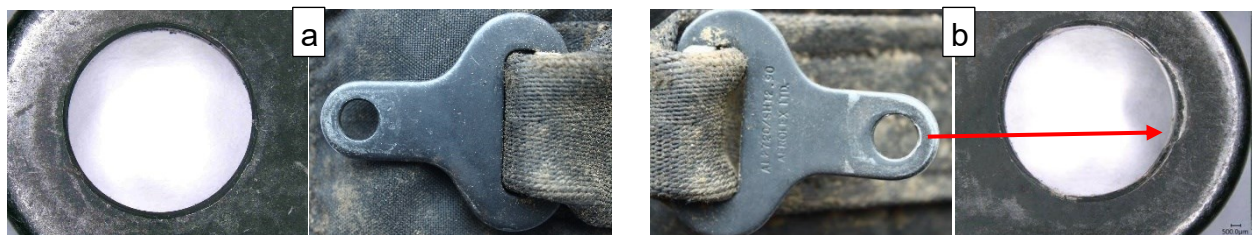
Fig. 6 – The left clamp on the lap seat belt; (a) front part of the left clamp; (b) rear part of the left clamp.

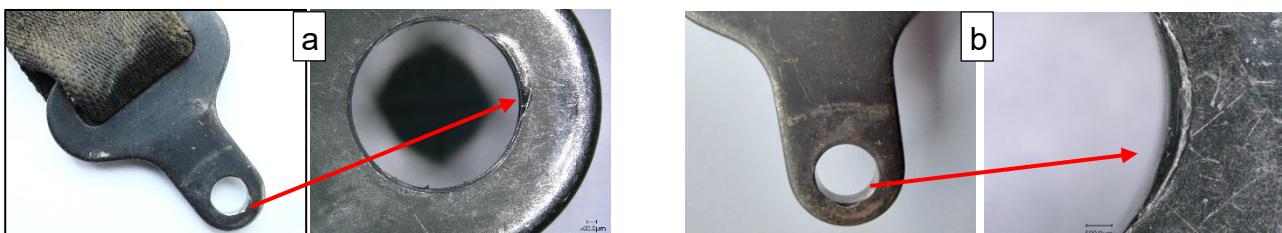
The holes in shoulder straps do not show significant deviations in regularity. Damage caused by significant sharp notches at the edge of the hole was detected on the rear part of the clamp on the right seat belt. See Fig. 7. Significant crushing of the inner edge of the hole can be seen on the rear part of the clamp on the left seat belt.

Fig. 7 – Rear side of clamps on shoulder seat belts; (a) right seat belt; (b) left seat belt

As regards the shoulder straps, the origin of the damage to the inner hole of the right seat belt clamp cannot be clearly determined as a result of either normal wear and tear or the accident.

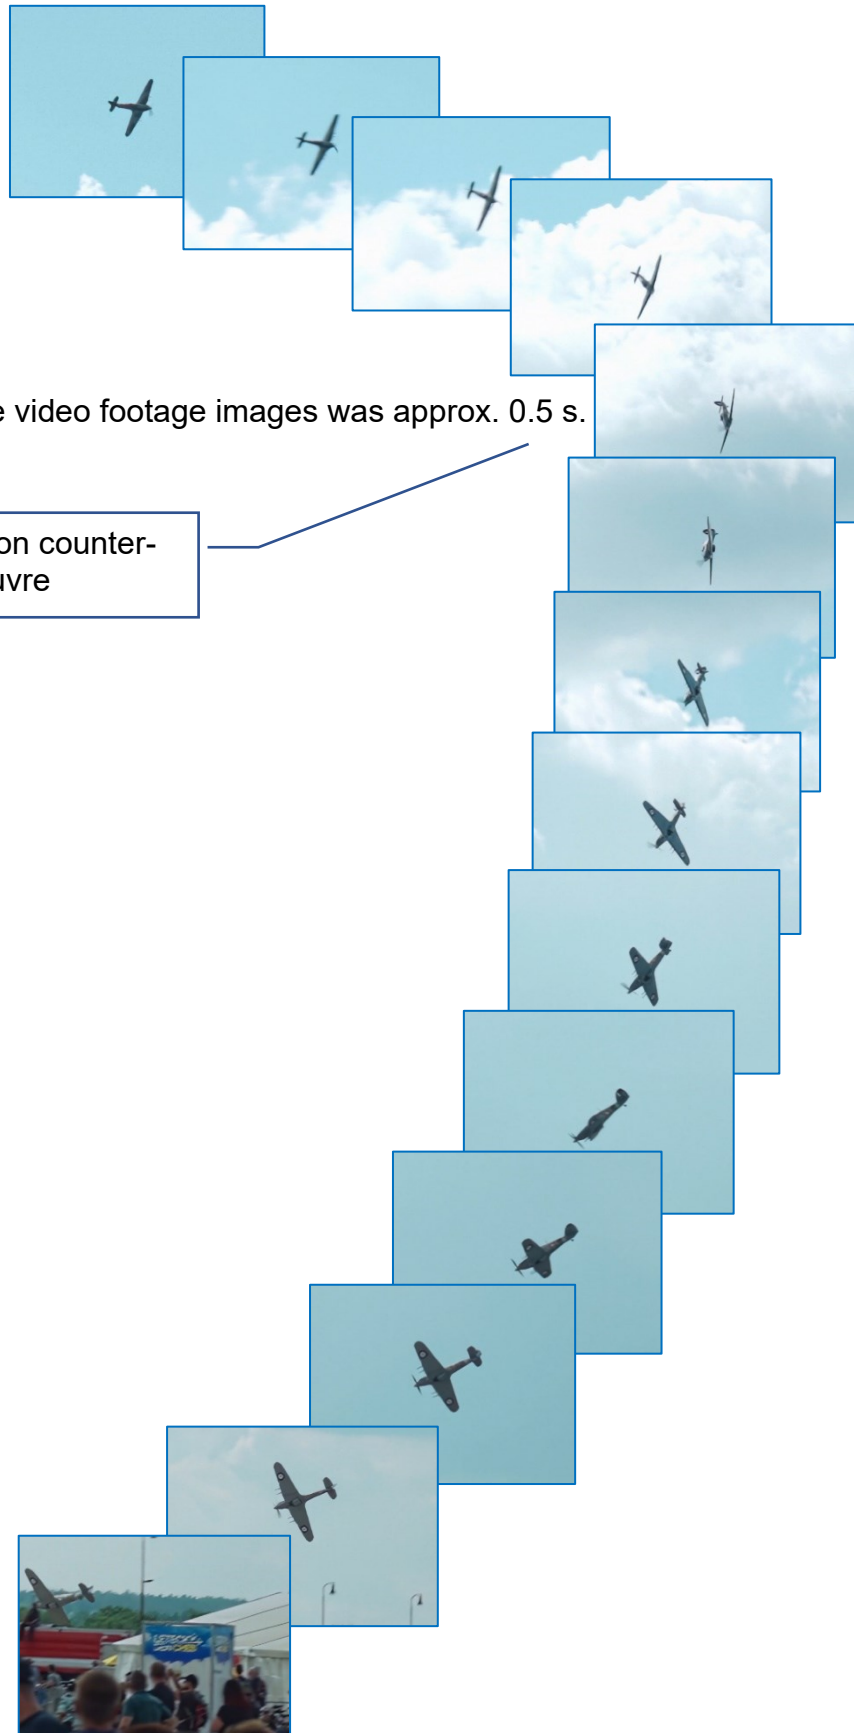
Appendix No. 1

Aircraft positions during the descending phase of the critical manoeuvre according to the video footage

The interval between the video footage images was approx. 0.5 s.

Aileron deflection counter-
manoeuvre
