CZ - 14 - 314

FINAL REPORT

**Investigation of causes of an air accident
of helicopter Robinson R 22 BETA II, registration mark OK-LPS,
on the field near Hlavenec,
20 June 2014**

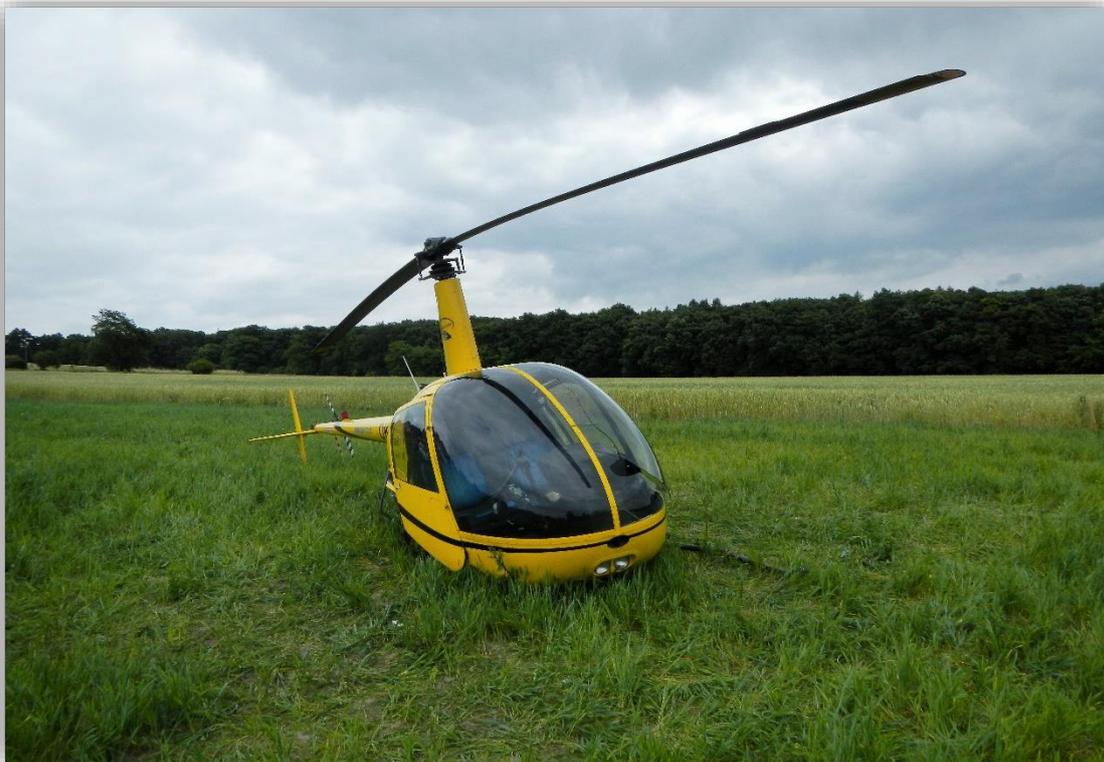
The helicopter was damaged heavily during rough landing. The skin on both sides of the fuselage was undulated, especially in the tail lower part. By the displacement of the control board a contact of the same board with the acrylic window panel on the left side of the cockpit, the panel cracked along its full length. The vertical partition was deformed in its lower part. The tail beam was partially broken in the place behind the joining with the fuselage due to the impact, the undulation of the skin took place and in some places visible fissures emerged. The door frame on the right side was deformed in its lower part. The impact caused the vertical displacement of the left fuel tank and breaking of the rear horizontal landing gear strut. Landing gear skids were open to the maximum in the direction of the collision of the helicopter impact on the ground whilst contact between the lower part of the helicopter fuselage and the engine with the ground took place. The vertical stabilizer skid was broken off.

The power unit was mechanically damaged, especially in the lower part. The rod structure of the engine bed was, in many places, bent and broken. The said damage caused deformation of the exhaust piping at the same time. The impact also caused slight turning of the ventilator in the direction of the flight by approx. 10 degrees.

Fig.1: R 22 helicopter after rough landing

The damage to the outer parts of the cockpit and of the landing gear occurred in consequence of the rough landing in the autorotation mode of the main rotor.

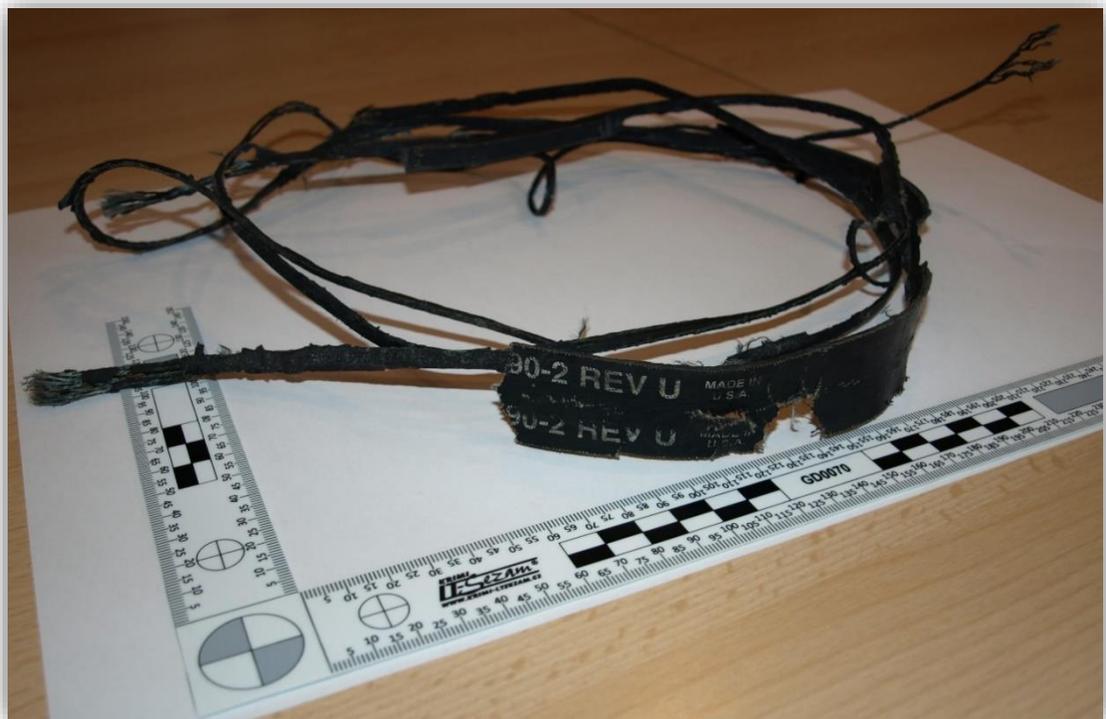
Further, the Commission attended to examining the remaining parts of the V-belts. The front double V-belt was located in the engineering compartment away from the sheaves. The belt was divided along its whole circumference. The condition thereof showed substantial wear and tear without the possibility of a clear assessment of its condition before the air accident. The inner walls of the engineering compartment were coated with dry rubber dust originating from the V-belts. In the lower part of the engineering compartment there were large fragments of the rear double V-belt. The rear double V-belt, extensively devastated, fell out of the helicopter after snapping, and it was found on a road in the village of Hlavenec.

Fig. 2: The damaged rear double V-belt

The Commission was, in cooperation with the villagers, able to find part of the rear double V-belt from the crashed helicopter. Substantially damaged V-belt was found in the village on the pavement next to the road to Kostelní Hlavno.

- both the belts did not exceed the lifetime and hourly TBO,
- the complete destruction of the rear double V-belt occurred probably due to the wear and tear effects,

The cause of the air accident was the gradual destruction of both the driving double V-belts in the powering system of the main rotor. Thus caused operational failure of the drive system influenced the RPM of the main rotor in a negative way not only in the transition into the autorotation mode of the helicopter, but primarily in the landing stage in the autorotation mode.

We recommend, in the course of the service and maintenance operations, to record the measured angle of the clutch shaft into the statement of operations performed.

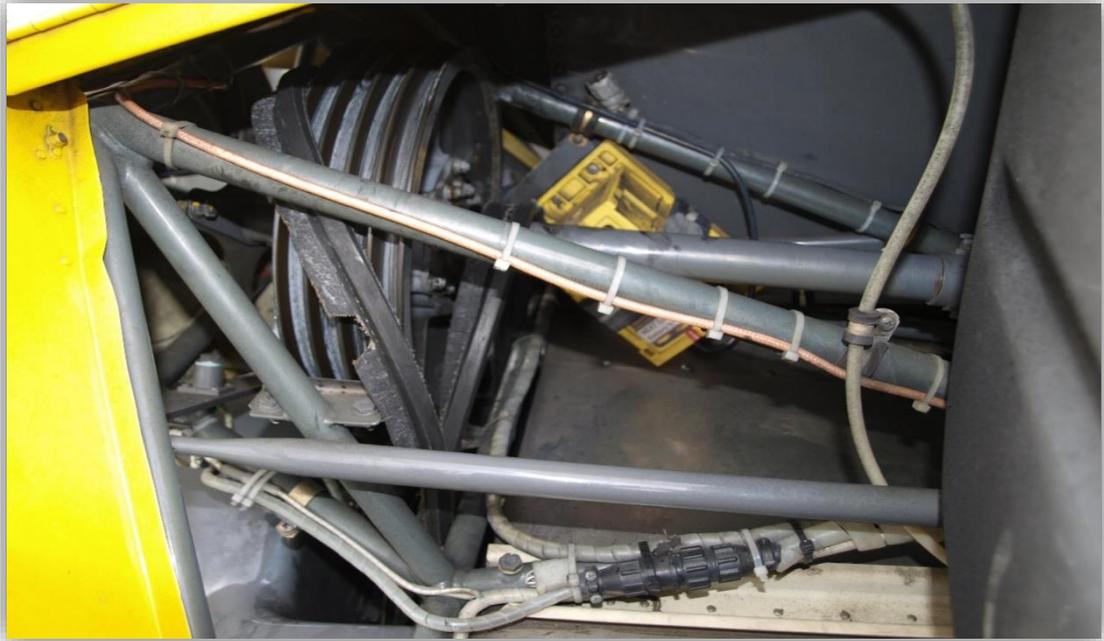
Fig. 3: The damaged front double V-belt in the engineering compartment

- freely moving parts of the rear double V-belt were, with high probability, the cause of the destruction of the front double V-belt and the consequent slipping thereof off the sheaves,

- the individual belts of the front double V-belt were, during the critical stage of the flight, mechanically separated from each other,
- the individual V-belts were not capable of transmitting the required power output from the motor to the main rotor individually,

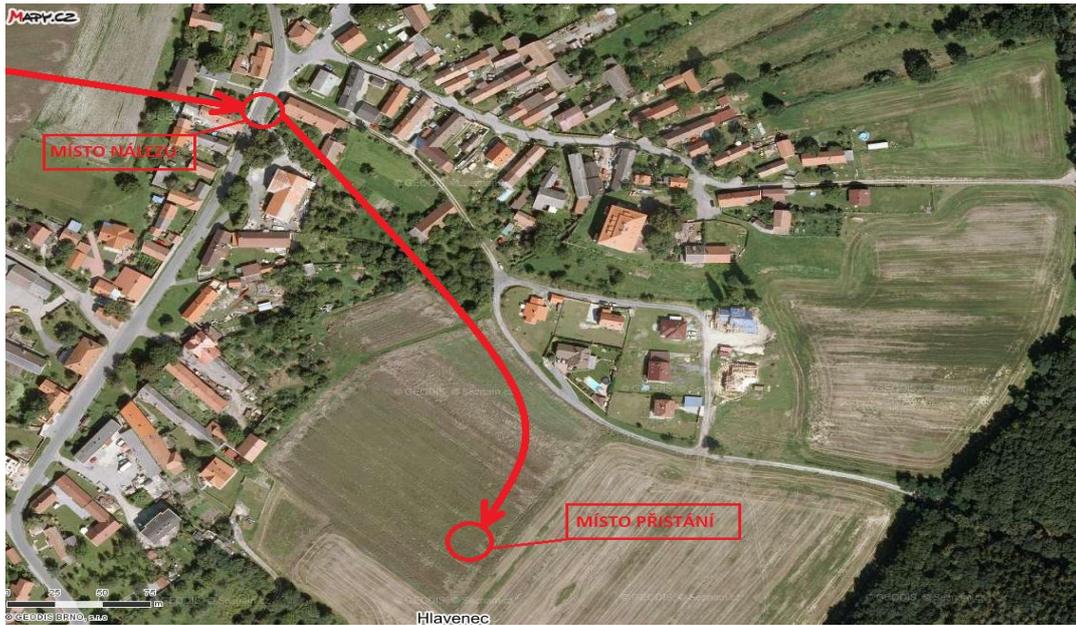
Fig. 4: Last stage of the event flight

The critical event occurred at the moment when the helicopter crew heard a strong bang from the engine compartment of the helicopter. This unusual sound was caused by the impact of the damaged V-belt on the walls of the engineering compartment. The helicopter was located before the village Hlavenec, at its north-east edge and was flying at approx. 900 ft ALT in the course of 120 degrees. At the same moment, the light and sound signal of the low RPM of the main rotor occurred, and the main rotor as well as the engine RPM dropped to 90 per cent. The pilot responded immediately to the situation by changing the mode of the helicopter to autorotation. The rotor RPM were not, however, increasing, therefore the pilot used the forward speed and by the means of moderate pulling of the cyclic control he attempted for the increase of the RPM. The main rotor RPM were increasing towards the operating values very slowly whilst the helicopter continued descending at the speed recommended for autorotation to the selected area. At this stage of flight, the pilot was attending the piloting of the helicopter with a full attention aiming at the most precise approach of the area, and to the actual landing in the autorotation mode. During the descent, the operation of the helicopter was standard. The change occurred when the pitch of the helicopter was being levelled in descent, when, in the decrease of the forward speed, the desired decrease of the vertical speed was not achieved. The pilot responded to the occurred situation by pulling the cyclic control by means of which he levelled the helicopter into landing configuration and by forceful pulling of the collective pitch control he attempted to reduce the vertical descent. After the pulling of the collective pitch control to the very end at the top position, the helicopter fell from the altitude approx. 3 m AGL with the landing gear skids to the ground.
