FINAL REPORT

Investigation separation minima infringement

CSA 689 and DLH 2JC

on 1st of November 2005

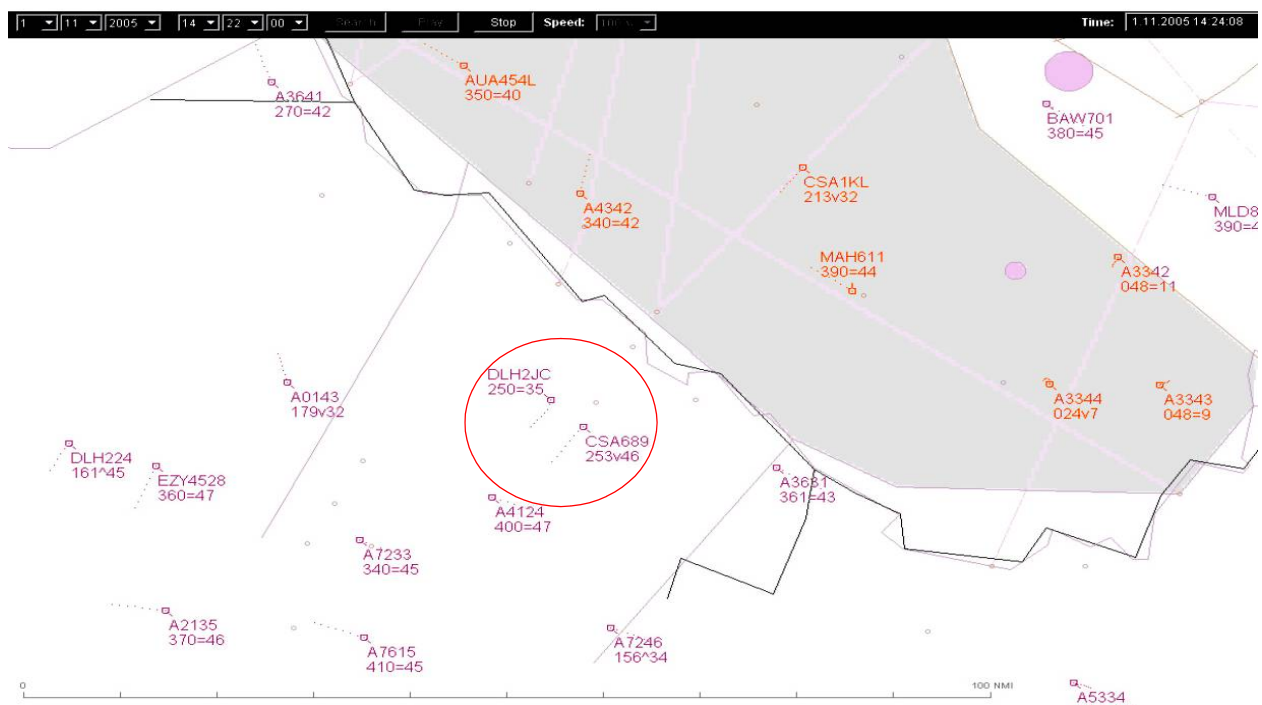
At 14:23:21 ACC WL EC Praha issued instruction to CSA 689 to stop descent at FL 260 and relayed information on significant traffic. CSA 689 read back the instruction and reported it was already at FL 256. So ACC WL EC issued instruction to change the heading by 20 degrees to the right. CSA 689 read back the instruction and reported that it followed the plane on TCAS. ACC WL Praha also issued an instruction to DLH 2JC to change the heading by 10 degrees to the left and informed DLH 2JC about the significant traffic at a distance of 4 NM (DLH 2JC was not yet in contact with ACC Praha).

At the time of the incident, the vertical separation was 500 ft, which is 50 % of the determined minimum separation, and horizontal separation was 4.31 NM, which is 86.11 % of the determined minimum separation. Since the safety of the aircraft in question were not put on risk (the planes were on parallel airways), the occurrence is classified as a “**Significant incident**” according to ESSAR 2 or as an **INCIDENT** according to L13 Regulation.
