FINAL REPORT

**Investigation on the accident
to PA-28-181
registration D-EREU
at Brno
on 14 November 2010**

Prague
January 2011

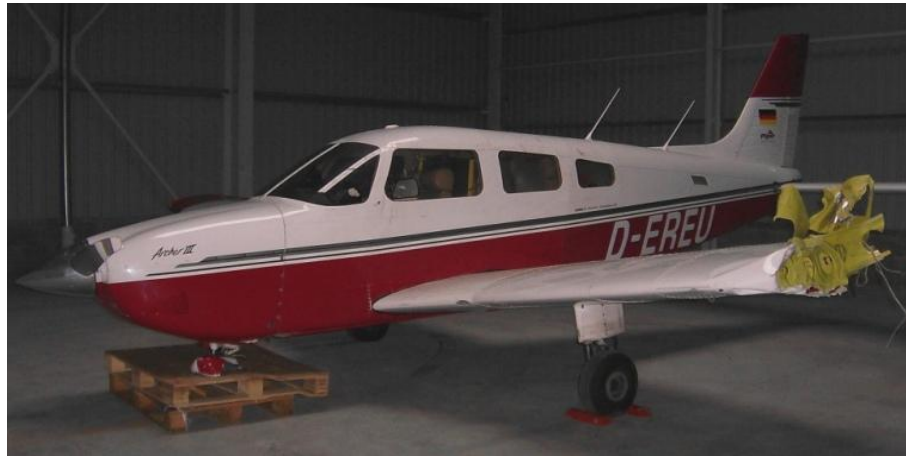
Fig. 4 Damage of the airplane PA-28-181 D-EREU

The airplane was seriously damaged due to its crash into the lighting pole and the road barrier and by its nose striking the ground; sees Fig.4. On the left wing, in place where the aileron had been attached, the whole outer part with the aileron was torn off. The wing and fuselage structure was deformed at the roots of left and right wings. The wing / fuselage midsection attachment was damaged and the wing hinges were shifted backward.

The nose was damaged owing to the crash into the road surface after the nose landing gear leg had been broken. One propeller blade was distorted backward, the second blade showed lengthwise grooves.

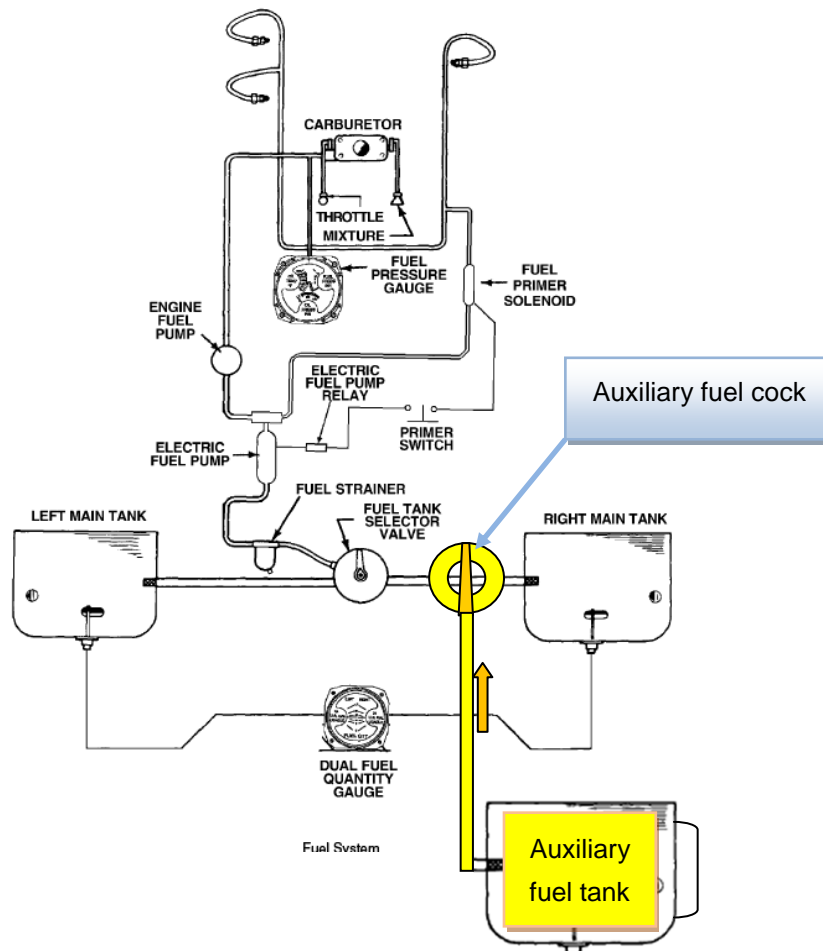
Fig 5 Fuel system with an auxiliary fuel tank built in

An auxiliary fuel system was mounted on airplane PA-28-181 ARCHER III serial no. 28 43055 before the flight, consisting of an auxiliary tank for 100 U.S. gal., an auxiliary fuel cock, a fuel gauge and a vent pipe. The tank was installed in the flight-deck in place of rear seats. The hand controlled fuel cock was connected to the pipe from the right wing tank. The auxiliary tank vent pipe was led out of the plane with a plastic hose on the left side of cockpit glazing.

The auxiliary fuel cock controlled fuel supply from the extra tank and from the right wing tank. Since the vent system of the right wing tank remained in the original state, the auxiliary fuel cock also prevented the fuel from flowing out through this vent pipe. An amount of 100 l (26.4 U.S.gal) fuel was filled into the extra tank before take off.

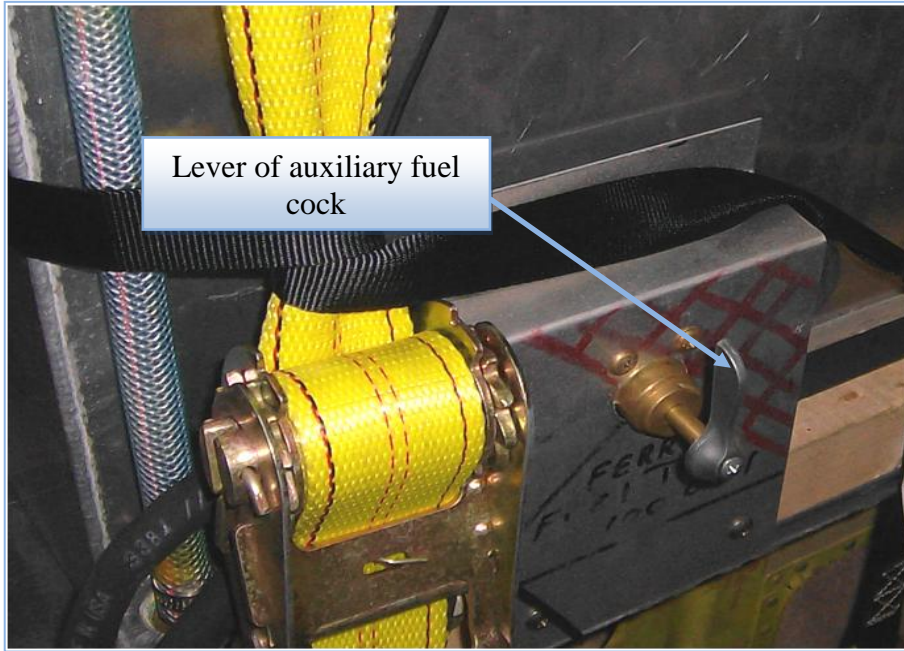
Fig. 8. Position of lever auxiliary fuel cock after forced landing 14. 11. 2010.

Auxiliary fuel cock was placed down behind the seat back of the right front seat and was accessible to enable handling from pilot's post from the left front seat. The auxiliary fuel cock has three working positions.

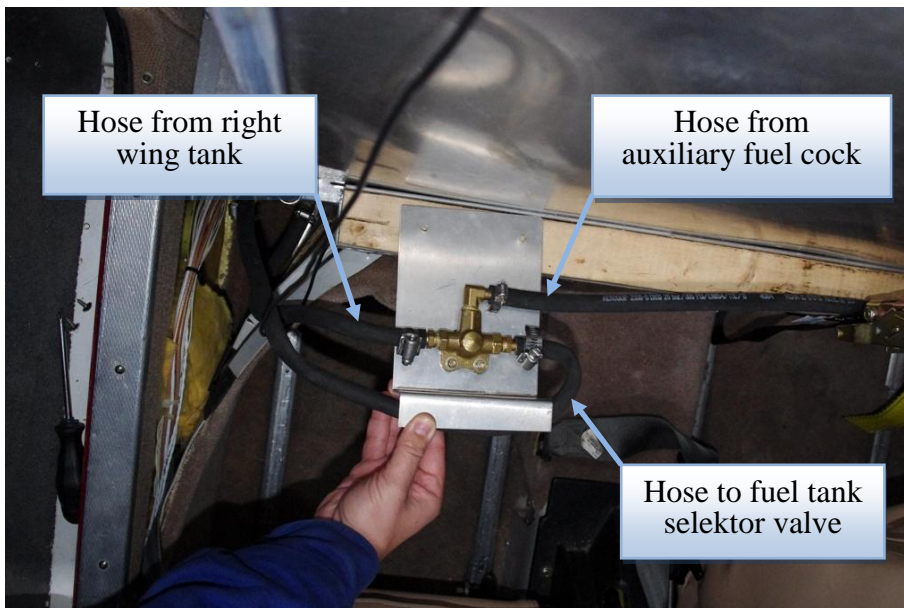
Fig. 9. Fastening fuel supply hoses to auxiliary fuel cock

Hose from right wing tank

Hose from auxiliary fuel cock

Hose to fuel tank selektor valve

Malfunction of the fuel system after the auxiliary fuel cock had been switched over to fuel supply from the right wing tank caused the fuel pressure and revolutions to drop, engine irregular run, and interruption of fuel supply to the engine. The pilot was not able to find out in flight what exactly the fuel problem was. The only information was the amount of fuel and its pressure as indicated on fuel meters and on auxiliary tank fuel gauge. The engine stopped working because there was no more fuel in the left wing tank and in the auxiliary tank, although there was enough fuel (approx. 90 l) in the right wing tank.

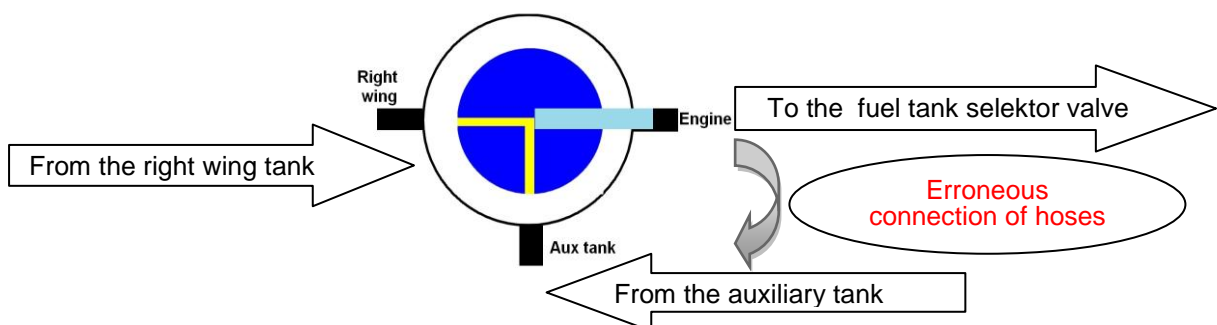
a) Shut of a fuel path from the right wing tank and the auxiliary tank into fuel pipe to the selector valve of fuel supply. In this position, only the right wing tank was connected with the auxiliary tank:

- Fuel from the auxiliary tank could flow by virtue of gravity to the right wing tank which was located cca 27 cm lower. When the right wing tank was full, the fuel could flow out of the plane through air vent,
- Fuel from the right wing tank could not flow to the auxiliary tank due to its location.

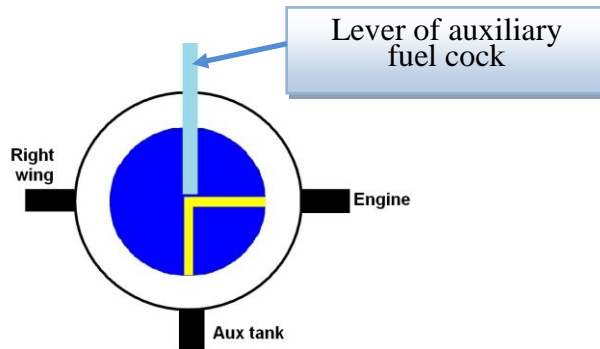
b) Position to take out fuel from auxiliary unit. If the cock was set to this position, fuel flow from the auxiliary tank into the fuel pipe to fuel tank selector valve only. This position of the auxiliary fuel cock does not enable fuel to be supplied into the system from the right wing tank.

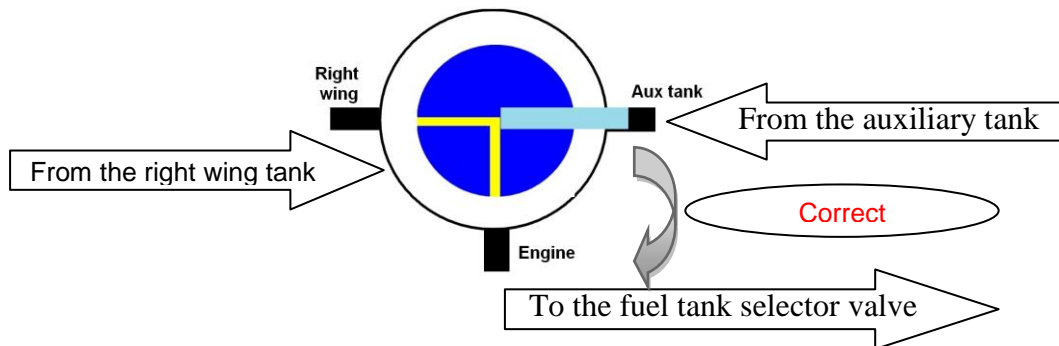
a) Pipe connection of right wing tank into fuel pipe leading to fuel tank selector valve.

For the auxiliary fuel system to work properly, hose connection to the auxiliary fuel cock would have had to enable working positions to be set as follows.

The following working positions corresponded to correct connection of the auxiliary fuel cock:

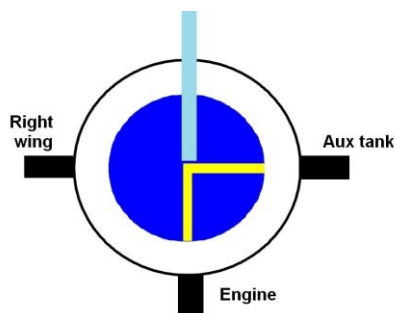
b) Pipe connection of auxiliary tank into fuel pipe leading to fuel tank selector valve.

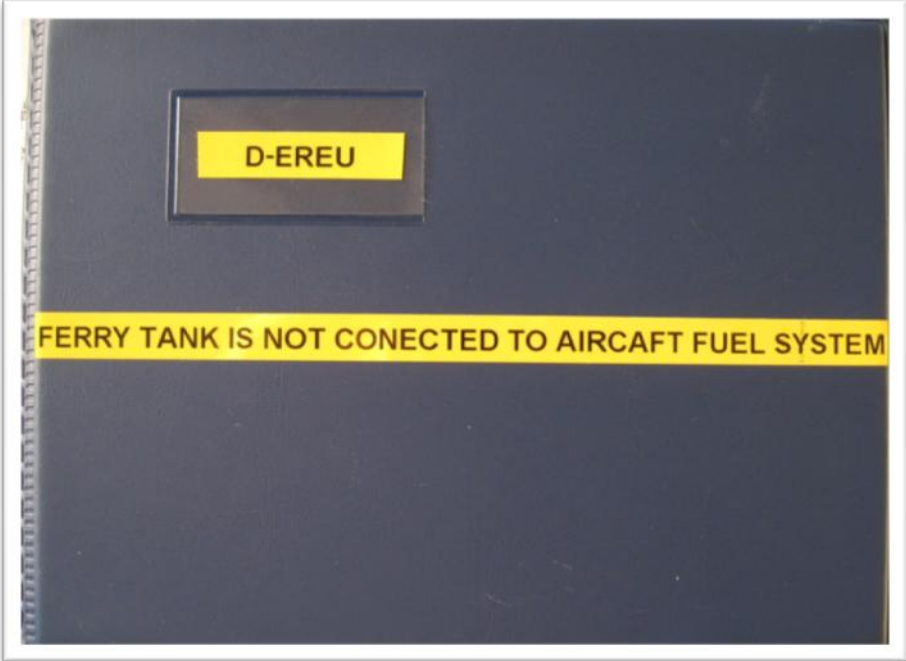
Ferry Tank is NOT connected to the Aircraft Fuel System!

Fig. 1 Warning sign on the plane written in the logbook page

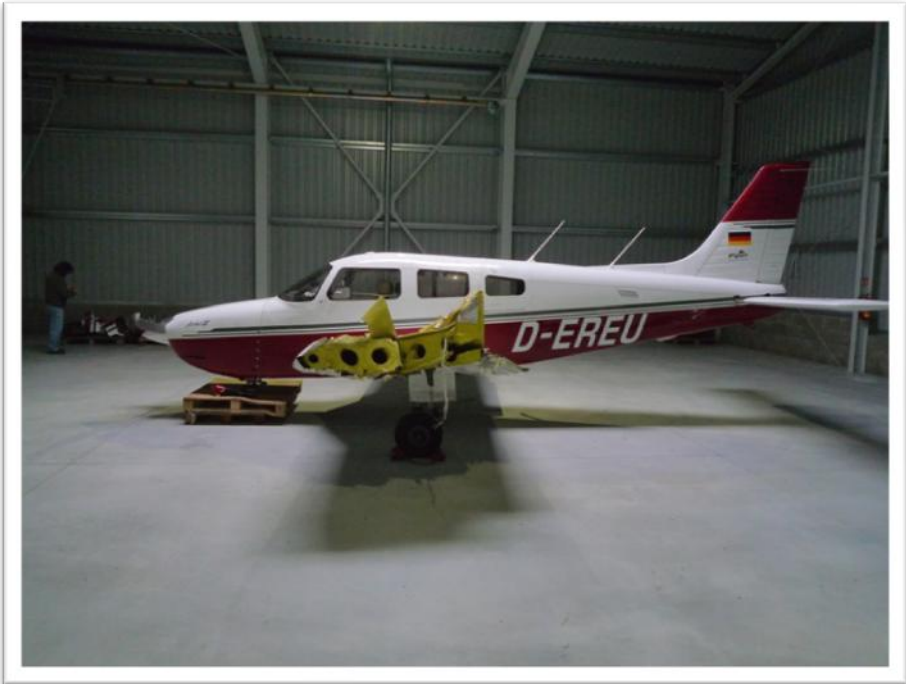
Fig. 2 Overall view of damage airplane

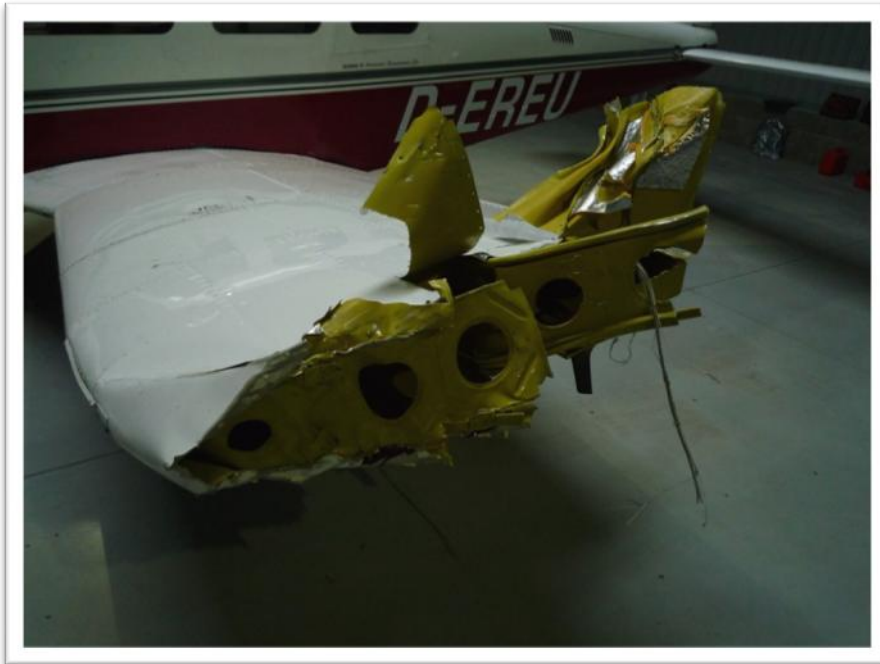
Fig. 3 Damaged of left wing

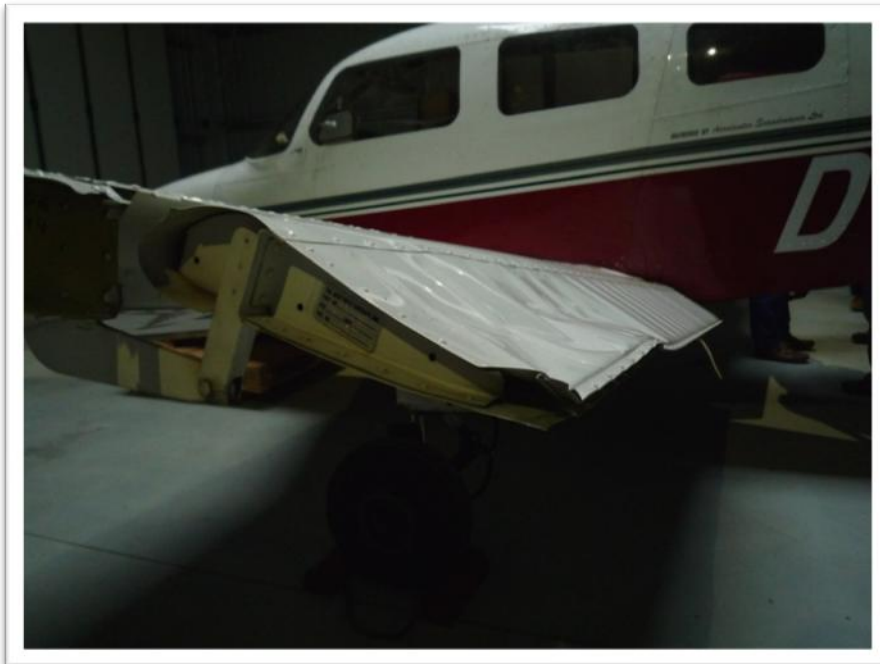
Fig. 4 Damaged of left wing

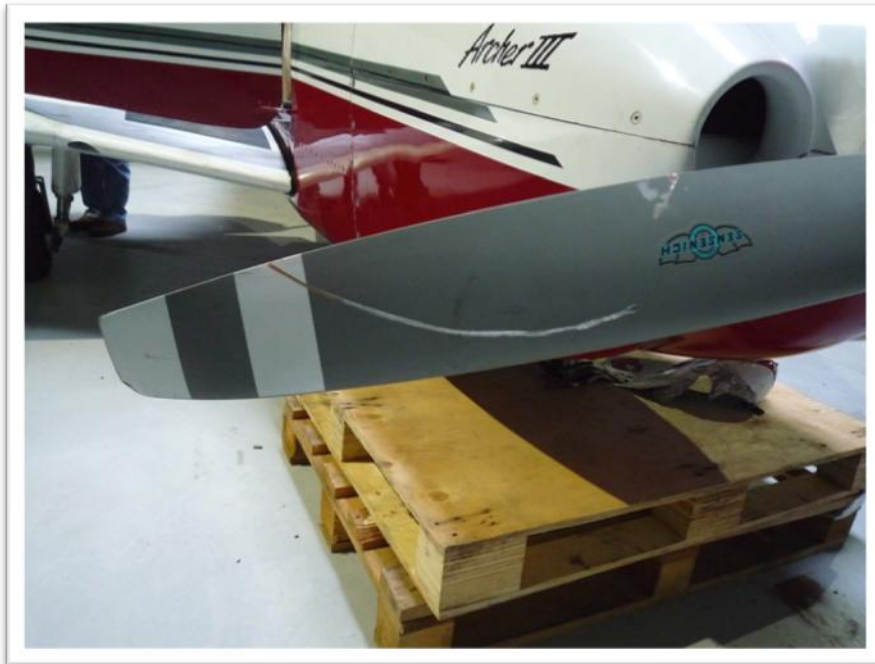
Fig. 5 Damaged of ride side the aircraft propeller

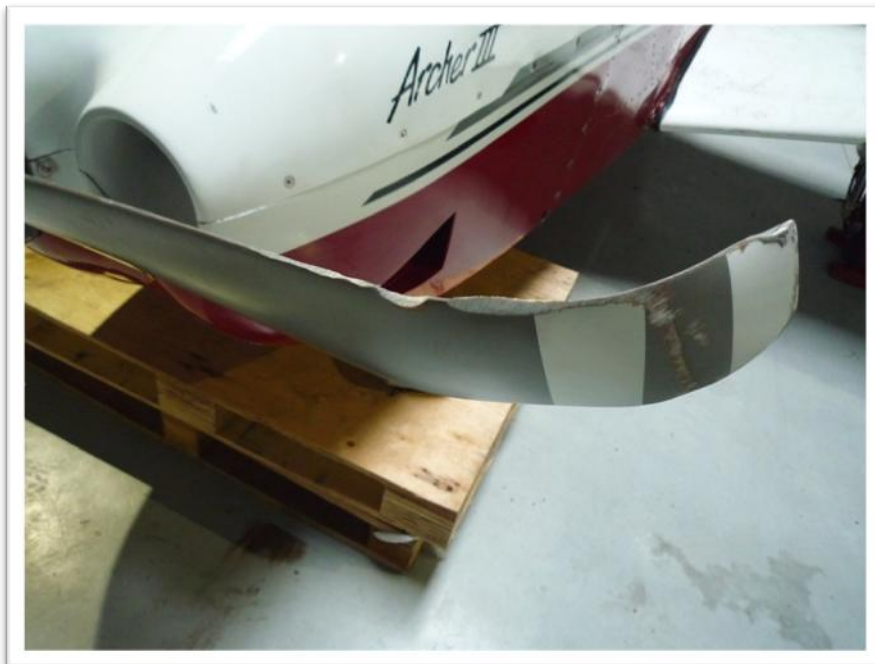
Fig. 6 Damaged of left side the aircraft propeller

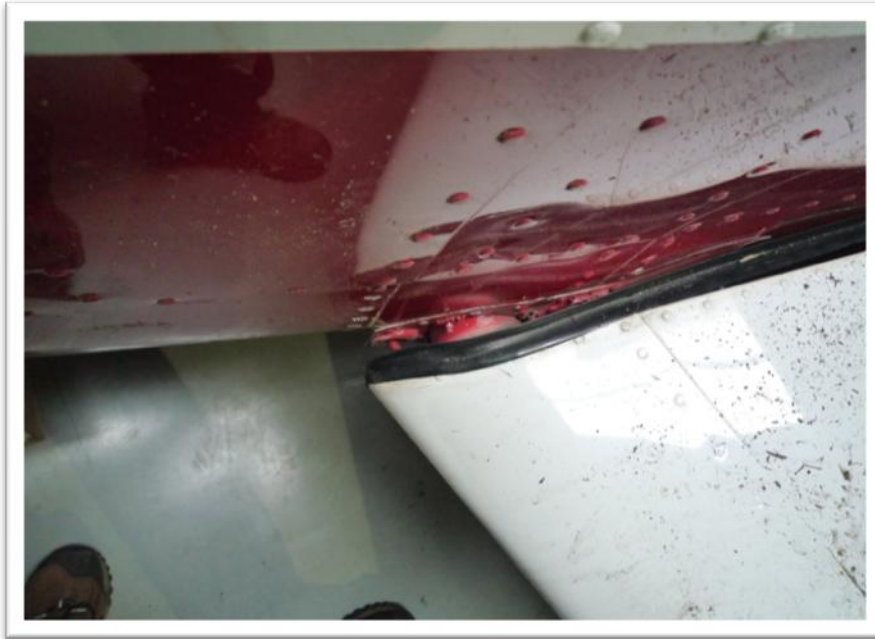
Fig. 7 Damaged of the left wing/fuselage midsection attachment

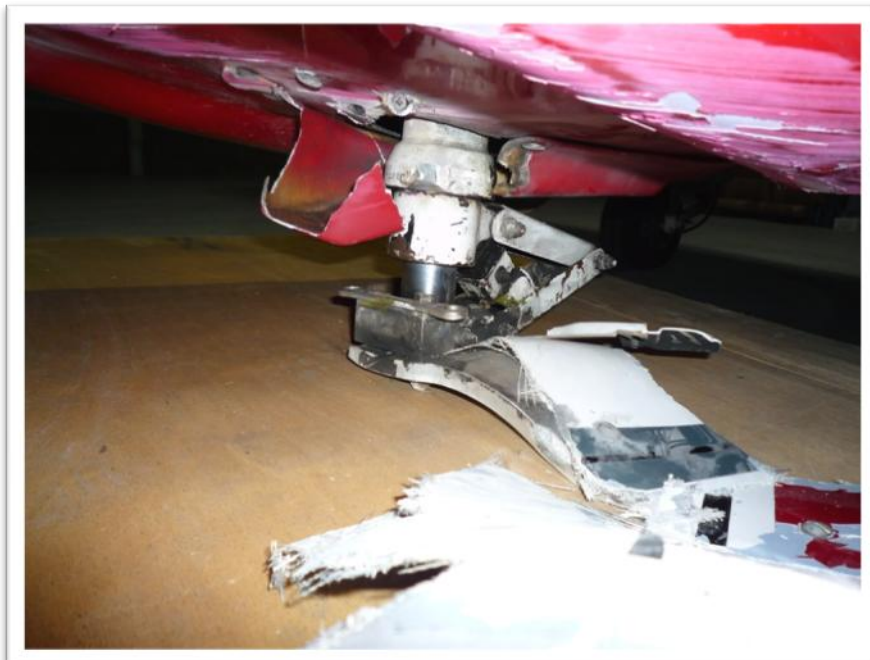
Fig. 8 Damaged of the nose landing gear leg

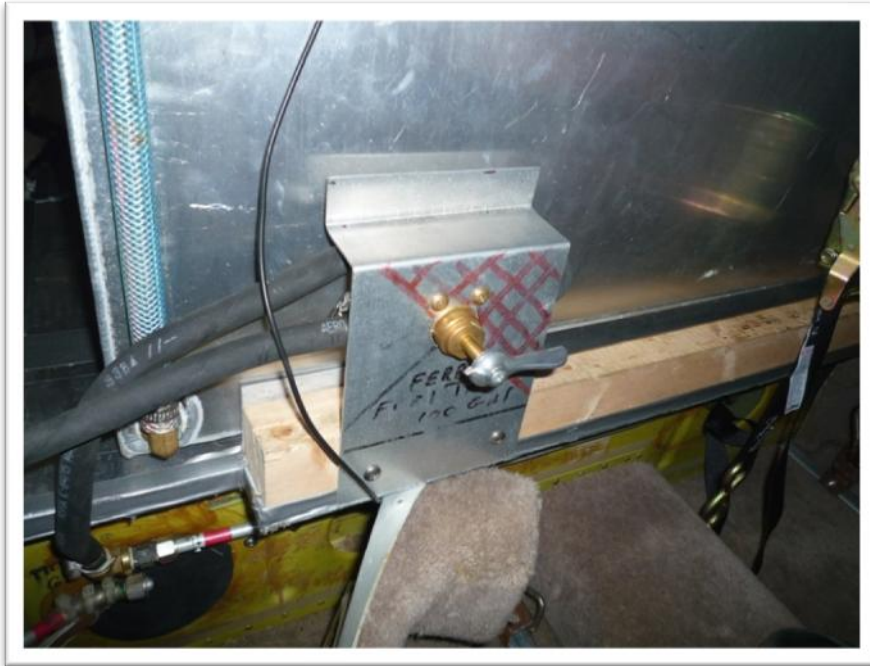
Fig. 11 The lever auxiliary fuel cock in the position when the right wing tank was connected only with the auxiliary tank

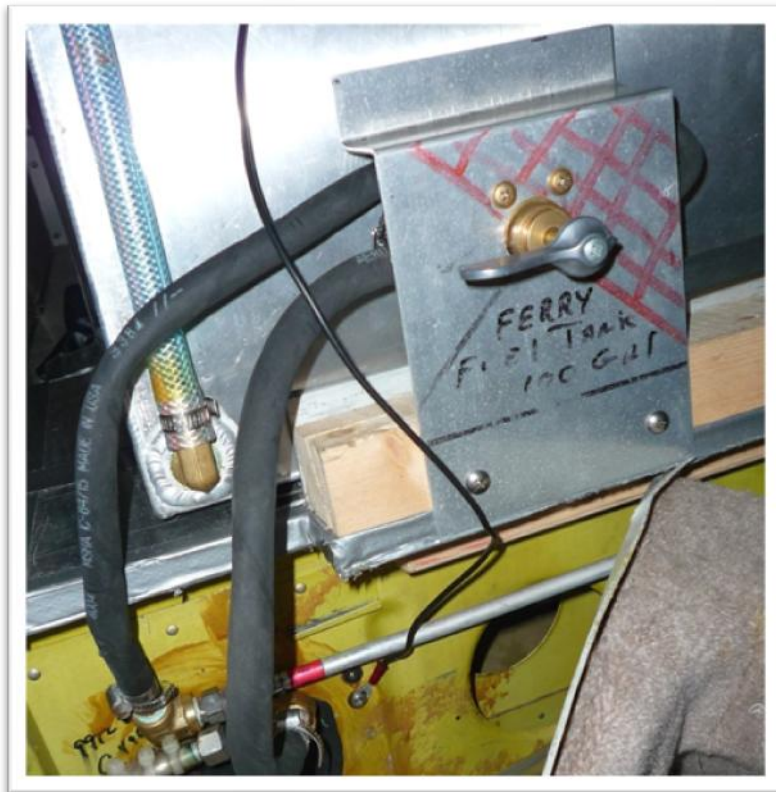
Fig. 12 The position of the lever auxiliary fuel cock, when the right wing tank was disconnected
