Ref. No. CZ-09-046

FINAL REPORT

**Investigation of microlight aircraft accident, type UFM 13 Lambada
Registration Mark OK-NUA 09
on 21st March 2009**

Prague
December 2009

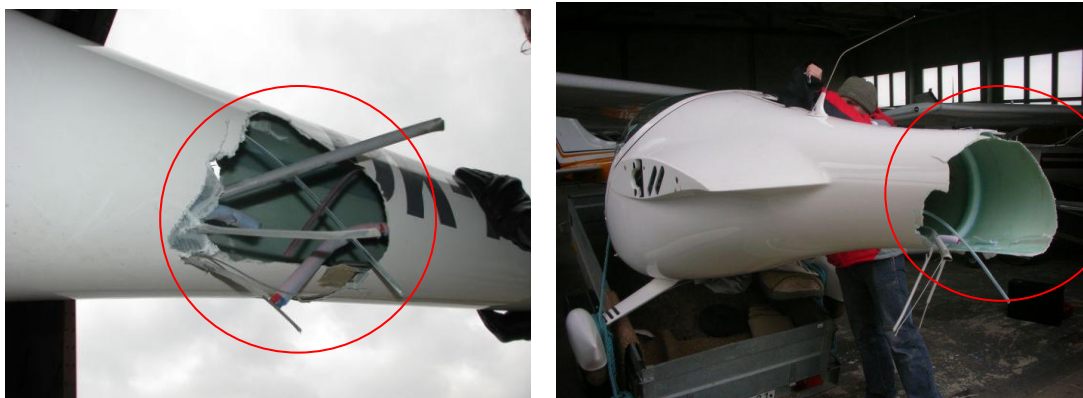
The fuselage got broken in flight in place where it changes to the spindle-shaped tail part. Further, horizontal tail plane and engine cowling were damaged, propeller was destroyed, cabin window and frame got broken and left wing trailing edge was delaminated. There was a crack in the right wing 10 cm from the root, causing lost of cavity tightness of the integral fuel tank.

Damaged of fusselsage

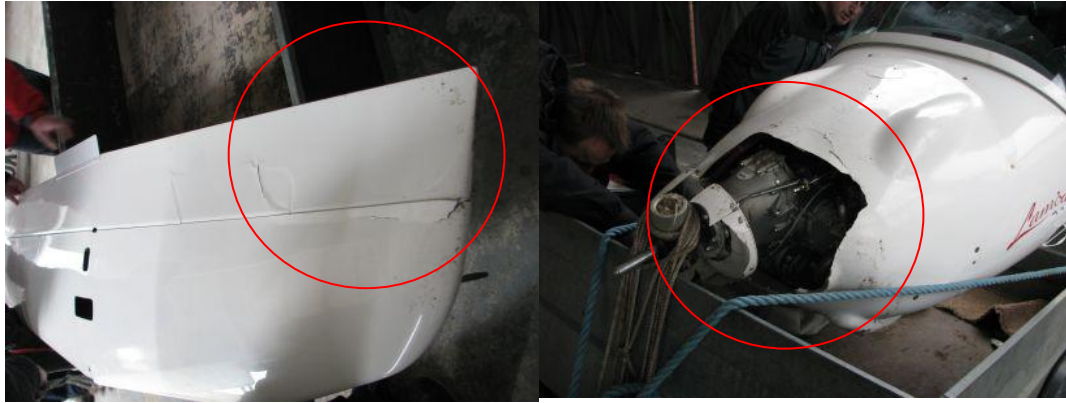
Damaged of horizontal tail plane and engine cowling

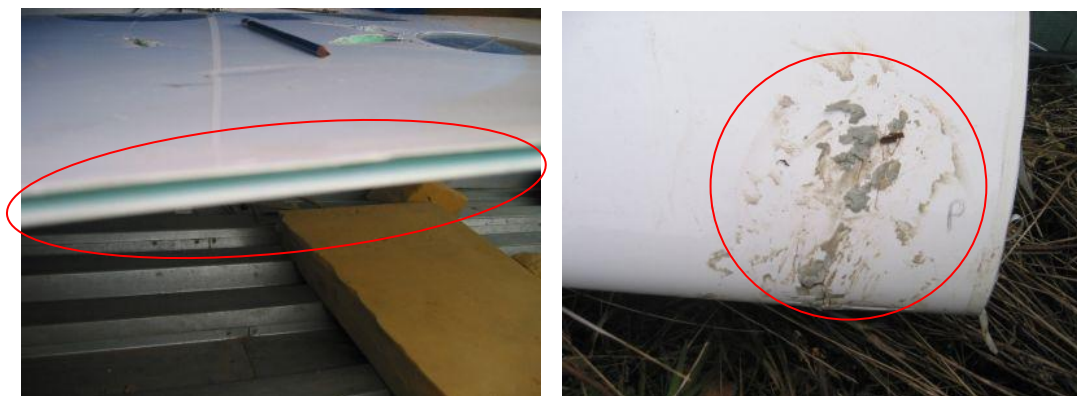
Damaged of left wing trailing edge and right wing

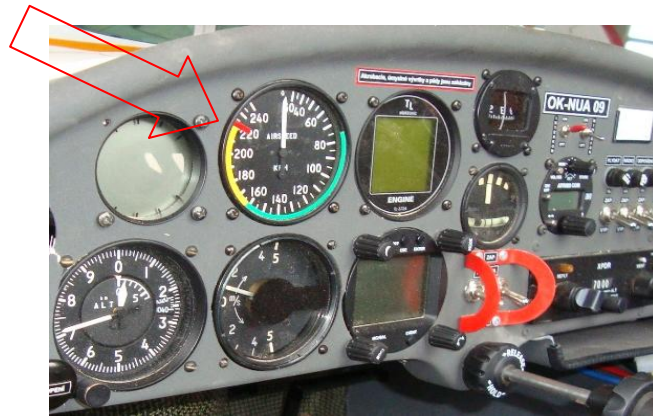
The speed limit colour designation on the speed indicator did not correspond to data in the flight manual. V_{NE} was marked at 220 km/h. This value holds for aircraft of S-LSA category.

Colour-codet of max. speed on microlight airspeed indicator Reg.mark OK-NUA 09

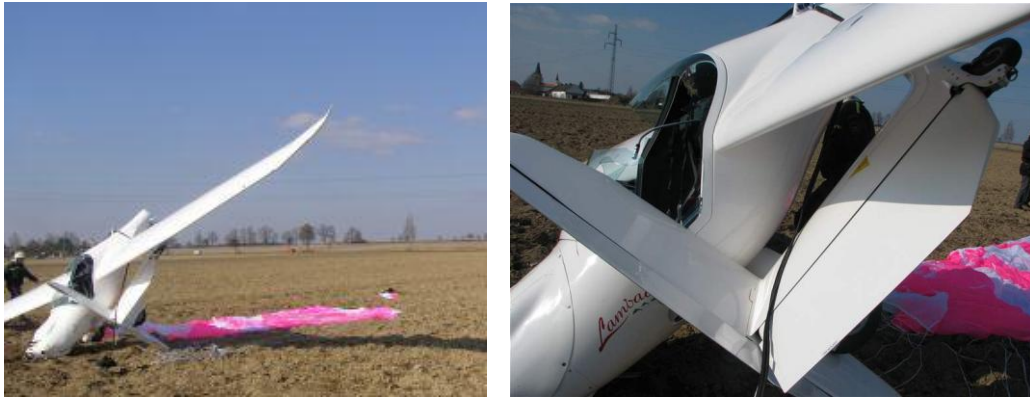
Fallen on the ground, microlight lay on its back. The aft part of the fuselage had been separated, hanging just on the rest of the cables of direction control and accumulator cables. The front part of the fuselage and the port wing's hinge were damaged by the impact. Fastening belts were unbuckled. The rescue parachute was attached to the fuselage. In the accident surroundings there was free land without obstacles.

On hitting the ground and firemen's action HZS was turned back

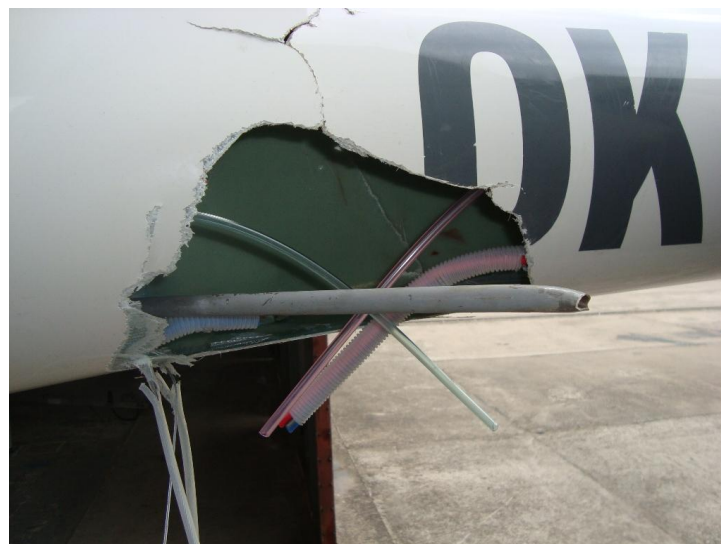
On the port side of fuselage was a crack at an angle of 45 – 50° in radial direction to the fuselage axis. The rest of the elevator control rod, cables and tubes had been deflected to left. The missing part of the body shell 10 x 10 cm large was found around 200 m from the impact spot opposite to the flight direction. After dismantling the elevator it was found out that connection between the elevator bracket and the fin, and the inner fin structure were delaminated.

Damaged of left side fuselage

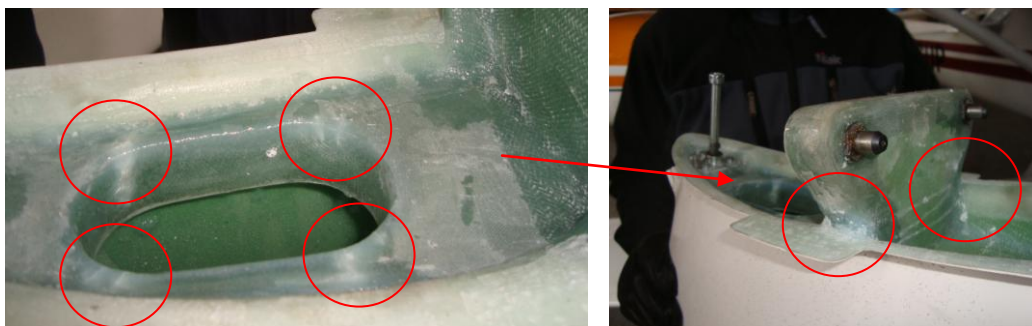
Damage of connection between the elevator bracket and the fin

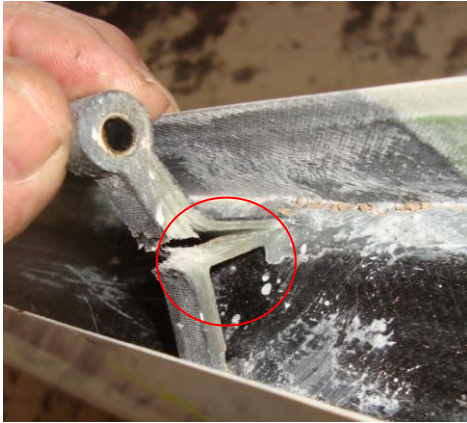
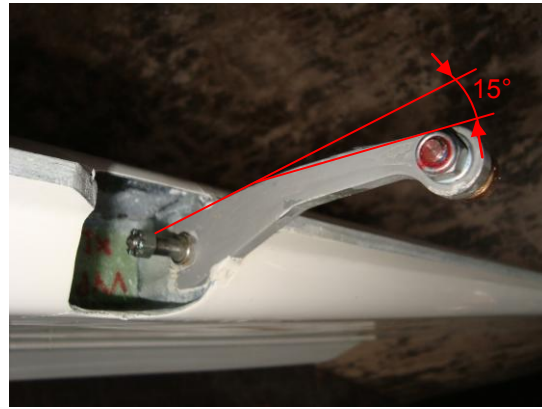
After dismantling the elevator it was discovered that three hinges of the elevator were damaged. The connecting lever of the rudder control rod was deflected ca 15° downward.

Damage of hinge and elevator control lever

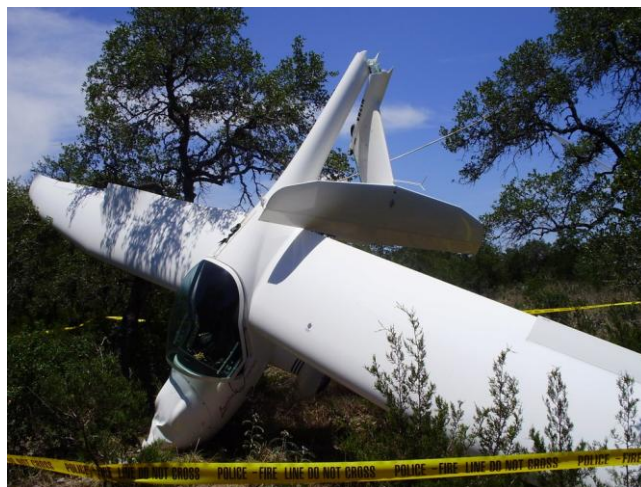
Photo of UFM-13 Reg. mark N17UA, air accident in U.S.A.

Taking into account the mishap consequences on the aircraft, both the US and the Czech accidents were most likely identical. Mutual exchange of information on both of
