Ref. No 156/06/ZZ

FINAL REPORT

**Investigation into the incident
of aircraft Beech 33 Bonanza,
at TMA II Praha - Ruzyně airport
on 11 May 2006**

Prague
November 2006

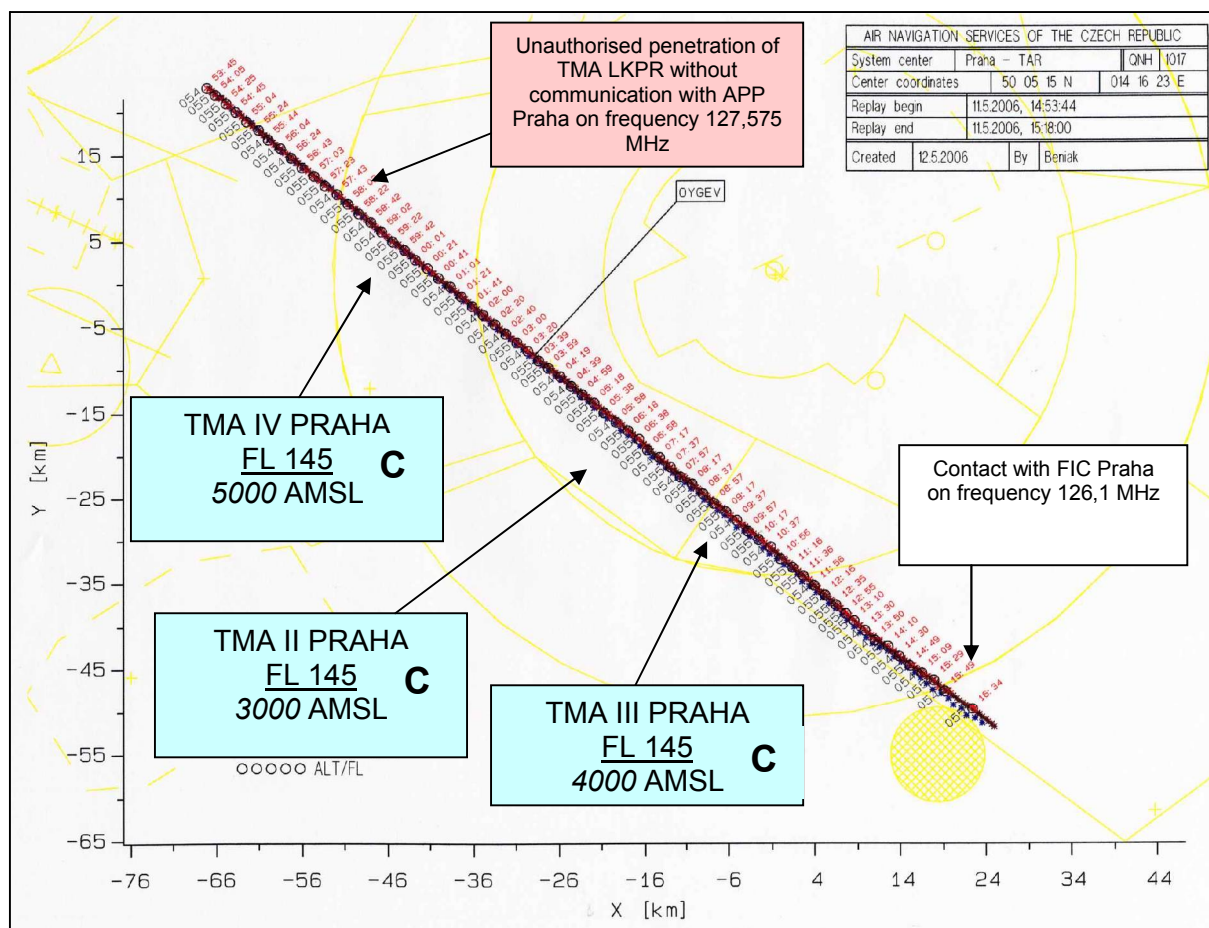
On 11 May 2006 the pilot of the aircraft, registration OY-GEV, was on VFR flight from EDAJ airport to LZIB airport. At 14:47 hrs he entered FIR Praha in the airspace of Klingenthal point, without having established contact with its respective ATC unit and at level 5,500 ft continued in the route according to his filed FLP. FIC Praha dispatcher (FID) watched an unidentified aircraft with SSR code 0022 and based upon information from FPL he thought it could have been the OY-GEV. He tried in vain to establish two-way communication with the OY-GEV aircraft on frequency FIC Praha, and at 14:55 he informed the APP controller that the OY-GEV aircraft had not established two way contact and that its route north of the Rakovnik point was heading for TMA LKPR at level 5,500 ft.

At 14:58 the OY-GEV penetrated TMA IV LKPR at level 5,500 ft without establishing two way communication with APP Praha and continued flying to VOZ. At 15:02 the aircraft penetrated TMA II LKPR and at 15:09 TMA III Praha.
