**Ref. No 040/06/ZZ**

# **FINAL REPORT**

**Investigation into the incident  
of aircraft A 320 - 200,  
at LKPR on 12 February 2006**

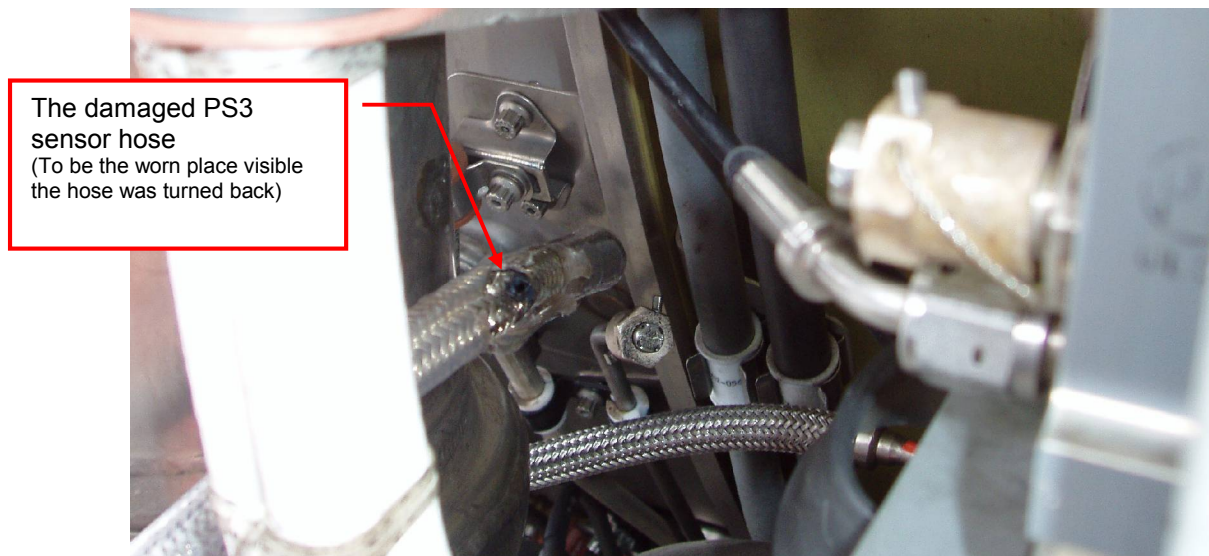
2.2 The PS3 sensor hose was tapped through at the place where it ran in the very vicinity of the starter lower air supply duct. The damage nature showed that the hose had worn through in operation due to insufficient clearance between the hose and the tube, which made the hose leak. The last repair in this place was carried out on 21 January 2006.

- No. 2 engine's speed drop was due to the PS3 sensor faulty hose that was tapped through;
- The PS3 sensor hose was in a position allowing its interference with the starter lower air supply duct.

The likely cause of the failure was that clearance between the PS3 sensor hose and the starter lower air supply duct had not been adjusted properly when assembling the hose. That made the hose come in contact with the air tube during engine operation, leading to damage of the hose that was difficult to detect visually.

The PS3 sensor hose had been replaced and the subsequent engine test run showed the engine was working free and clear.

The Civil Aviation Authority should verify if there are proper checks in the maintenance procedure of aircraft with CFM56-B4 engines in operation to make sure the PS3 hose and the starter lower air supply duct will not get in contact.
