Ref. No. CZ 09/029

FINAL REPORT

**Investigation of Incident A/C Boeing B 737, Registration VP BBL,
on 1st March 2009 on LKTB**

Prague
July 2009

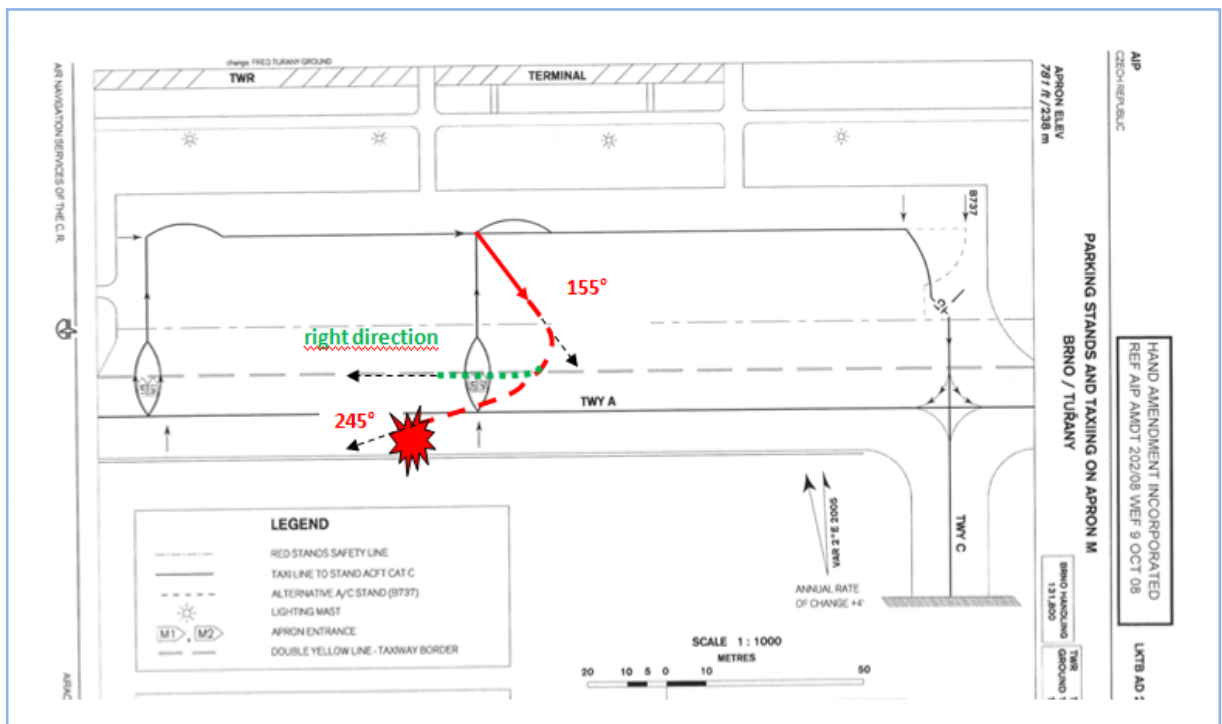
The incident happened on the south edge of TWY, five to ten metres on grassy surface, 70 m away from the stand. The TWY A surface is concrete and the adjoining surface is grass.

The plane went on the grass with nose landing gear and main left undercarriage leaving trails three to fifteen metres deep. When checking the setting of control elements and electricity breakers it was found out that the hydraulic pump circuit breakers on panel P6-2 were cut off.

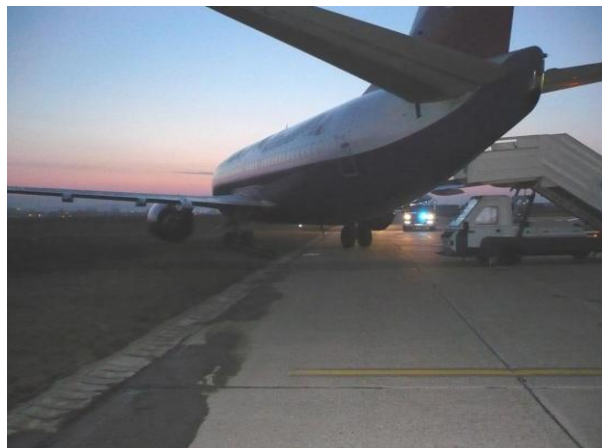
Situation of the incidents area
