AIR ACCIDENTS INVESTIGATION
INSTITUTE
Beranových 130
199 01 PRAHA 99

Ref. No 135/05/ZZ

FINAL REPORT

**Investigation into separation infringement between
EEZ 1978 and OK-RMA.
at CTR/TMA LKPR
on 22th of April 2005**

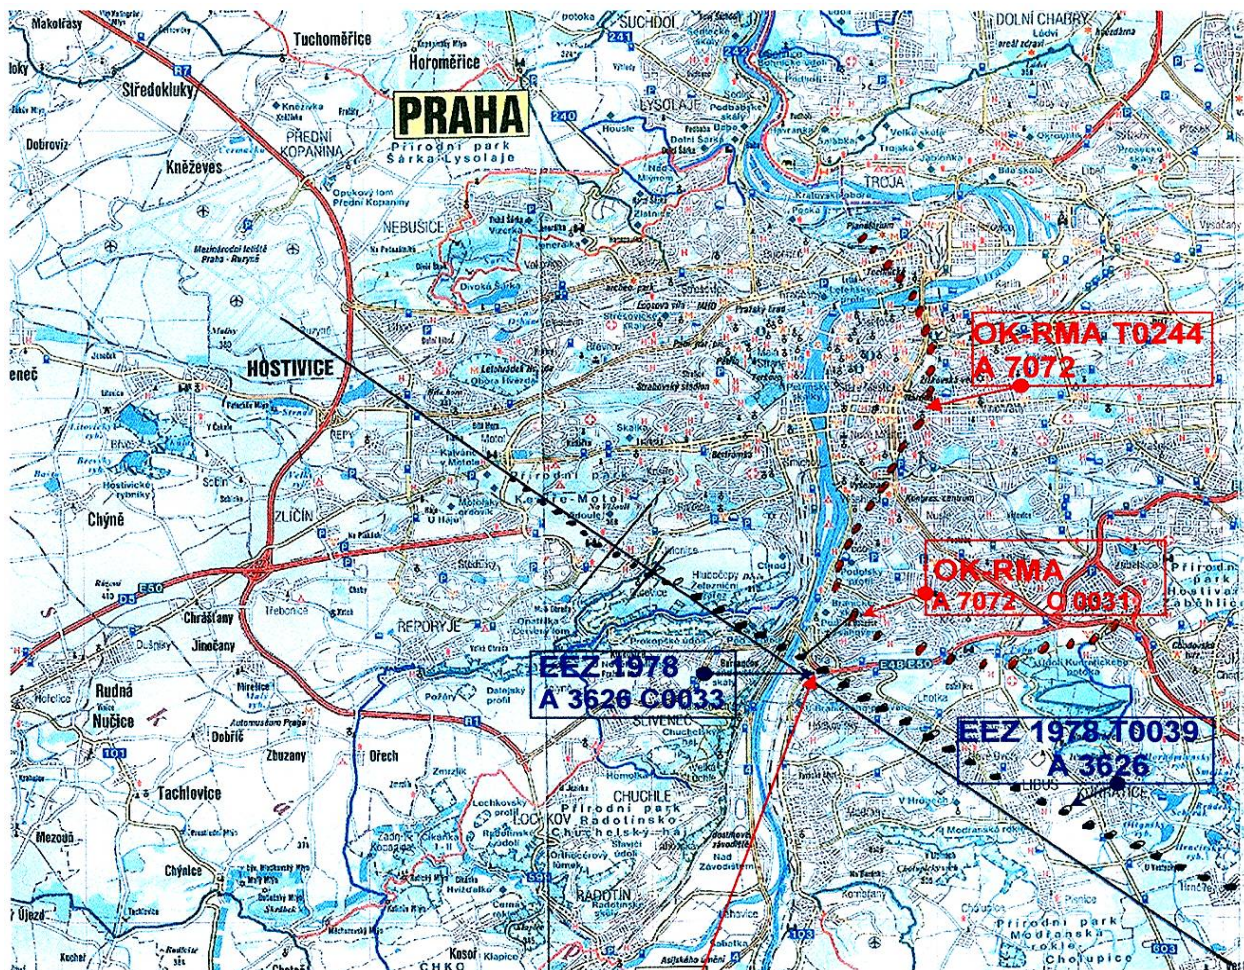
At about 6.2 NM from THR RWY 31 it came to lowering minimums of separations set between EEZ 1978 and OK-RMAo 0.87 NM horizontally and 200 ft vertically.

The incident took place on the VOR/DME approach centre line for RWY 31 cca 6.2 NM from THR RWY 31.
