Ref. No. CZ-13-193

FINAL REPORT
Investigation into the incident of aircraft type Fokker F100,
registration mark OE-IIB, at LKKU aerodrome
on 3rd June 2013

Prague
February 2014

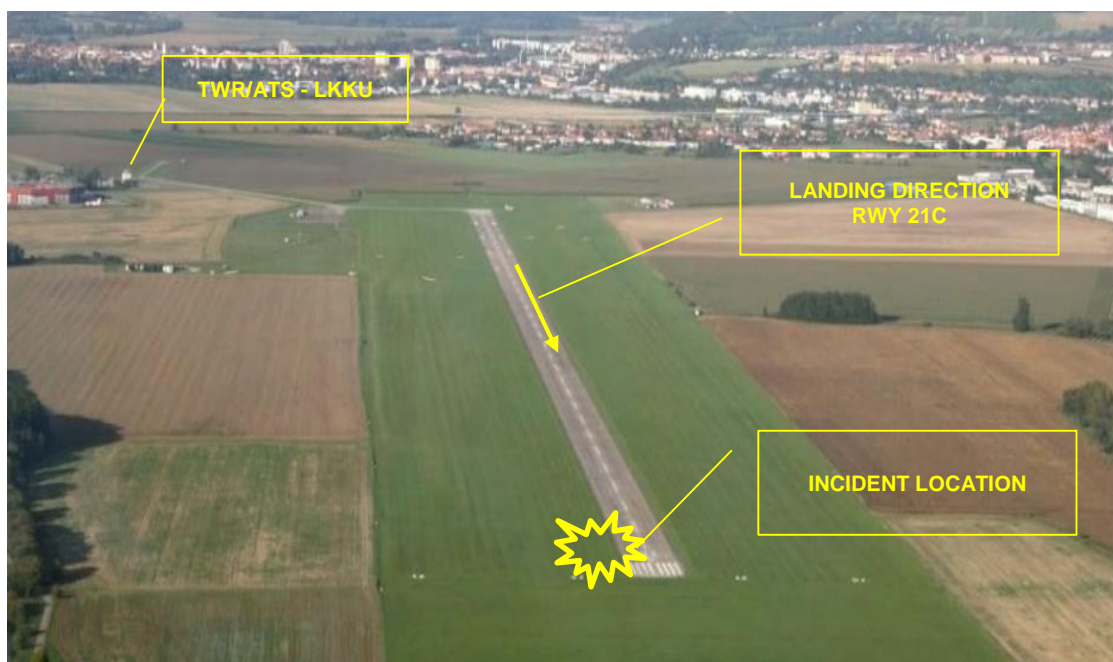
Incident Location Description

The incident was located at the end of RWY 21C (hereinafter the runway) at the right side. No tyre traces attributable to an aircraft of the Fokker type have been detected on the concrete surface of the runway. The traces of rolling aircraft front wheels started in the grass, 1.50 m from the centre of the runway, forming an approximate 10-15 degree angle with the edge of the Runway end, and finished 16.6 m from the right edge of the runway. The traces were 0.1 - 0.2 m deep and clearly visible up to the point of an aircraft full stop. The aircraft was turned to the right with its nose in the heading of 293 degrees. The virtual line connecting the axes of the main wheels was located 2.5 m from the right edge of the runway. The main wheels sank 0.1 - 0.15 m in the soggy grass surface at the edge of a drainage launder.

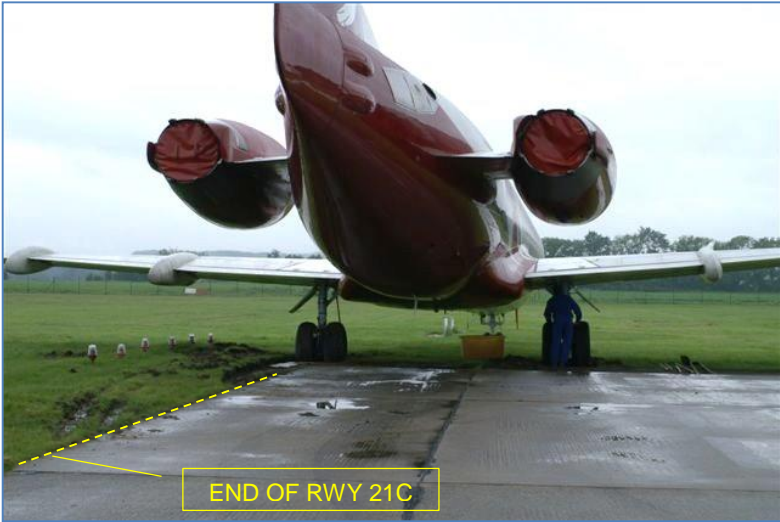
- the pilot estimated incorrectly the initial point from which the aircraft would start the 180 degrees turn and ran off the concrete surface of the runway;

Pic.1 A/C position

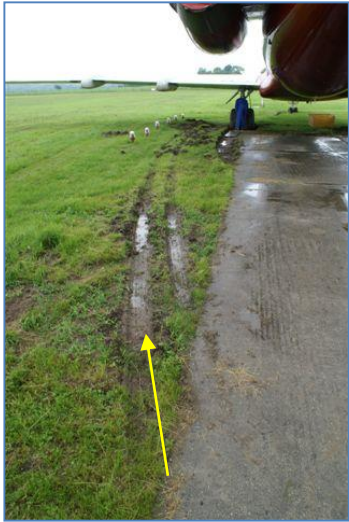
The angle formed by the trajectory of the front gear wheels and the edge of the runway end proves that the wheel steering limit value of 76 degrees was reached. Therefore, we may deduce that the effort to free the aircraft by increasing the left engine thrust with a maximum displacement of the steering mechanism resulted in static overloading of the said mechanism and partial chipping of the mechanism gear teeth and thus in damaging of the system.

Pic. 2 Traces of front wheel

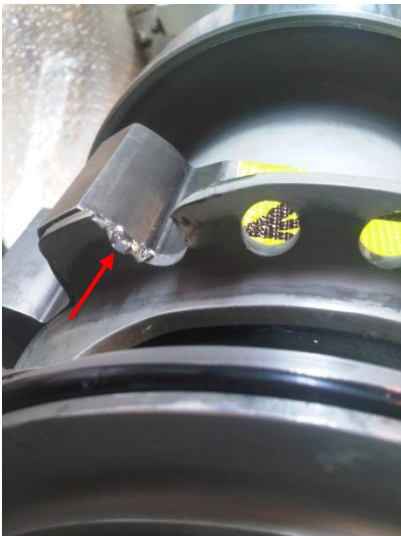
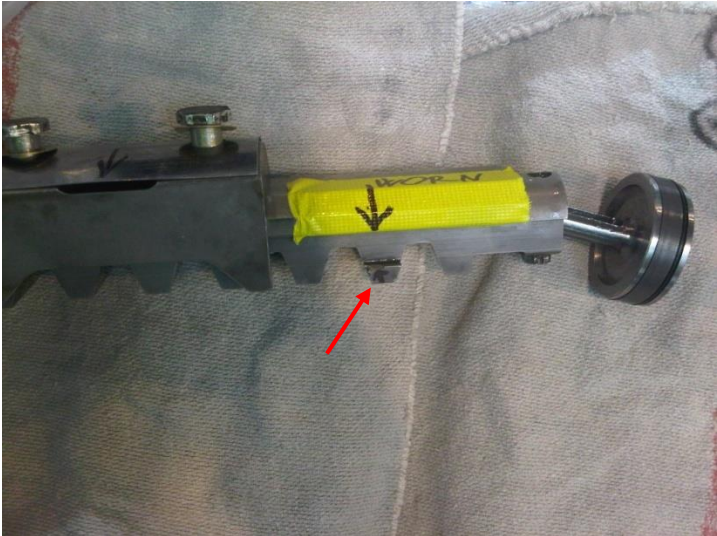
After the incident, the aircraft was checked by the technical personnel of the operator with the aim to evaluate its technical condition and to verify whether the incident had not been caused by a technical defect and/or malfunction. The damage to the steering mechanism found after the incident was caused in direct effect of the increased rolling resistance force on the front landing gear wheels. The mechanism was damaged due to impressions and partial chipping of teeth in the position that corresponds to the limit position for the right turn.

Pic. 3,4 Damage to the steering mechanism - p/n 200429305

During the check after the event damage to the steering mechanism of (p/n 200429305) was disclosed. The defect was removed by replacing the damaged part with a new one.

The damaged parts of the aircraft were replaced on site and the the aircraft was permitted to make a technical overflight to Vienna by the technical personnel of the operator.

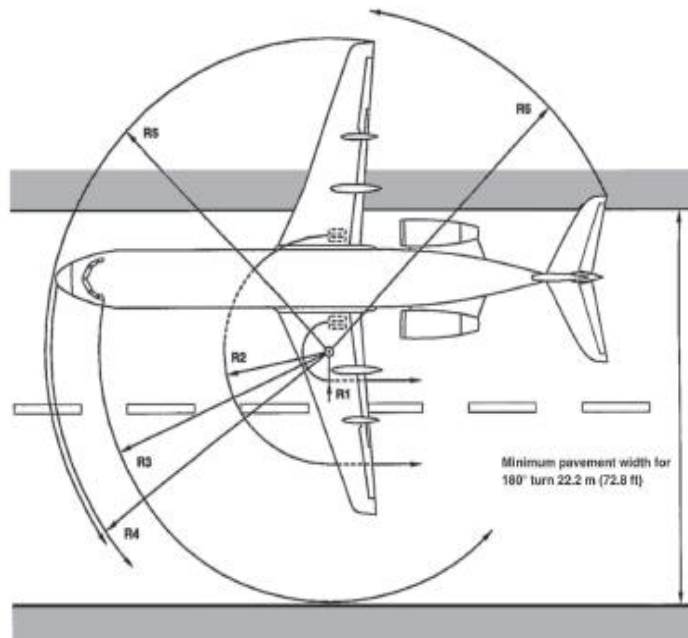
2. Scheme of U-turn Fokker F100, steering angle 76 degrees

The respective aircraft flight and operating manual reads that a 22.2 m wide stripe is sufficient for maximum turning of front wheels to the angle of 76 degrees. This dimension applies to the position of main wheels on one of the stripe edges and is delineated by a circumscribed circle corresponding to the movement of the front wheels. The LKKU Runway (RWY 03C/21C) is 30 m wide. We may therefore deduce that the runway dimension was sufficient for turning of the aircraft by 180 degrees. In practice this procedure may be applied if the crew knows the given aerodrome well or when the aircraft turning is guided by the ground assistance service. In this particular case the crew after landing in the given direction required no assistance and the pilot failed to correctly estimate the initial position of the aircraft for safe turning. The pilot probably tried to free the aircraft with all his energy and gave up only when reaching a dead end.

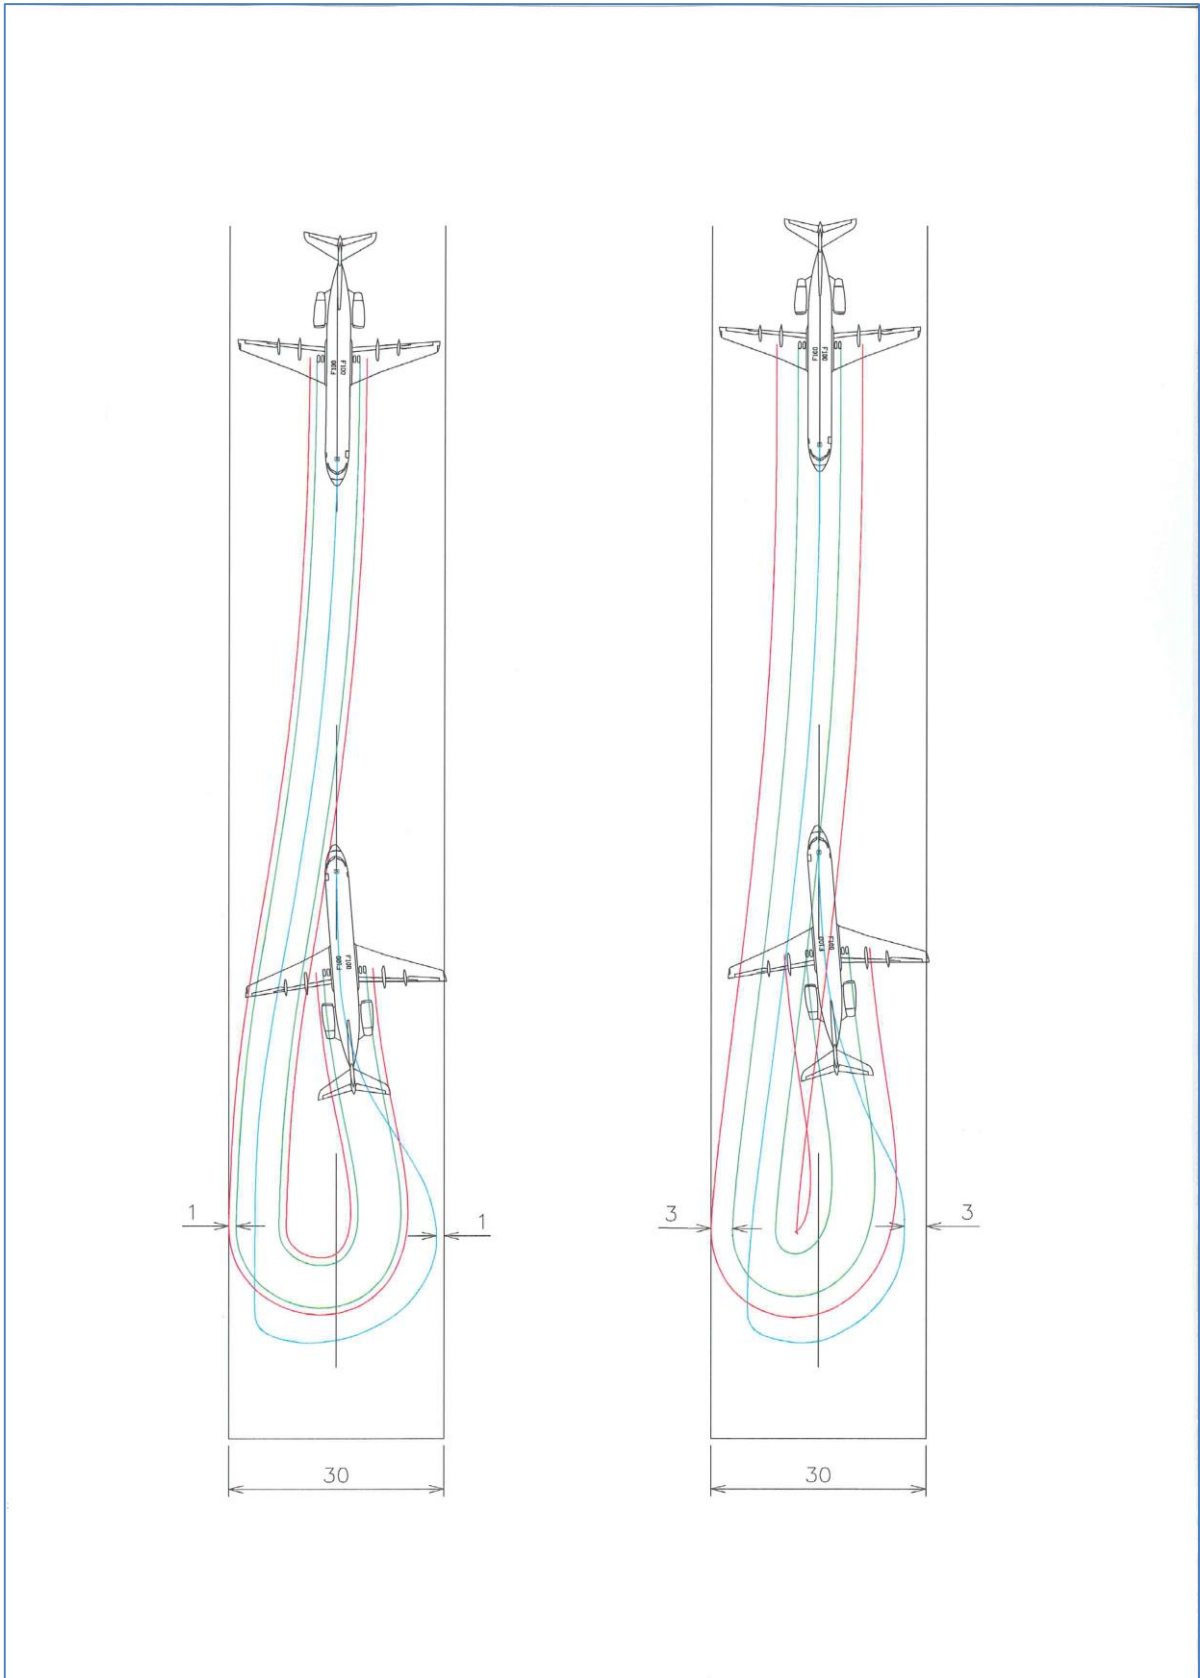
The turn pad criteria are published in Appendix 4, Doc 9157 AN/901. The relevant provision in Article 3 recommends the proportions of the turn pad and the adjacent taxiway to accommodate aircraft turn with the maximum front wheel turn at 45 degrees. The geometric trajectory construction and calculation show that the width of the pad needs to be 36 m whereas the starting position of the main wheels would be closely on the edge of the pad.

3. Scheme U-turn Fokker F100 on RWY (wide 30 meters) and starting position of the main wheels would be closely on the edge of the pad 1 or 3 meters.

We recommend to the aerodrome operator to review and, if need be, implement further procedure description in providing assistance to similar types of aircraft in cases when the landing would be carried out in the RWY 21C course and in respect to the technical abilities and limits of both, the aircraft and the runway, and thus would be able to provide adequate service and assistance for aircraft ground control.
