**CZ-08-562**

# **FINAL REPORT**

**Investigation into serious incident  
of Boeing 737 - 400,  
registration mark OK-WGX,  
at Ostrava Mosnov Airport,  
on 14 November 2008.**

Prague  
December 2009

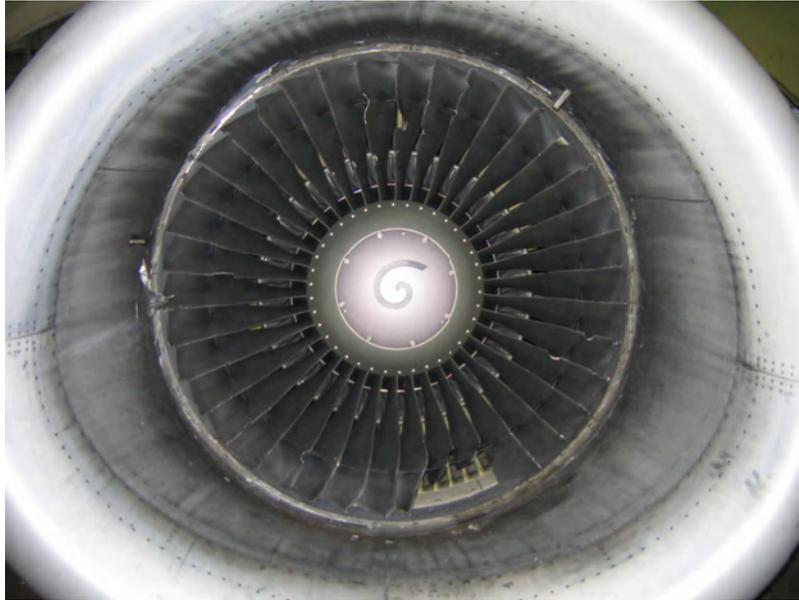
The engine 2 was seriously damaged as a consequence of having sucked a bird. Directly on the stand of the aircraft it was found that the fan blades were damaged, the inlet cowl inner wall had been pierced, and a small amount of fuel had leaked from the engine control system. A closer inspection revealed that assemblies on the engine outer part and their hinges (starter, Main Engine Control, fuel pump) were damaged too.

*Fig. 1 Overall view of engine inlet*

Based on this findings and after discussion with the engine manufacturer it was decided to remove the engine and send it to a foreign repair shop to know the damage in more detail and the way and scope of repair.

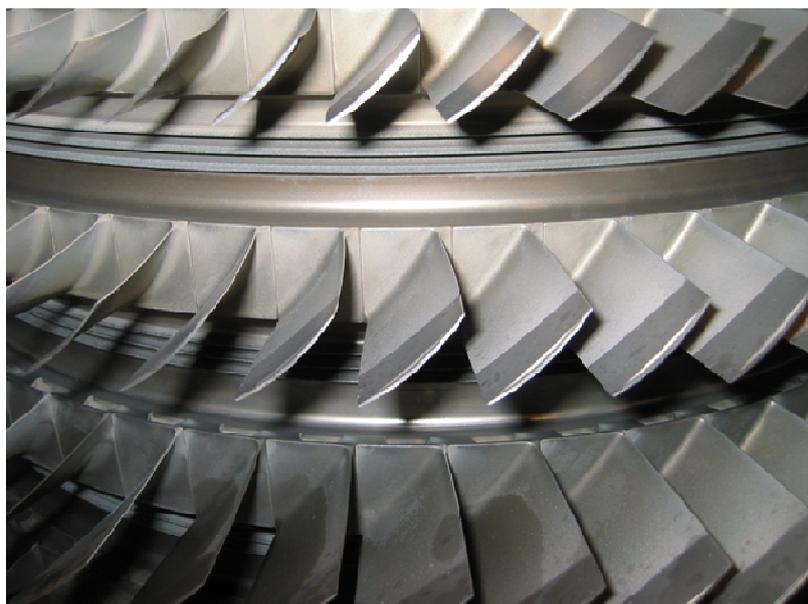
Apart from the damage already mentioned, extensive damage to the compressor was also found. The low pressure and high pressure rotor blades were ground off by the contact with compressor case and seriously damaged. The combustor was without damage only some deposit of brushed dust from the compressor was found. The high pressure turbine had its cooling holes blocked with brushed dust, which caused its overheating. The low pressure turbine moved to the rear due to the nut of bearing 1 coming loose, thus making contact between the rotor and stator of the turbine, resulting in low pressure turbine damage.

*Fig. 2 Abrasion of high-pressure compressor blades*

A few fan blades broke off after engine 2 took in a bird. Rests of the bird and blades left the engine with by-pass flow, damaging the fan case. Broken blades caused the engine to vibrate strongly. Consequently, parts on the engine external side were damaged. The bearing no.1 nut came loose, causing the LPT shaft to loosen and move back. This made the stator get in contact with the LPT rotor discs. The strong vibration caused mutual oscillation of the high-pressure rotor and the HPC box, which in turn caused LPC and HPC rotor blades and box to get in contact. The blade tips were ground off on the case. The created grind dust moved to the rear through the engine where it plugged cooling holes on HPT NGV and HPT blades. Consequently, the cooling capability was gradually reduced, causing exceeding of engine maximum allowable temperature even at flight idling regime.

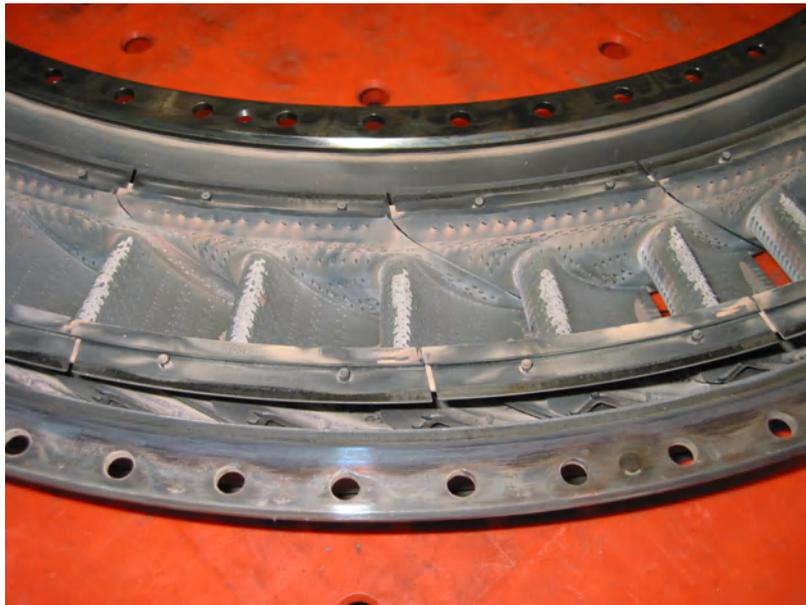
*Fig. 3 Deposit of abrasion dust on high-pressure turbine stator blades*

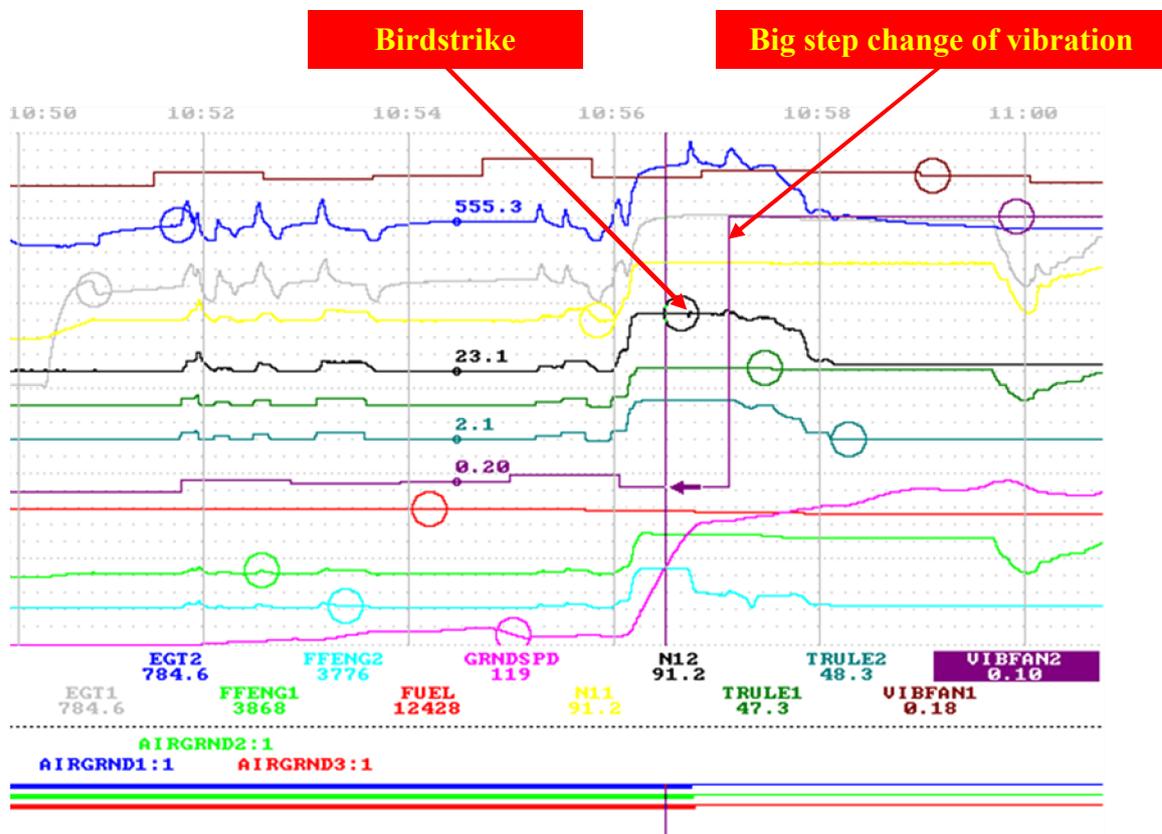
- 10:54:28 engines 1 and 2 are on idle regime, parameters of either engine are steady and vibrations of fans of either of them are at value 0.20
- 10:56:28 take-off regime set in the course of take-off run, fan vibration of engine 1 at value 0.18, fan vibration of engine 2 at value 0.10
- 10:56:43 at an airspeed of 166.5 kt revolutions shoot of engine 2 low-pressure compressor (take in a bird)
- 10:57:08 ramp change of engine 2 fan vibration from 0.10 to 4.88; engine 1 fan vibration at 0.27 value
- 10:58:07 engine 1 regime reduced to flight idling
- 11:05:27 exhaust gas began to rise from 531.4 degrees Celsius
- 11:06:15 exhaust gas maximum temperature reached 974.8 degrees Celsius
- 11:06:18 engine 2 shut down

Fig.4 Engine parameters as recorded at the time of collision with bird

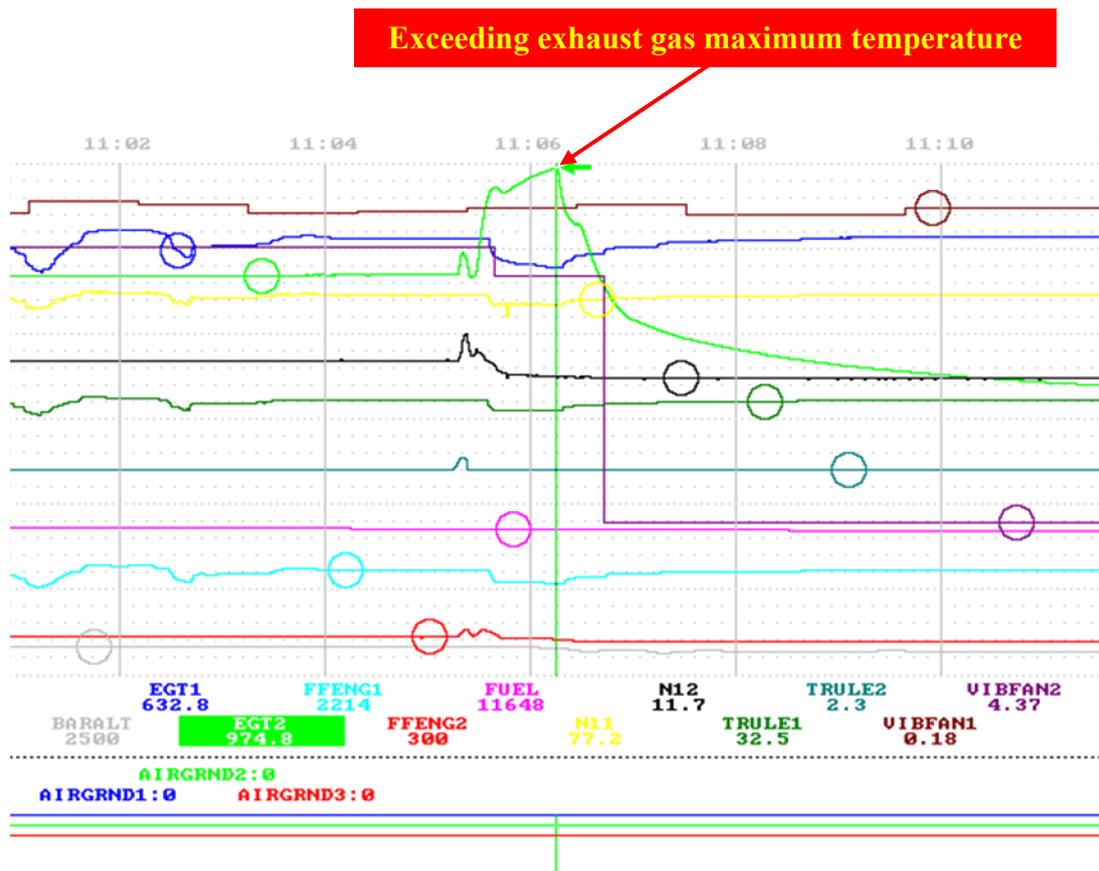
Fig.5 Engine parameters as recorded when exceeding exhaust gas maximum temperature
