Ref. No. CZ 08/359

FINAL REPORT

**Investigation of Serious Incident A/C Airbus A 310, Registration OK-WAB,
on 31st July 2008 on KJFK**

Prague
June 2009

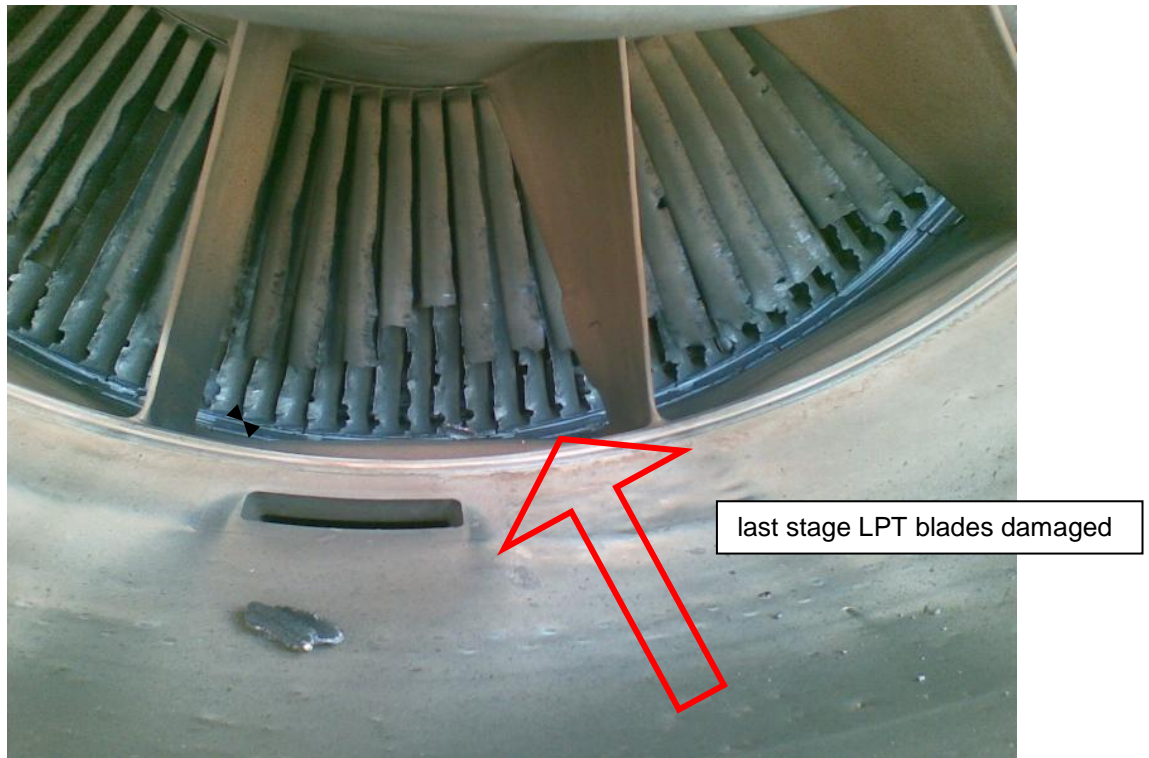
The loosening of the engine no. 2 metallic parts did not cause damage to aircraft surface or to the primary structure of the plane. Landing gear was not damaged by the fact that the maximum landing weight was exceeded. An external inspection by the crew of the engine no. 2 outlet revealed that the low pressure turbine last stage blades were damaged. A contract technician of SR Technik Company confirmed the damage. The damaged engine was not usable for further operation of the airplane.

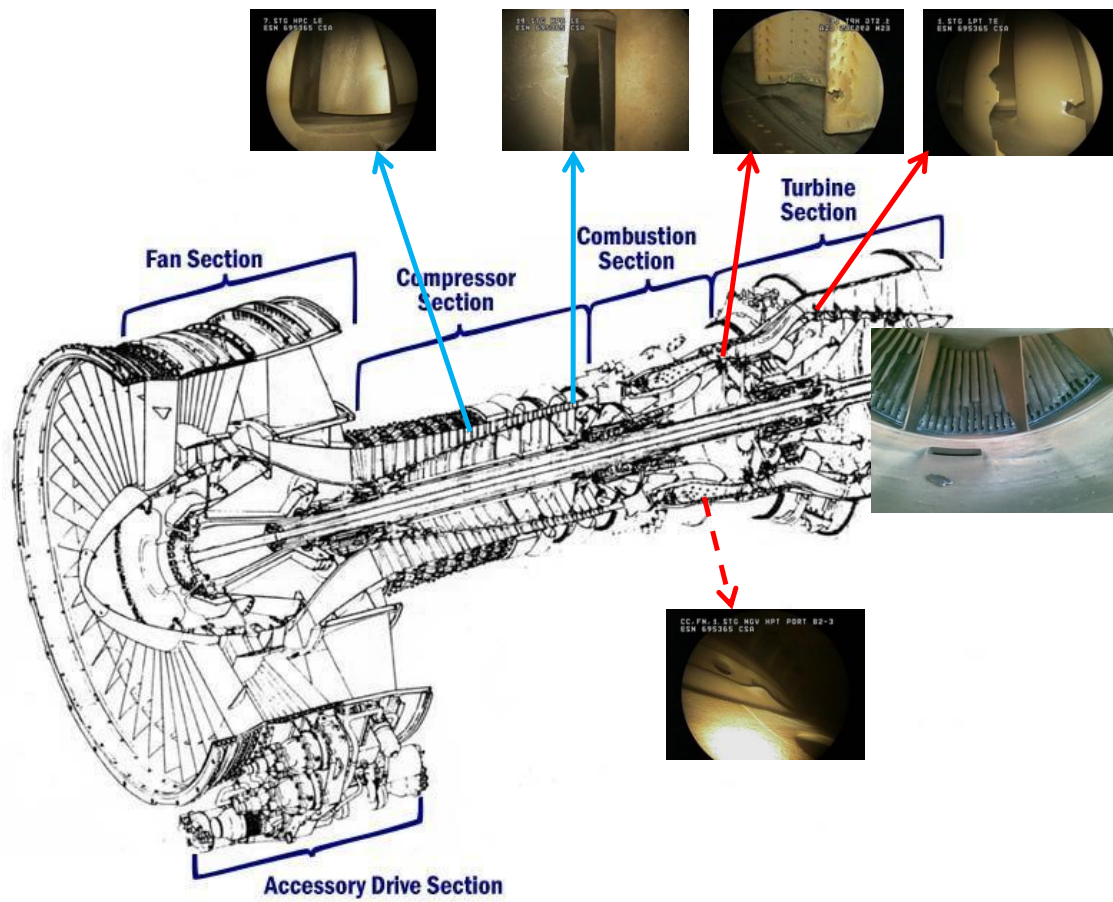
BSI showed the damaged engine

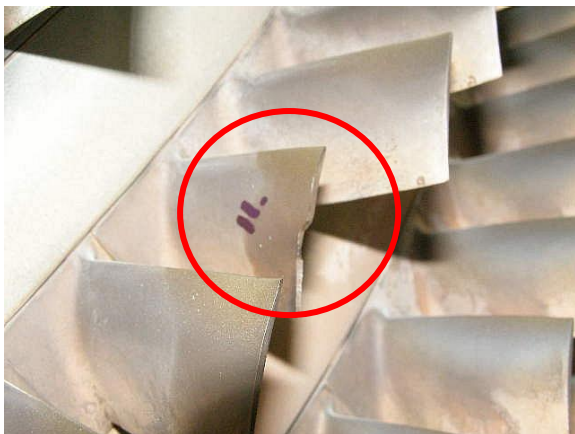
one blade in the HPC 11th stage had one third of its working part broken off

HPC 11th stage blade: The blade is broken off at about 1/3 height from the end. The stub of the blade was sent to the lab for metallurgical examination of the fracture surface.

Macroscopic examination of the blade's fracture surface revealed a zone of fatigue fracture near the leading edge taking up around 40 percent of fracture surface.

Crack's front shape, as seen on the crack fracture surface after it has stopped, and typical marks of fracture surface indicate that the fracture originated just on the leading edge. The other blades of this stage show some traces of foreign object impact at leading edges at the same locations (further referred to as impact). A few small impacts are visible on the concave surface of the damaged blade along its full length. They are located at a place where the fracture surface runs through the blade profile. The mutual position of impacts after the crack stopped and the impact traces show that these small impacts took place only after the fatigue crack got initiated. Examination using an electron scanning microscope revealed that the fracture fatigue surface and the surface of the final break present different structures. EDX analysis did not reveal any organic matter on the profile surfaces.

The fracture nature corresponds to a high cycle fatigue mode.

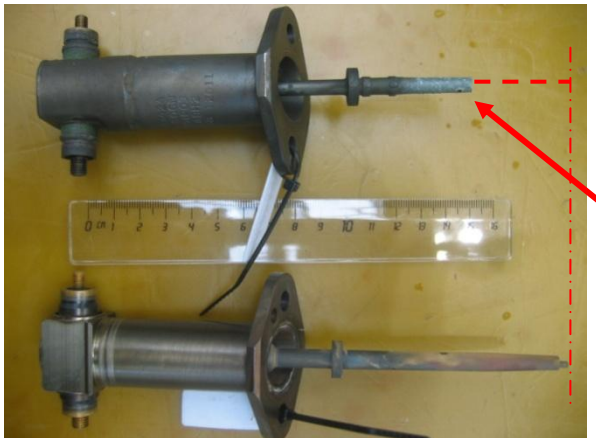
measuring probe EGT, 1/3 of the probe body was missing

EGT probe: the EGT probe showed an oxidation crack area with a fatigue fracture, orientate from both a ventilating hole. The metallographic analysis of the crosscut from crack area in source disturbances disclose extensive an oxidation in this area probe EGT. The probe's fracture surface was sent to the metallurgical lab for examination.

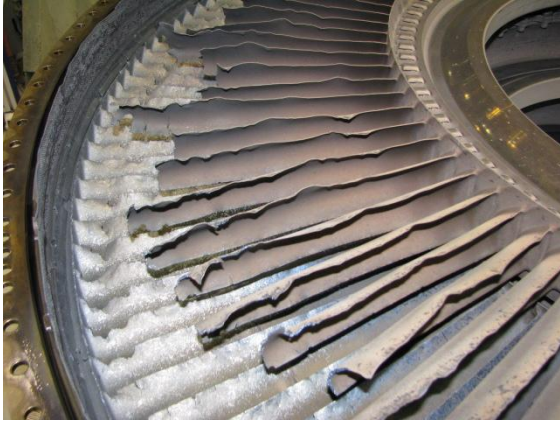
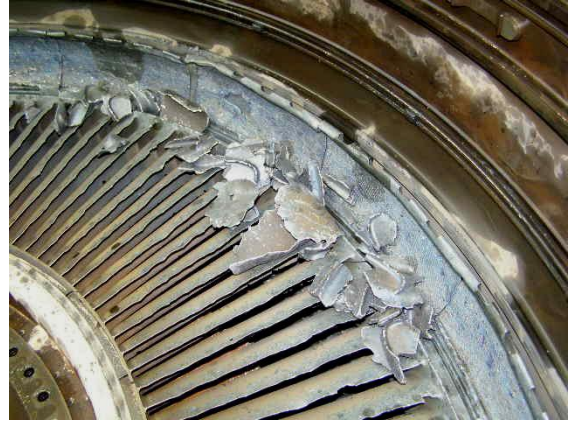
the 2nd to 4th LPT stages blades were damaged too

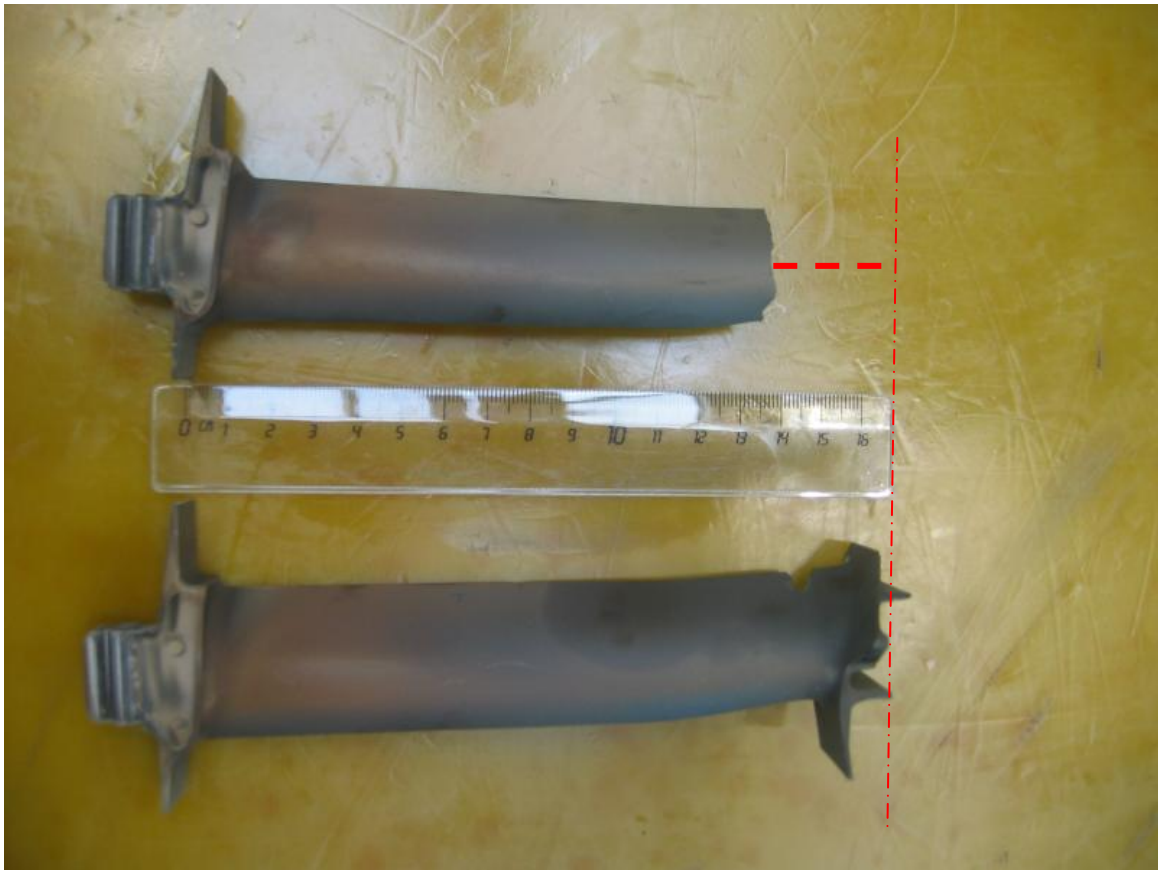
1/5 of the working part of a blade of LPT's first stage was broken off

LPT rotor: on one blade of the first stage, the blading cover came off approximately at 1/5 of the blade length. The blade stub was sent to a metallurgical lab for fracture surface examination.

The engine speed dropped abruptly likely due to the braking off of one blade of LPT first stage during the plane taking off, the time the engine was under an utmost strain. However, the impact print, leading edge deformation and oxidization traces in the fracture surface of the blade of LPT first stage show the failure could have been also caused by a foreign object intrusion, or by a shock from separated parts of blade of the HPC 11th stage or by some parts of EGT probe. Macroscopic and metallurgical findings on the blade's fracture surface do not allow to precisely fix the time of the failure. Mechanical deformation provoked stress concentration in the LPT first stage blade material in the radial direction. The thing got worse gradually till the blade integrity failed. Breaking off the blade of LPT first stage caused more extensive damage to engine parts aft of the rotor of LPT first stage. The damage found on the HPT eleventh stage blade and on the EGT probe was older. The propagating fatigue crack, which was probably caused by a previous impact, gradually reached the critical size before the failure of LPT first stage blade occurred. The traces of organic material found in an LPC part and small impacts on HPC blades point to the intake of foreign objects during engine operation. The soft consistence matter is very likely to be tiny pieces of rubber or tar sucked in as the plane moved on the ground or at takeoffs and landings, which were not indicated by the crew in operation.

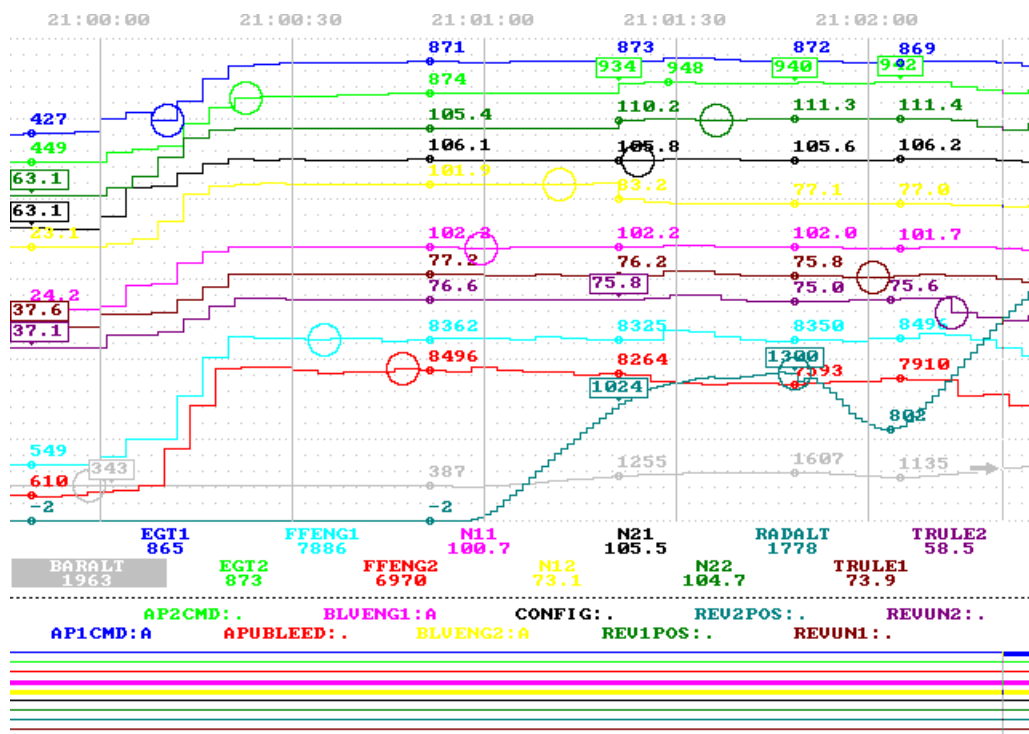
engine parameters as recorded at the Take off

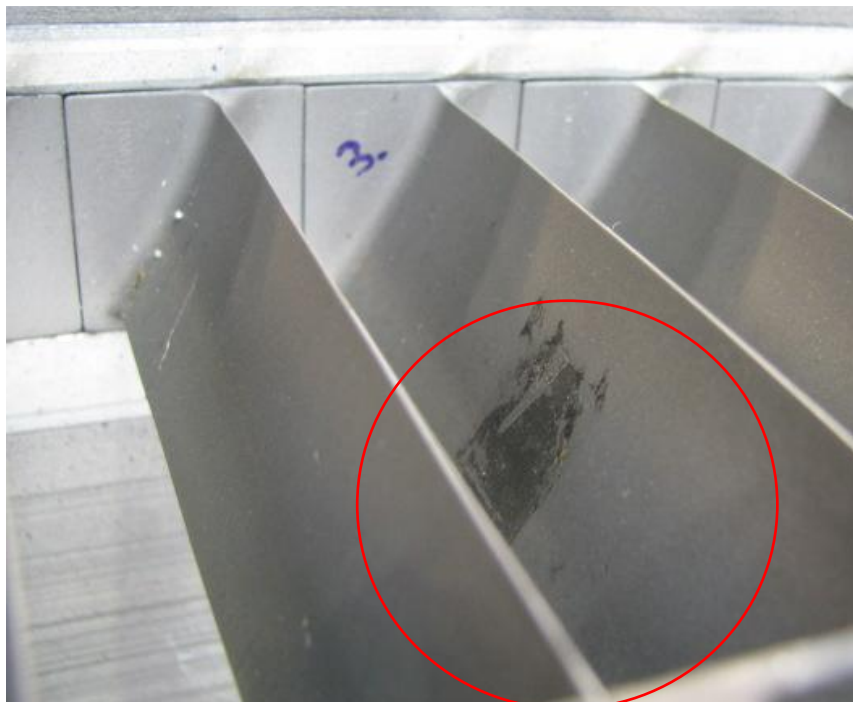
LPC Stator: In the trough of 3rd stage blades there were rests of black stuff. The stuff was sent to the lab to know the material composition.

- EDX analysis was done. The composition of rubber-like contamination on the 3rd stage LPC stator blades proved the main elements to be carbon, oxygen and silicon. Consistence of the black colored samples goes from soft and malleable to hard and brittle. These contaminations are very likely to be organic compounds. The material deposited on the reinforced shroud at the mid span of the 1st stage HPC rotor blades contains these organic compounds too. Moreover, this material deposited on the mid span shroud contains a lot of sand grains.

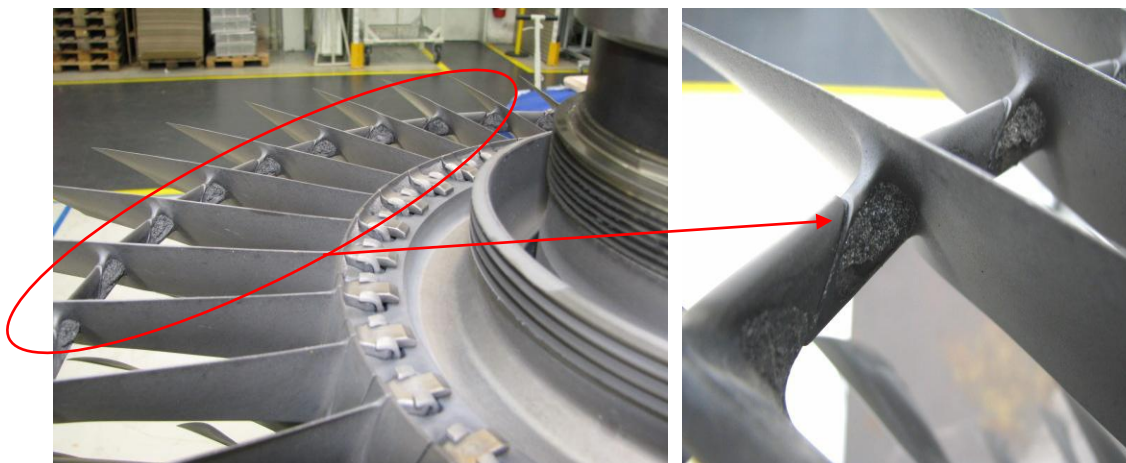
LPC rotor

LPC Rotor: On the bottom of mid span shroud there were big deposits of an unknown matter. The matter was sent to the lab to know the material composition.

Long-term operation on routes across continents and oceans may cause hardened atmospheric pollutants to deposit on “mid span shrouds” (see ICAO Document 7910/81).

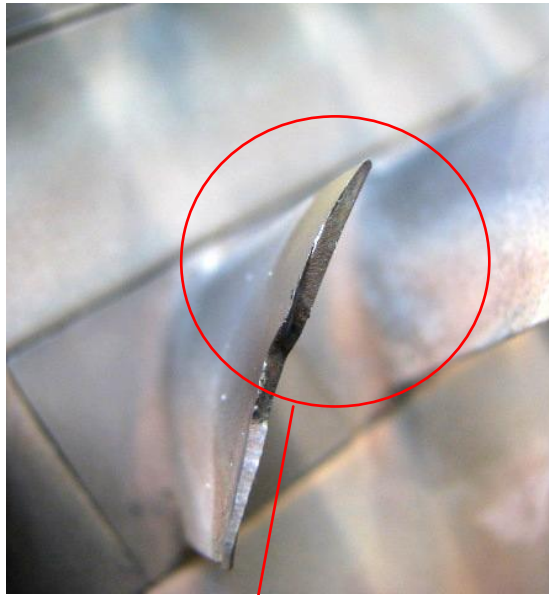
Fatigue area (40%)

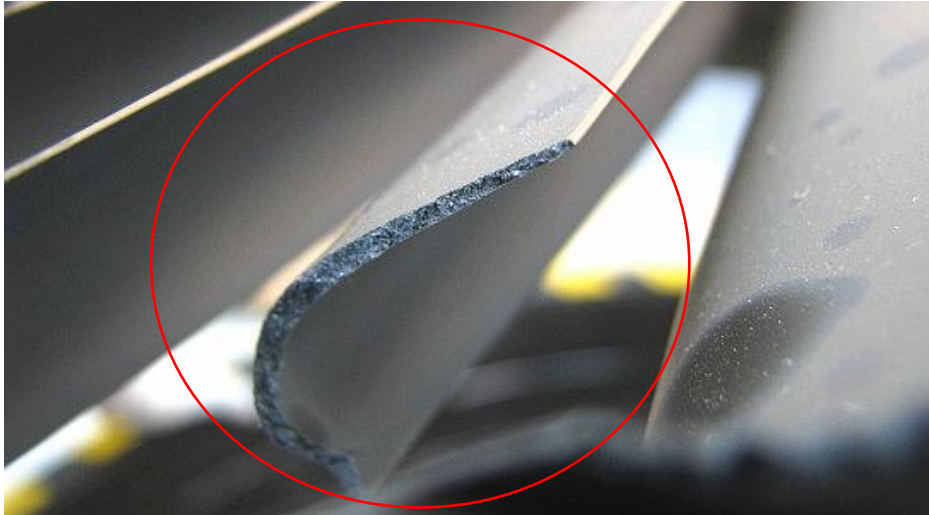
The profile of the damaged blade features slight deformation in the fracture zone and a trace of big impact on the profile convex surface near the leading edge. There are visible star-shaped cracks on the profile concave side under the fracture surface.

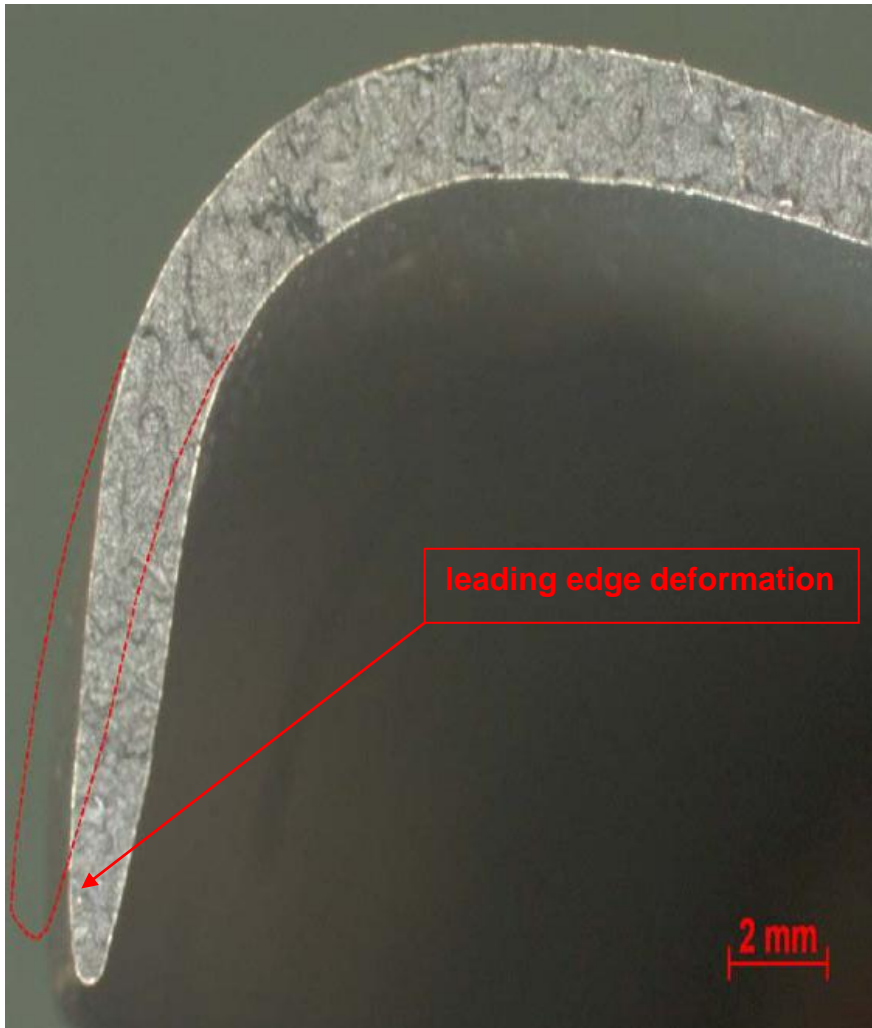
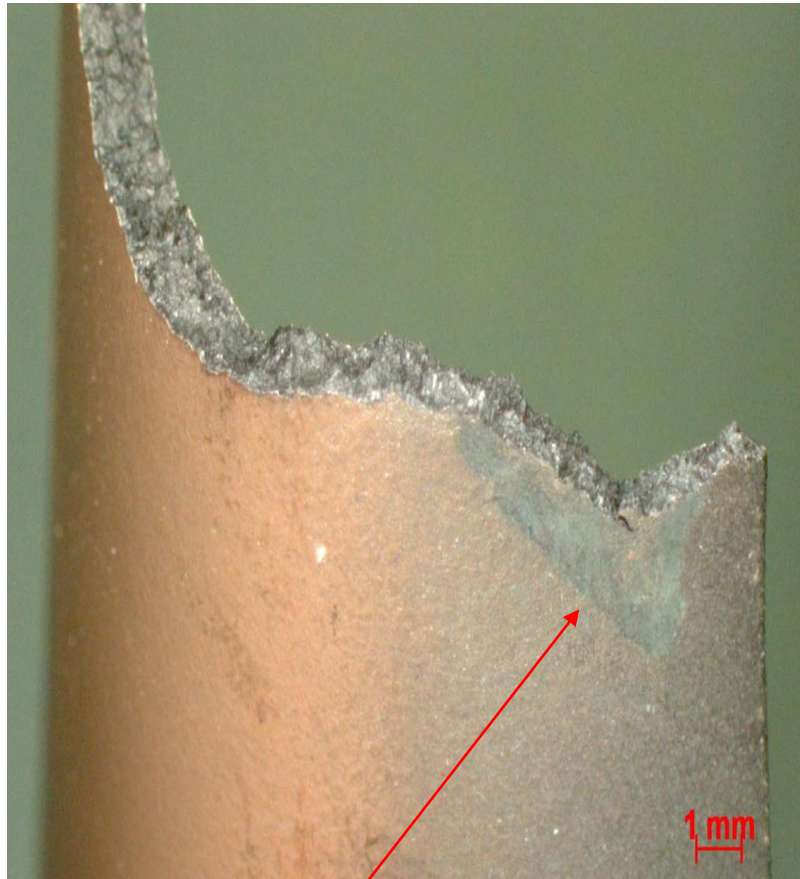
This blade was primarily damaged by an unknown object that hit the profile on the concave surface near the leading edge.

EDX analysis of impact zone revealed no other material. In addition, metallurgical investigation revealed a lot of cracks caused by oxidation mainly on the profile convex side.

This bad status of the blade could have contributed to its accelerated fracture. The blade was not overheated.

Impact a foreign object
