AIR ACCIDENTS INVESTIGATION
INSTITUTE OF THE CZECH REPUBLIC
Beranových 130
199 01 PRAHA 99

FINAL REPORT

**Air accident involving
Socata Rallye 150ST, registration mark OE-DII,
on 16 August 2012 at LKZA.**

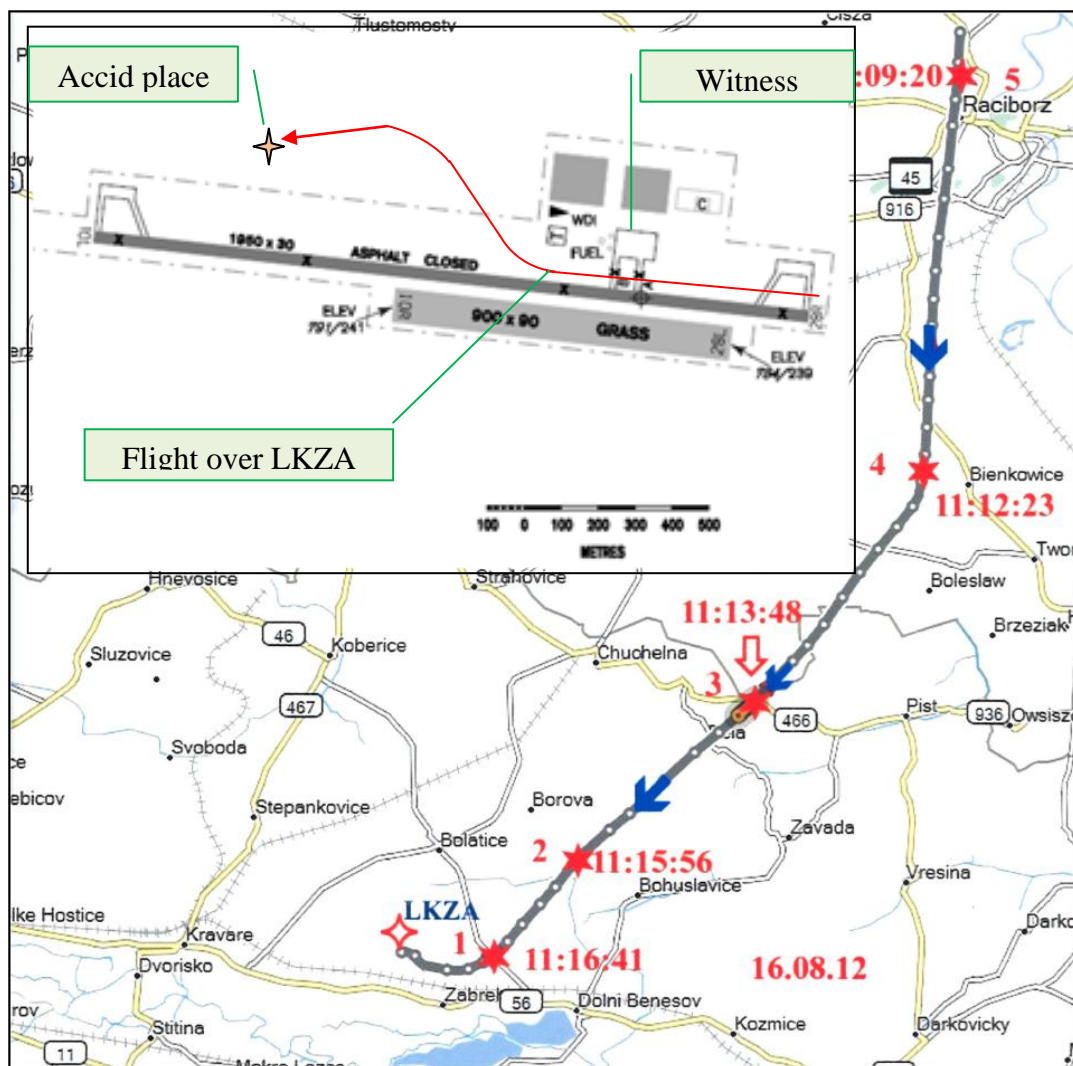
At flyover to Poland at 11:09:20 (position town of Raciborz ca 23 km NE of LKZA, point 5, Fig 1) the plane turned to heading 180° and began to descend from a level of ca 3,300 ft with a vertical rate of descent 1-2 m.s⁻¹. On the level of the town of Bienkovice (ca 15 km NE LKZA, point 4, Fig 1) at 11:12:23 the pilot turned to heading 200°. The flight speed was 190 km.hr⁻¹. The plane crossed the border of FIR LKAA (ca 12 km NE from LKZA, point 3, Fig 1) at 11:13:48, flight level 3,100 ft descending ca 3 m.s⁻¹ at speed of 180 km. hr⁻¹. At this descent at 11:15:56 it reached a level of 2,000 ft (ca 3 km NE of LKZA, point 2, Fig 1.). From this position the plane increased its rate of descent to ca 5 m/s while simultaneously decreasing flight speed to 136 km.hr⁻¹. At 11:16:41 on heading 214° in descending 5 m.s⁻¹ it reached a level of 1,267 ft, point 1, Fig 1. From this position the pilot began to take a right turn into the direction of RWY 28R LKZA. In turning he continued reducing the level down to 1,000 ft (ca 60m AGL) and at the same time slowing the speed to 110 km.hr⁻¹. These values were reached just ahead of THR RWY 28R LKZA. Then he flew over RWY 28R, keeping descending ca 3 m.s⁻¹ and lowering the height and speed. At a distance of ca 500 m

from THR RWY 28R (at level TWYs A and B) the plane's height was 928 ft (ca 35 m AGL) and speed 97 km.hr⁻¹. From this position it turned gradually to the right to a heading of 337° on level 909 ft (ca 30 m AGL), with the speed going down to 86 km.hr⁻¹. Then there was transition to a left turn to heading 311° and further with an increased angular speed up to the final heading of 263°, flight level 909 ft (30m AGL) and speed 87 km.hr⁻¹. In a short straight section the plane went down to level 865 ft (ca 20m AGL), its speed went up to 105 km.hr⁻¹, with vertical rate increasing to ca 9m.s⁻¹. At the same time the vertical rate of descent dropped 0 -1m.s⁻¹. Simultaneously the airspeed fell to 74 km.hr⁻¹.

Fig 1: Final section of flight track

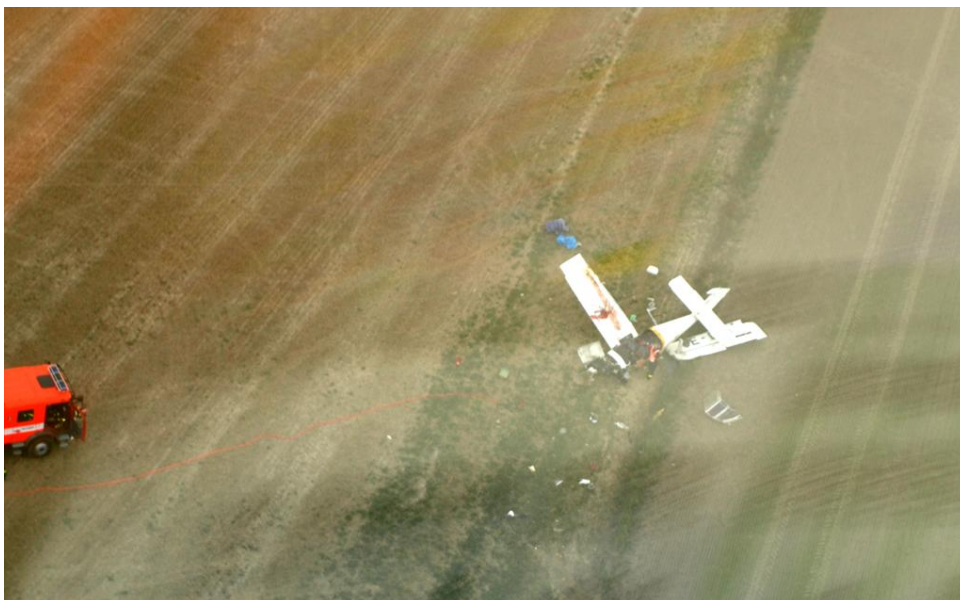
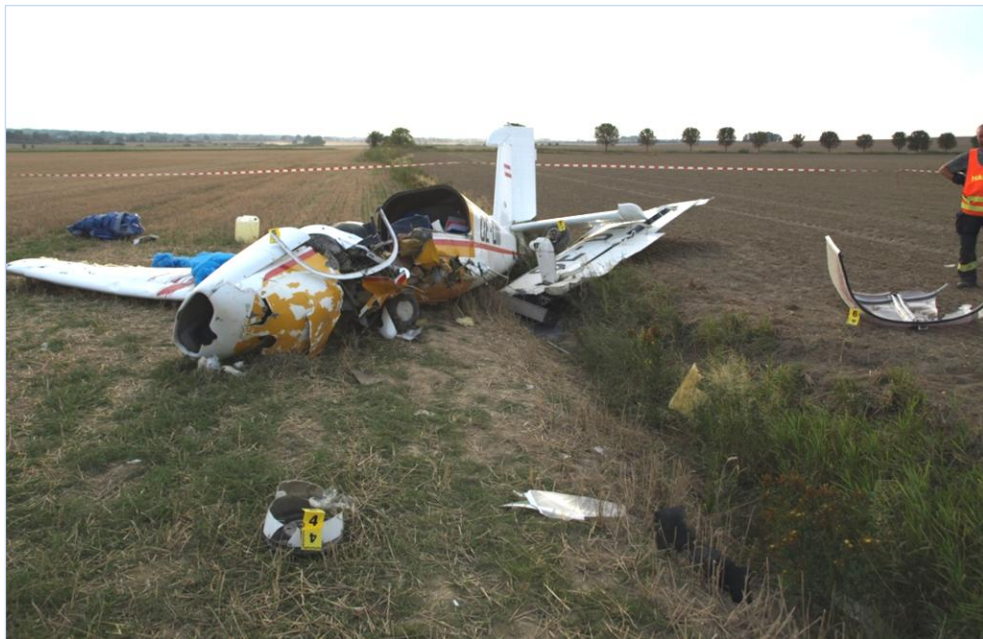
Figs 3 and 4: The plane wreckage

The aircraft fell on the ground, heading ca 260°. It lay on the belly. Wreckage of the main structural parts, wing, fuselage, tail plane, and power plant were at one place, on the edge of a ditch about one meter deep. The left half wing was broken off, lying beside the fuselage behind the ditch. Taking into account the wreckage condition it seems very likely that the plane dropped banked slightly left at a relatively small vertical speed. The state and functionality of the plane's control surfaces before the accident could not be established at the accident site because they were damaged by impact with the ground.

The cockpit canopy and objects were scattered to a distance of about five meters.

Subsequent technical check showed that all the control elements were connected with control surfaces, which indicates that the plane controls were fully functional. The flaps were retracted. The leading edge slots were pulled out. Both the engine control rods in cockpit were set to the position low power or idling. The engine control rod in the middle of the dashboard was bent left ca 20° and down. HZS pumped about 30 l petrol off the tanks.

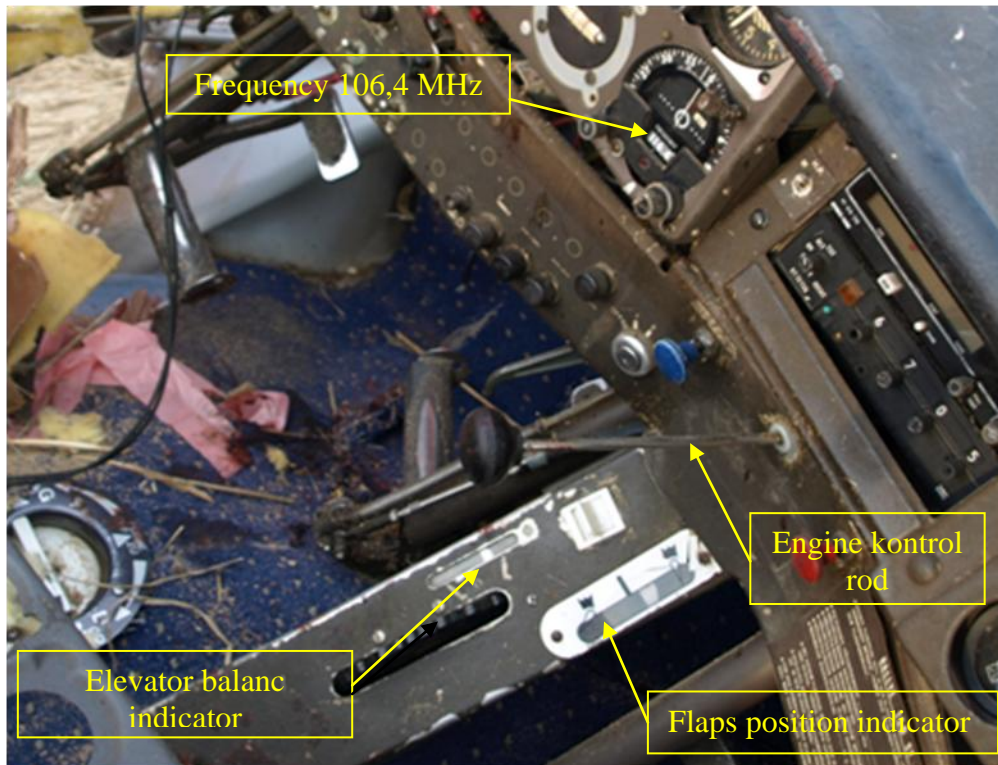
After the accident values as indicated on cockpit instruments were as follows:
Altimeter - indicated H - 440 ft. Pressure set to 1,018 hPa.

Airspeed indicator - position of indicator hand 0, or you like in basic position.

Combined instrument – compass/VOR – compass indicated ca 350° / VOR, set frequency 106.4 MHz.

Transponder control KT 78TSQ was at ON position.

Switchbox at OFF position, key removed.

Engine speed indicator was at value 0, engine hours indicator showed 3,852.52.

Flaps position indicator was in position extended to ca 1/3.

Elevator balance indicator was in position "heavier on tail" (ca 2 cm fore past neutral position).

Fig 5: View into cockpit
