CZ-14-587

FINAL REPORT

**Investigation Serious incident involving
of Airbus A319, registration mark OK-NEP,
in FIR Sofia and Istanbul on 9 September 2014.**

April 2015

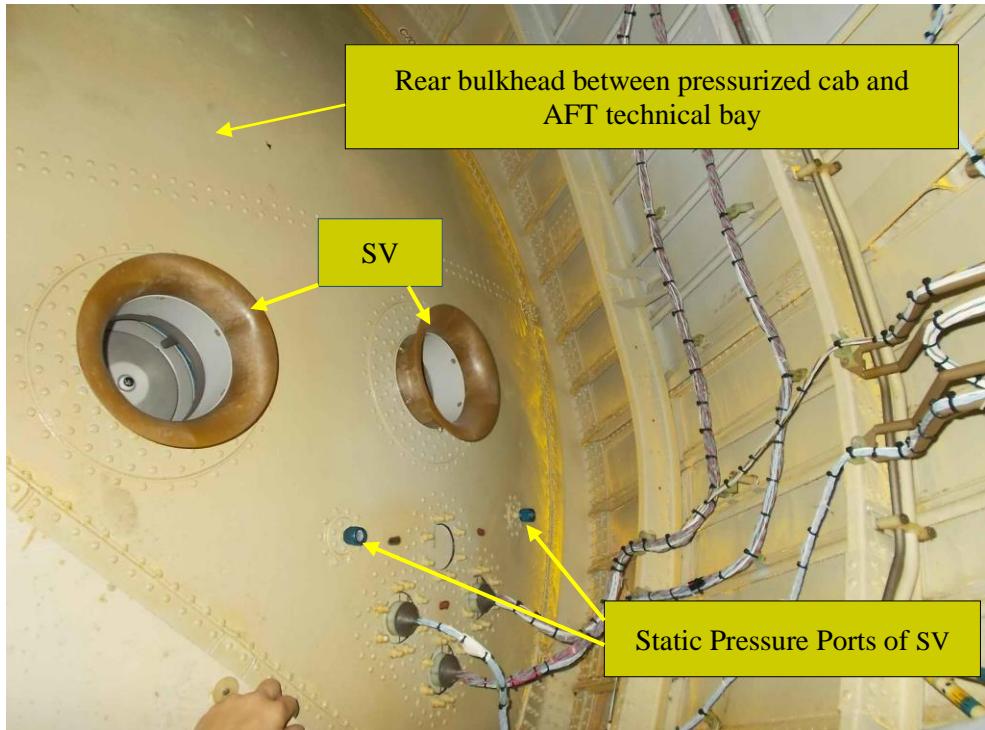
Fig. 4: Location of SV, view of the AFT technical bay

Upon their disassembly, a small amount of fluid was identified inside the pneumatic regulation, which controls the valve. It was water with biggest probability. Based on this fact, the valve bodies and gaskets were subject to a detailed inspection. No body cracks or gasket damage was founded during the inspection. The valve manufacturer stated that the only way how the fluid might have got inside into the valve control section through the static pressure ports only. The valves were installed on the bulkhead separating the AFT galley hermetic area that is inside the aircraft's heated and air-conditioned cabin and the non-hermetic AFT technical bay in which the static pressure ports are located as well.

At 22:56:09 when the aircraft was at FL 370 probably the presence of fluid, which partially froze inside the SV pneumatic controller, affected its proper control function. Resultantly, one SV or both SVs suddenly opened. The pressurization system identified a rapid aircraft cabin pressure decrease and the MASTER WARNING lamp illuminated in the cockpit.

The cause of the serious incident was the spontaneous opening of one SV or both SVs without any prior indication. It is highly probable that this was caused by the presence of not fully specified fluid and its freezing in the SV control section. Upon the SV opening, the aircraft cabin pressure suddenly and significantly changed.

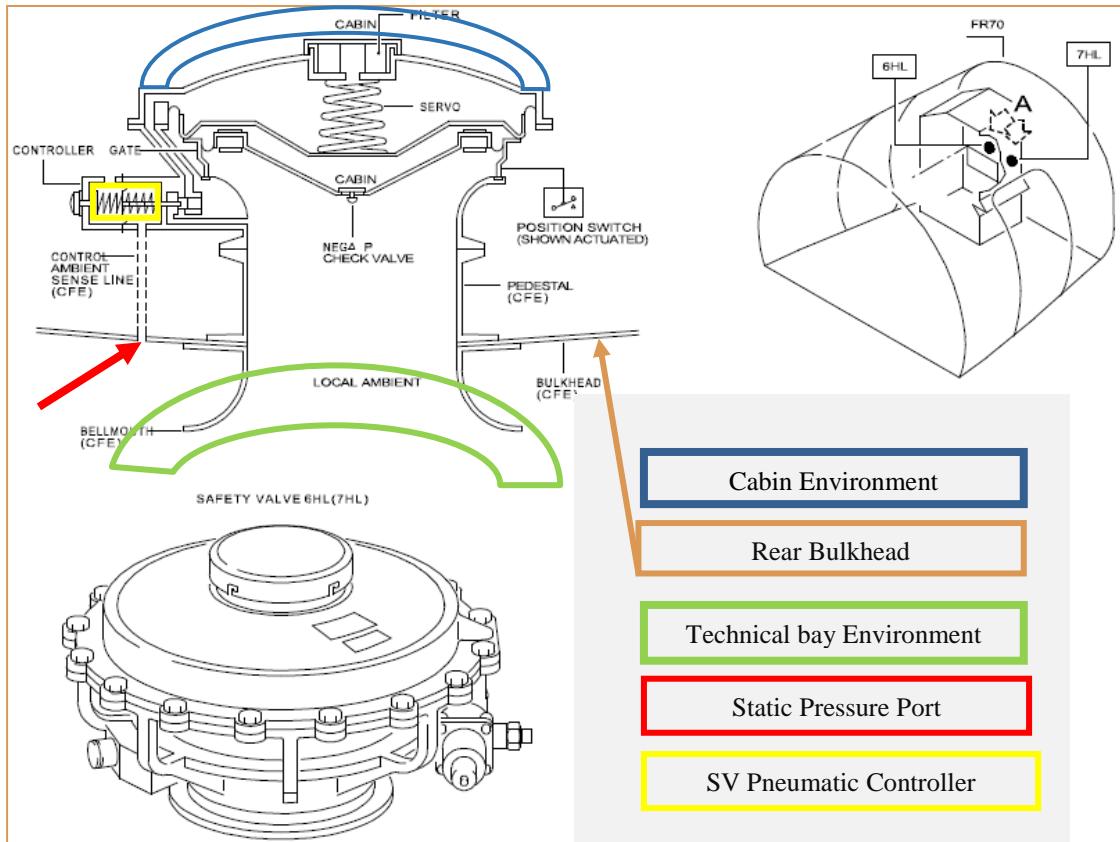
Fig. 6: Scheme of SV and their location in the aircraft

The fluid identified in both SVs might have reached the valve control section as external contamination or air humidity condensate. Per the aircraft manufacturer's statement, the only option was the non-hermetic area air proceeding through the static pressure ports.

The air humidity condensate might have been caused by different temperatures in the aircraft hermetic and non-hermetic areas that the valves face during flights at high altitudes above the sea level.
