Ref. No CZ-11-212

FINAL REPORT

**Investigation on the accident
to Schweizer HU269C-1
registration OK-XIS
at Šumvald
on 25 June 2011**

Prague
October 2011

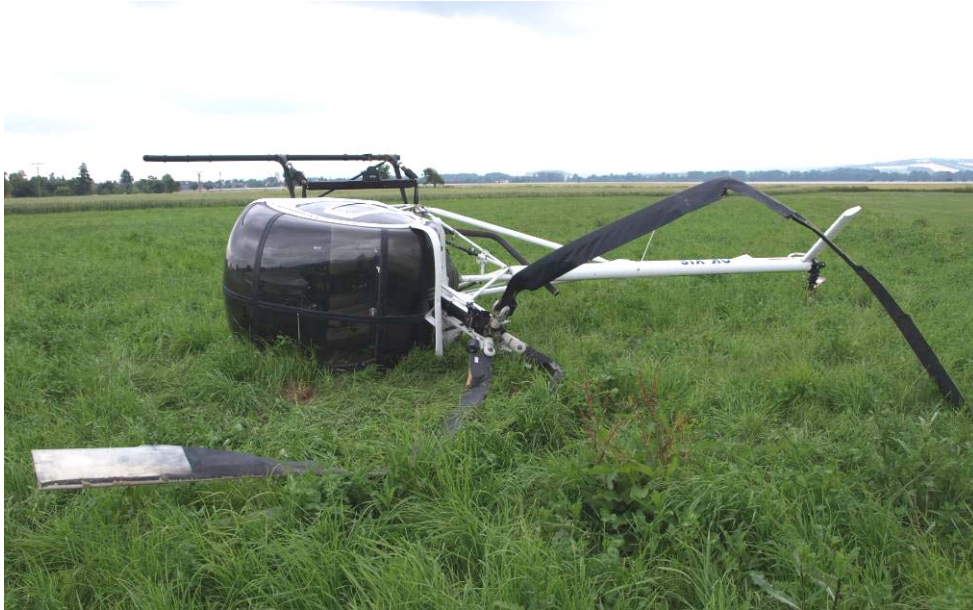
After the skids had touched the ground, judging by traces approximately 38 m ahead of airfield surface edge, the helicopter began to swerve right. The pilot increased pressure on the directional control left pedal, got a feeling of its movement forward, but the helicopter did not respond to the pedal movement and continue to turn right. So he tried to avoid turning over by moving the cyclic pitch control lever to the right to get a feeling that the helicopter was sliding on its right skid. He responded to the unfavourable situation by lifting the helicopter through raising the collective. But the pilot suspended this control manoeuvre at once due to the sliding movement and increasing tendency to turn right. As the right hand skid hit a transverse bump, the helicopter began to turn over onto its portside. The pilot has said he gave a strong lift to the collective and moved the cyclic control lever to the right, but failed to avoid capsizing. The main rotor blades struck the ground, got damaged and the helicopter turned over to its portside, see Fig. 1. The helicopter's left and front parts, fuselage and fuel tank were damaged.

Fig. 1 The site of the accident - OK-XIS

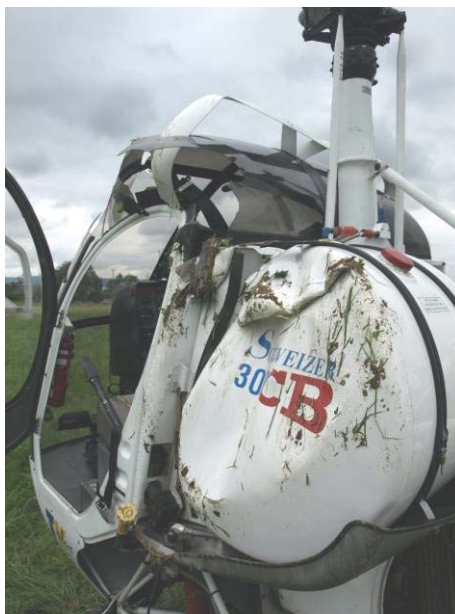
The fuselage left side was dented on several places. The cabin left door was damaged and left door windows were broken. The fuel tank was distorted, see Fig. 2. The tube structure was deformed in places where the power unit and the tail beam were attached. The skid struts were damaged.

Fig. 2 Damaged left side of the helicopter OK-XIS

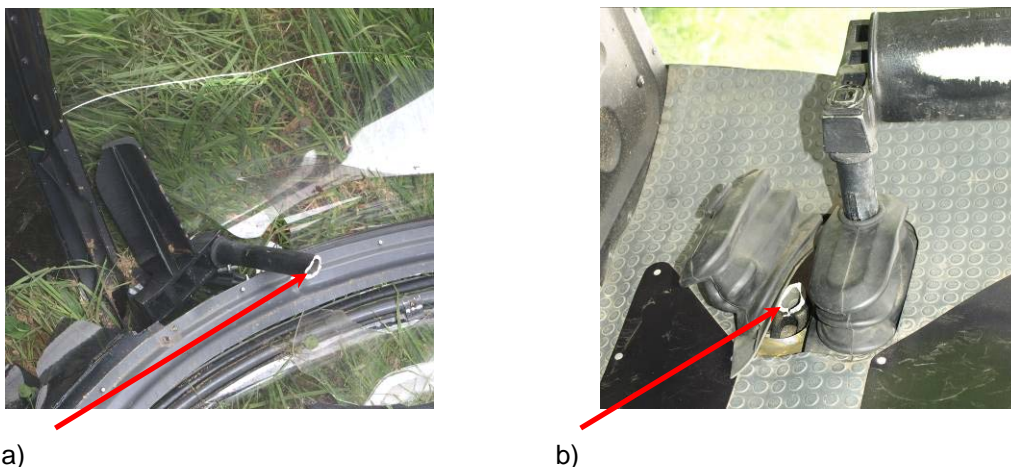
The pedal web is made of a light alloy casting. The fracture took place in transition into the socket. On the socket, the fracture surface divided and there was a small adjacent fragment. The web broke, which led to a directional control failure, see Figs. 3 and 4.

Fig. 3 View of directional control pedals of OK-XIS helicopter; a) Broken left pedal, b) Rest of web and right pedal.

The Federal Aviation Administration, in conjunction with the European Aviation Safety Agency should consider the way of inspection of the directional control pedals which are used on Schweizer 269 C-1 helicopters with the aim of lowering to minimum the possibility of cracks being formed leading to a similar failure.

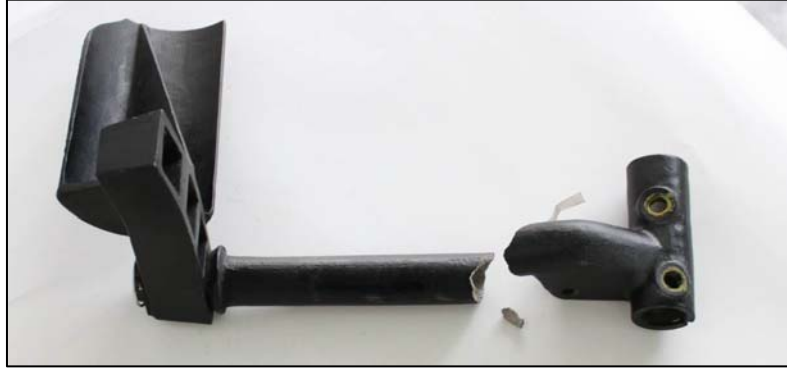
Fig. 4 Disassembled broken web of left pedal

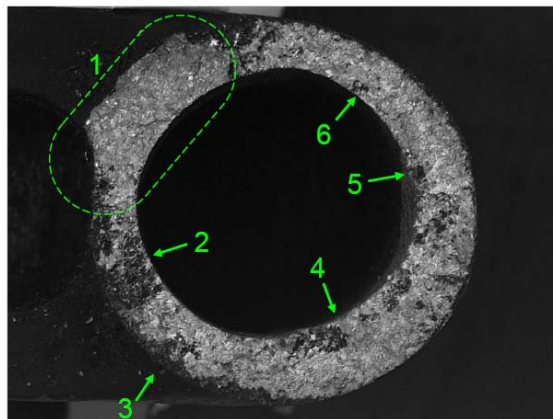
The nature of fracture mechanics analysis done indicates that the fracture was probably caused by fatigue failure that followed visible damage of casting internal structure through impurities of unknown origin. Those places could have developed high stress concentration leading to forming fatigue cracks. Other evidence for fatigue failure hypothesis is cracks in the second transition radius, in several nearby planes perpendicular to the direction of the applied loading force. Through joining these cracks together, one magistral crack formed, which might cause a small fragment to break off in the second transition radius. Fatigue cracks along with impurities in the casting reduced the cross-section load bearing capacity up to fracture.¹

It followed from the fracture mechanics analysis of the left pedal fracture surface that the internal structure of the pedal web casting was visibly damaged through impurities, see Fig. 5, which caused loss of integrity of the material. Stress concentration might have increased there, leading to forming fatigue cracks in the web.

Fig. 5 Impurity localities (2. – 6.) in casting and region of small fragment. (1.).

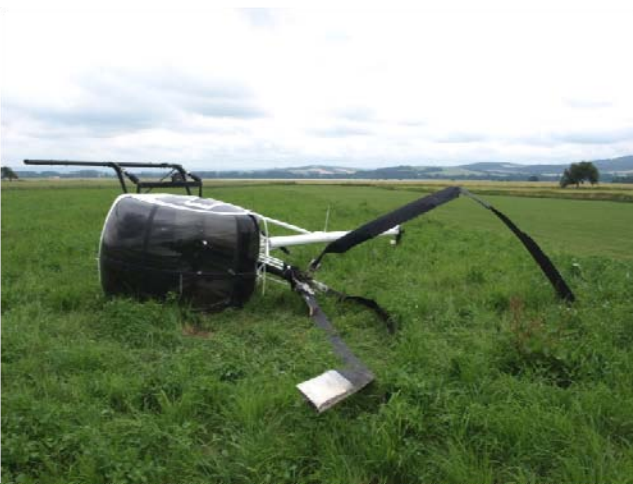
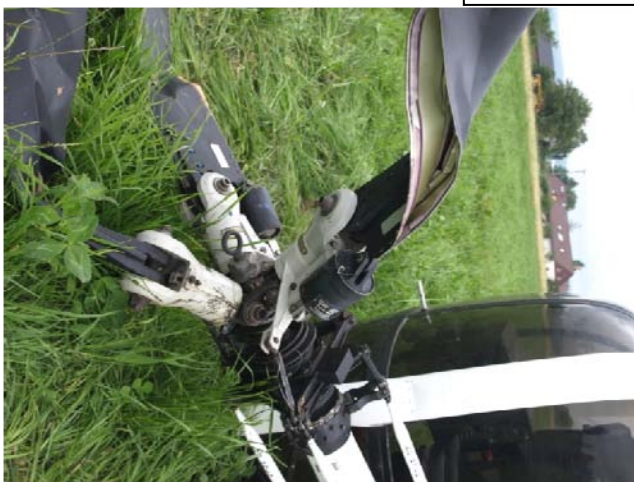
All the three main rotor blades were destroyed; the blade control rods were deformed. The main rotor hub was damaged. Possible damage of the shaft was not apparent at the visual inspection.

The main rotor blades

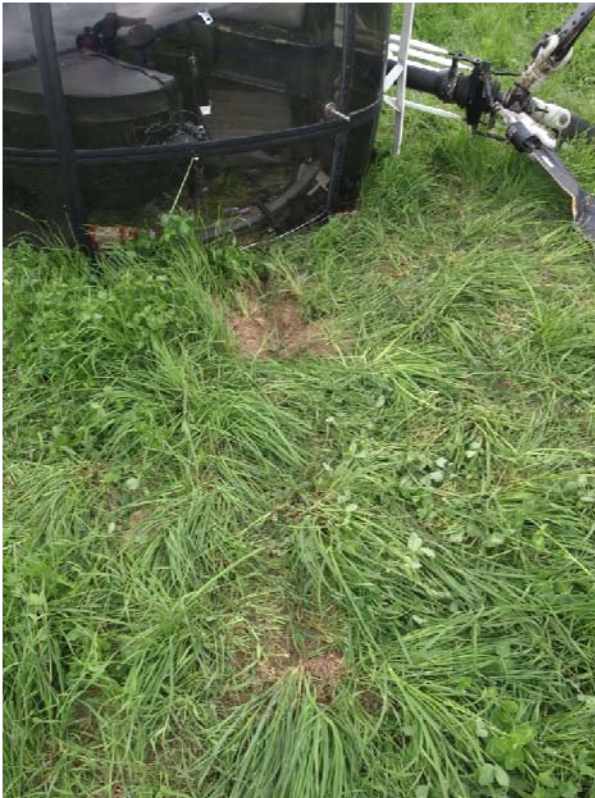
The evidence of impact of main rotor blades

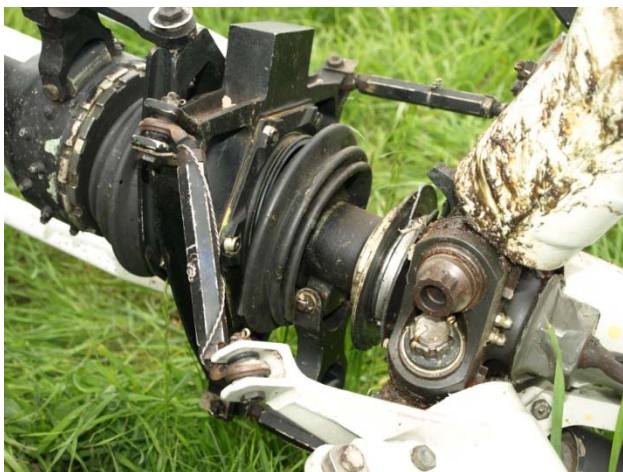
Damaged blade control rods

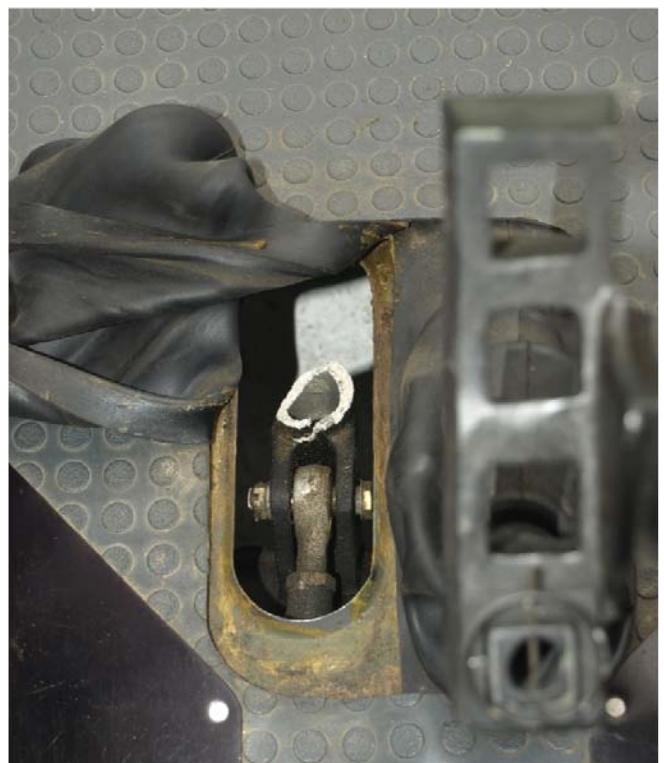
At the accident site in the cockpit, the left pedal of directional control on the right-hand side, which was broken off, was found. No evidence of other faulty control elements was found during inspection or at subsequent technical examination.

The broken socket of the left pedal

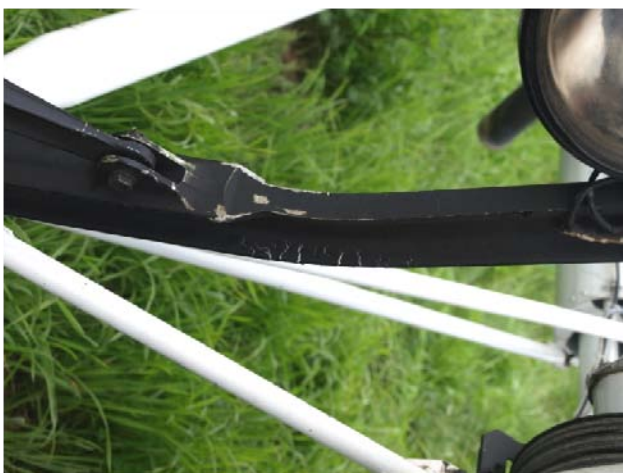
Damaged skid
