FINAL REPORT

**Investigation into the incident
to Hawker 800 – H25B
in TMA PRAHA
on 25 November 2007**

Prague
January 2008

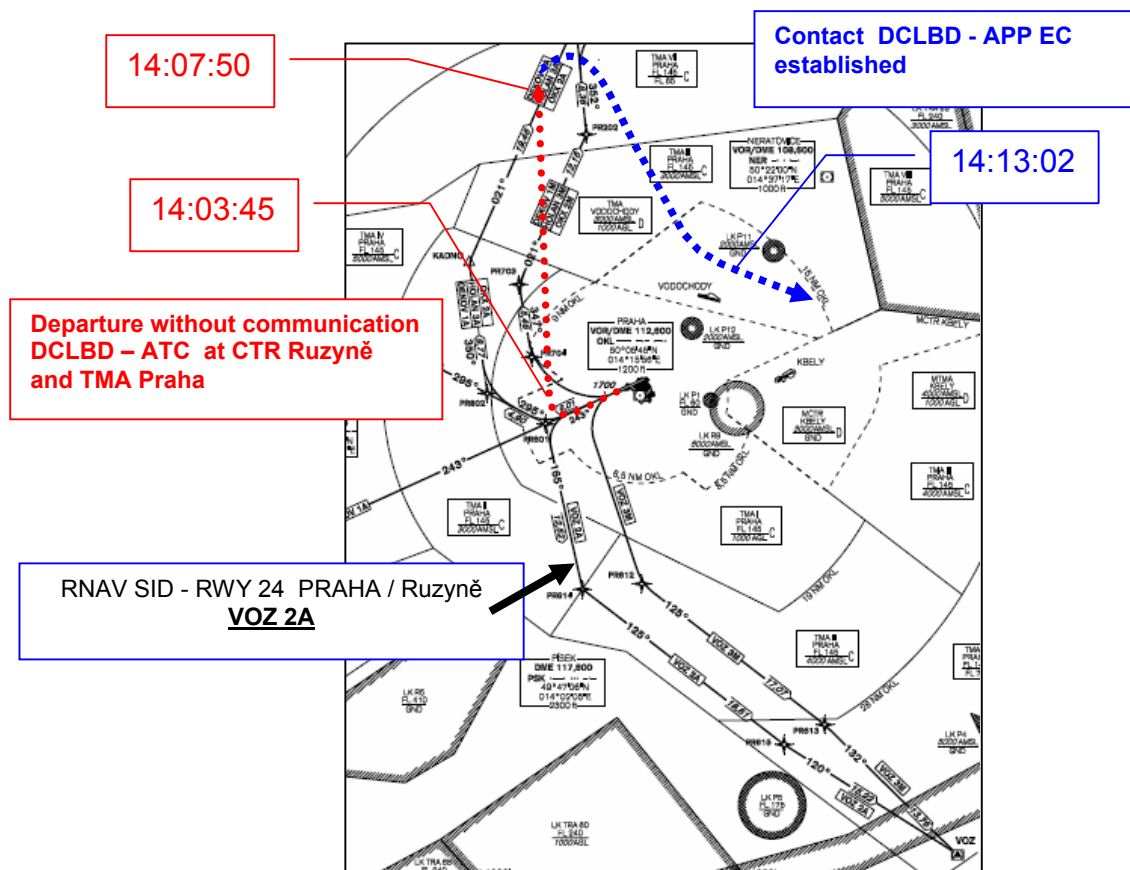
Figure 1

At 13:59 the pilot acknowledged the takeoff clearance from RWY 24 and the instruction to go to a frequency of 120.525 MHz after takeoff. According to a radar record, the airplane after takeoff climbed to 5,000 ft AMSL, then turned right to a heading of about 360 degree and from 14:03 to 14:07:50 kept to this course till the distance of ca 25 NM north of LKPR airport. During all this time the crew did not answer the repeated calls on the frequency of Prague traffic controller APP EC, Ruzyně DELIVERY frequency, Ruzyně TOWER frequency, on the frequency of another plane in the air, and on the emergency frequency of 121.5 MHz. The flight history is in Fig. 1.

The DCLBD flight was identified after takeoff. The airway profile with a heading of around 360 degree (a difference more than 180 degree from the published heading of 165 degree) and the flight without contact established on the determined frequency for a time period from takeoff to 14:08 indicates that the aircrew may have made a mistake during briefing before takeoff. After takeoff the aircrew worked in conflict with determined and confirmed description of SID.
