**CZ-597-08**  
Copy N° 5

# **FINAL REPORT**

**The investigation into Air Accident  
Cessna 510 aircraft, registration mark OE-FMZ, at LKPR  
On December 11, 2008**

**Praha  
July 2009**

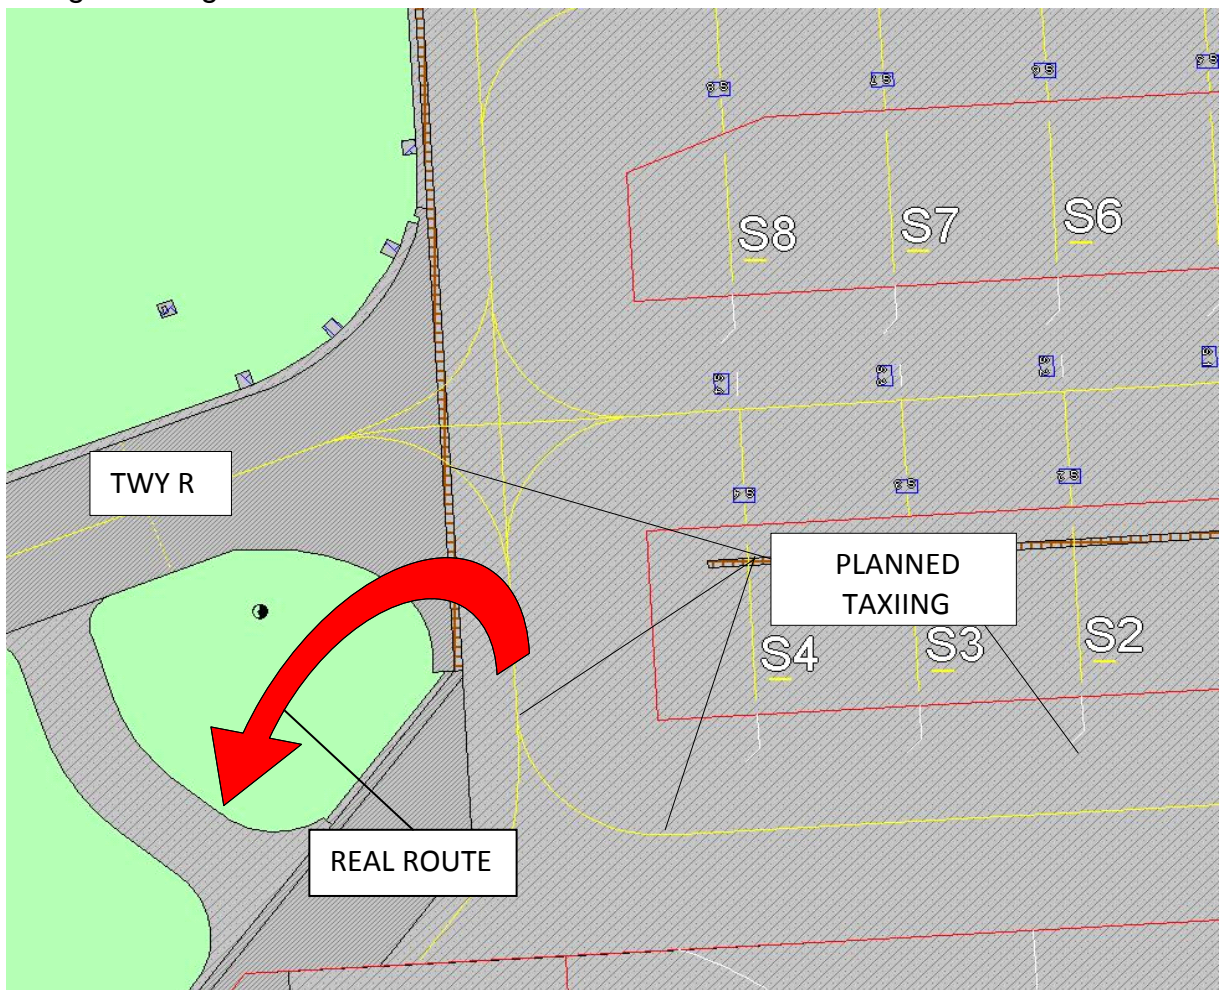
The aircraft parked on OPJ LKPR stand S2. The pilot received instructions to taxiing onto TWY R to the RWY 31 waiting point. A pilot and two passengers were on board the plane. After the plane's turn around had finished, the pilot drove from the stand S2 to the right and continued making a turn towards the TWY R exit which lay some 190 m away. After turning ca 150 deg to the right and traveling about 130 m, the pilot swerved left to take the plane to the unpaved surface adjoining the parking area. The pilot continued taxiing 40 to 45 meters and got to another paved surface. As the plane's nose wheel and main undercarriage right-hand wheel were crossing the border between the unpaved and the paved surfaces, the main undercarriage left wheel broke off. The pilot reported on LKPR GND frequency that he "hit something". Asked by ATCo if he needs assistance he said yes. After this announcement the pilot did not communicate on this frequency any longer. The LKPR's technical team was sent to the aircraft. After arriving at the scene, the team confirmed the aircraft had run off the OPJ (apron south) and been damaged – left wheel of main undercarriage had been broken off. The passengers had got off the plane using onboard stairs and left the airport. The pilot stayed at the incident scene to wait for technical assistance. He gave the explanation that when running from the stand S2 he navigated by yellow lines horizontal marking which he lost past the first turn to the right and so went on taxiing following the onboard GPS.

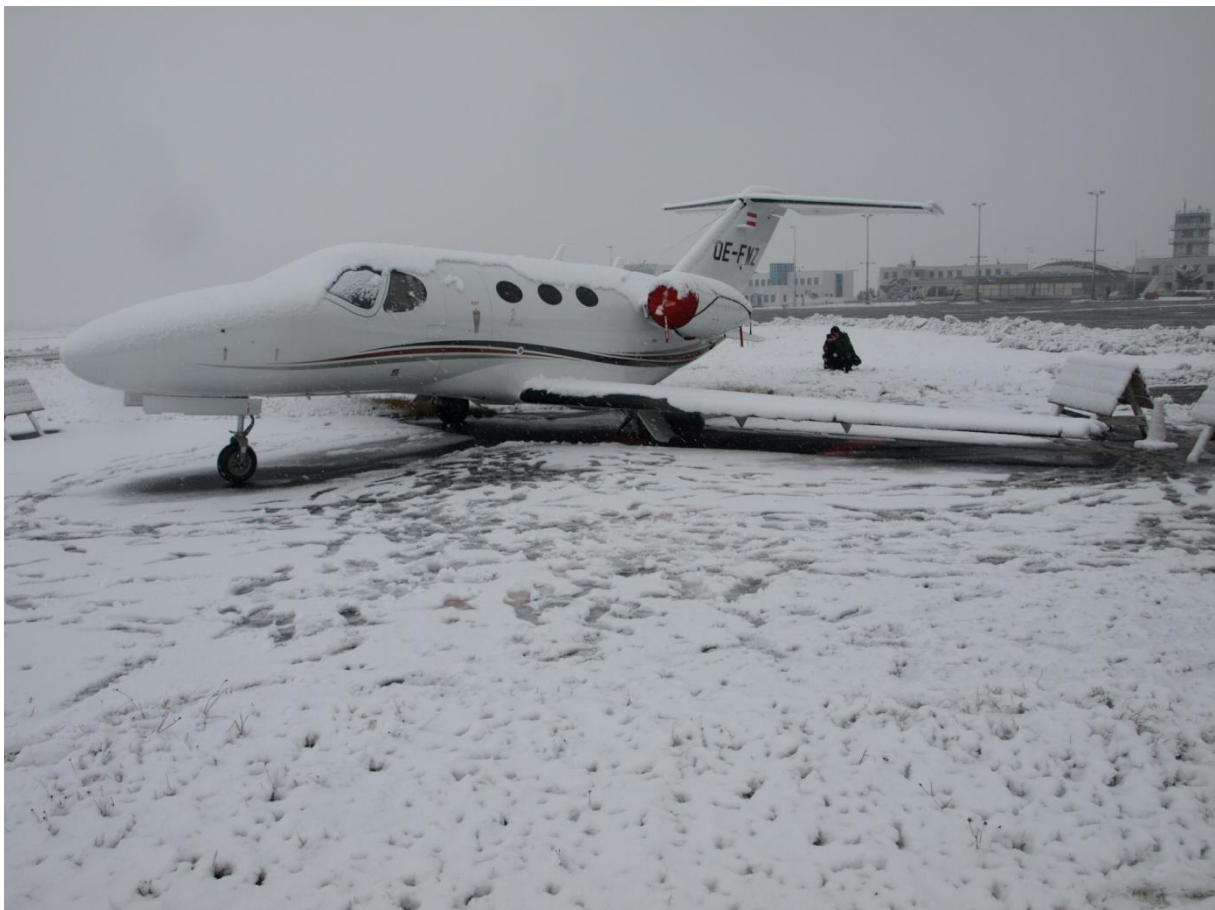
It was found out by external examination that the left-hand wheel of the main undercarriage had been broken off. Also damaged was the skin on the lower part of the left half-wing where the broken-off wheel touched the wing. Further damage parts were subsequently described by a foreign maintenance team as part of the aircraft repair work, which is not part of our investigation.

View of the accident scene on the following day in the morning

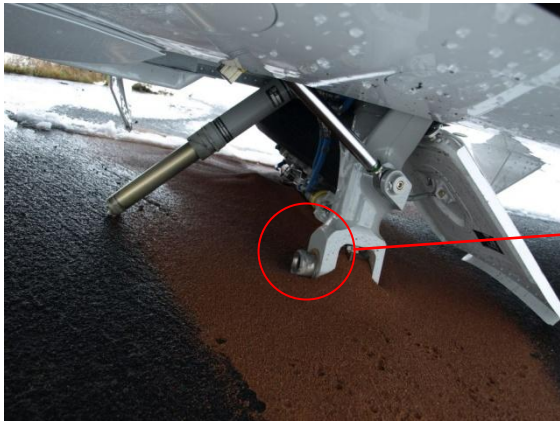
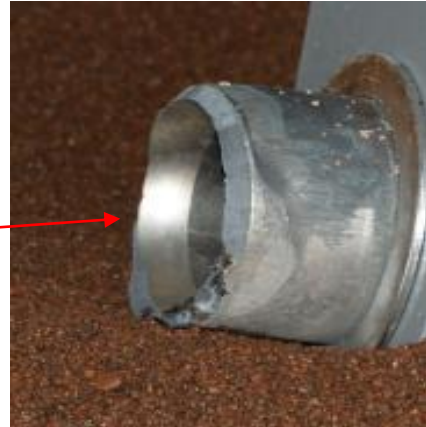
Following an agreement with a representative of the European manufacturer of the aircraft, the fracture surface of the remaining pin of the main landing gear left wheel axle was examined in the manufacturer's plant. The fracture surface character responded to the load from bending and shear forces acting on the critical cross section of the wheel axle.

Fractured pin of left hand landing gear wheel axle

- The pilot was properly qualified and trained for the flight, medically eligible;
- The plane had a valid airworthiness certificate
- The pilot did not notice any functioning anomalies as regard to plane's control on the ground during the previous flight;
- Breaking off the wheel was not caused by material fatigue of the wheel axle;

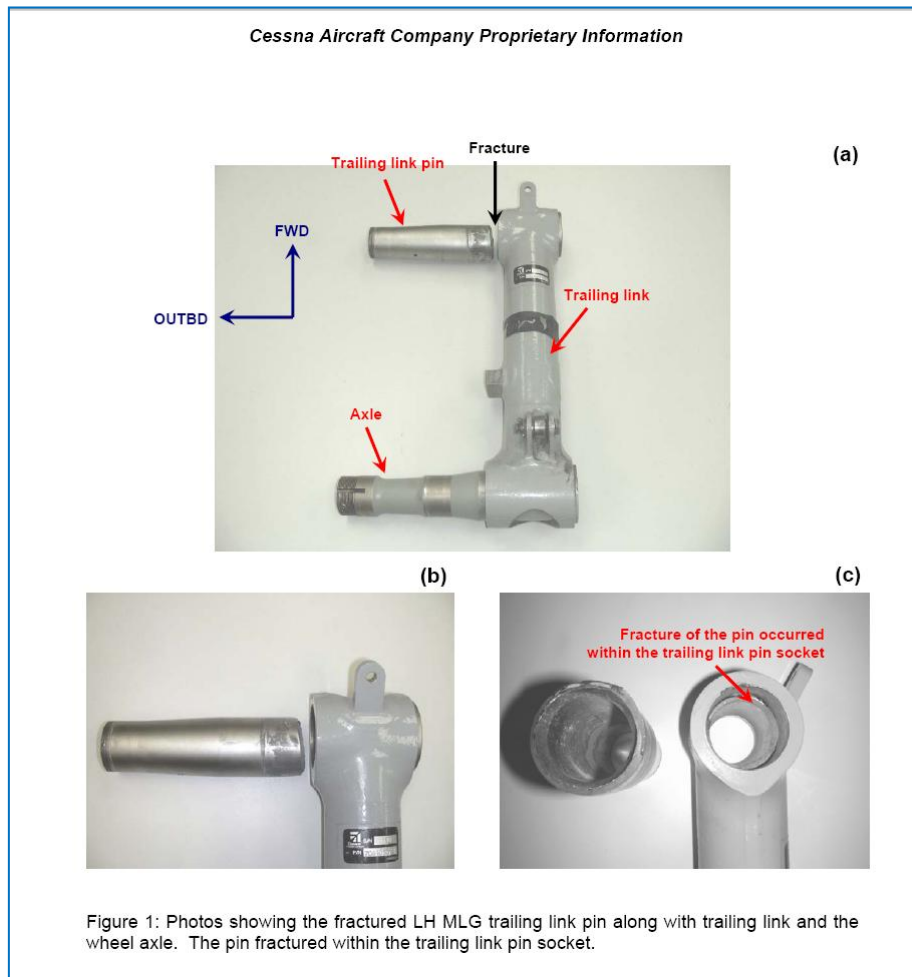
Direction of forces acting on critical cross-section

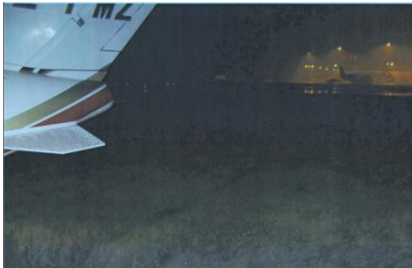
The scene of accident was on the south-west edge of the parking area marked as OPJ in the Airport Scheme. The paved surface is made of asphalt, coloured dark grey to black. The unpaved surface is grass. The grassy surface was less load-bearing following the rain. The aircraft left its trail on the surface 0.05 m deep. The landing gear wheel broke off as the plane moved from grass to asphalt. The concrete edge height was 0.17 m.

View of OPJ from the scene of accident

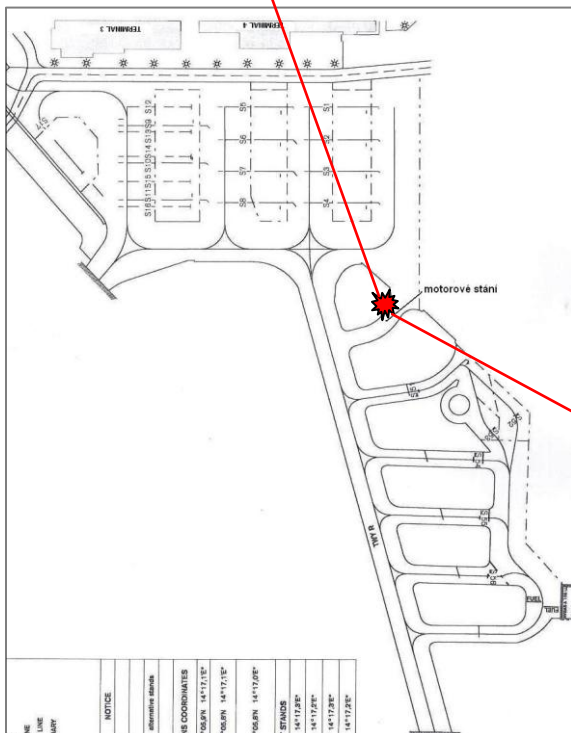
OPJ scheme, S2 and TWY R stands

LKPR is a public international airport. OPJ is used for the parking of small aircraft of general aviation. The S2 stand is marked as passable according to no. 007/2008 Airport Prague Regulation. The space of the parking area is illuminated with overhead halogen lamps of medium intensity. The overhead illumination was ca 80 m ahead of the S2 stand and ca 100 m from the left, or if measured from the unpaved entry point, 120 m from the left and ca 140 m from the rear. Exit from S2 stand and the route towards TWY R is marked with horizontal yellow lines. TWY R entry into OPJ is marked with day markings “TWY R”.

- Owing to the fact that OPJ area is used for parking general aviation aircraft and small transports and since the crew of these airplanes uses the airport only occasionally, I recommend:
- That the exit marking from OPJ to TWY R should be made better visible in bad light conditions;
- Implementing supplementary markings to prevent planes from getting onto wrong areas.

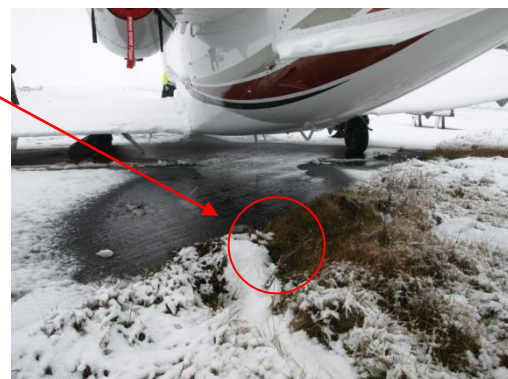
Transition from unpaved to paved surface

Horizontal visibility was 800 to 1,000 m, according to pilot. The accident happened at night after rain. The horizontal markings were less easy to see since the wet taxi way was gleaming from the light reflection. At taxiing in this part of OPJ, the light conditions were varying from illumination of the whole area up to darkness at space where TWY R began, marked with side blue lamps on the right in the direction of the aircraft movement. The aircraft did not get in this place as it turned 40 m earlier. The pilot's view from the cabin was 1.9 m above the ground, which is rather low. That could have been the reason why the pilot had become disoriented on the large area with lots of disturbing reflections from the wet surface. The landing gear wheel got separated when crossing the border between the grassy land and asphalt surface.
