AIR ACCIDENTS INVESTIGATION INSTITUTE
Beranových 130
199 01 PRAGUE 99

CZ - 15 - 087

FINAL REPORT

**Investigation of causes of an accident
of helicopter Robinson R 44 Raven II, registration mark OK-RRJ,
in the forest near Filipova Hut',
on 29 March 2015**

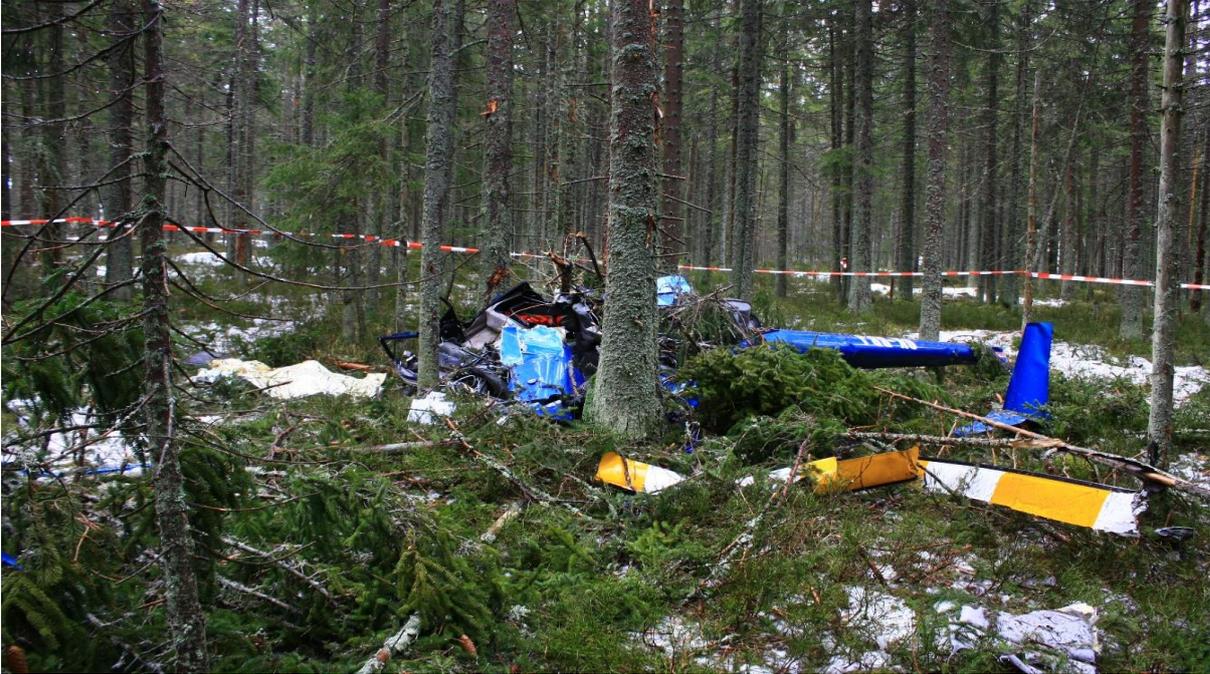
Due to the collision with treetops and subsequent fall to the ground the helicopter was completely destroyed. Because the helicopter was moving among tree trunks, the cabin was entirely demolished and the instrument board was extensively damaged. The engine with the change gear box for the main rotor drive was deflected backwards and wedged into the deformed engine bed. Main rotor blades were bent and broken. The tail beam was deformed, the tail rotor change gear box was separated from the tail beam. No fire broke out during the accident.

Fig. 1: R-44 helicopter after a fall into the forest

The identified damage can be ascribed to the mechanism of collision of the helicopter with the treetops and the consequent fall to the ground. From the completely destroyed front part of the fuselage and the cockpit, and from the deformation of the shaft extension of the main rotor towards the rear, it can be deduced that the collision into the trees took place at a high speed. The fall from the height of tree tops together with a contact with tree trunks caused significant damage to the structure of the helicopter.

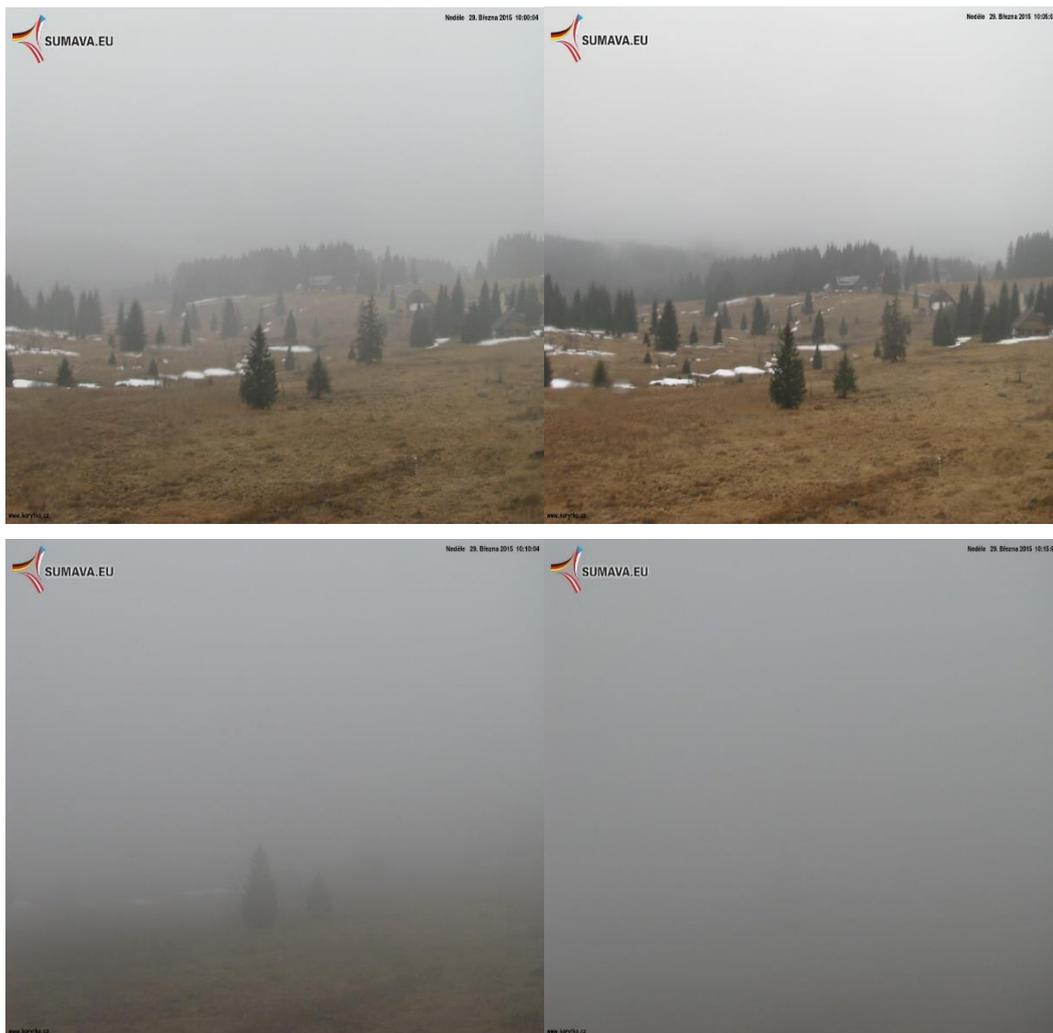
Footage of the web camera located on the Korýtko guest house (1,118 m AMSL) has been found in the operating records of the Šumava National Park. The camera was recording a view with the shooting angle in the south-west direction towards Modrava in five-minute intervals and was located approx. 900 m east of the accident site. On 29 March 2015 from 10:00:04 to 10:15:04 CEST, the following meteorological conditions were captured:

Fig. 2: Photograph depicting the weather situation in the area of Filipova Huť from 10:00 to 10:15 CEST

The meteorological conditions did have an immediate effect on the course of the flight and the event history development. At the time of the accident, a rather strong wind was blowing in the east-west to west direction at the speed of 10–17 kt with gusts up to 32 kt in the area of Modrava-Filipova Hut'. As a consequence of the mountainous terrain configuration due to the strong breeze low clouds drifted from the valley causing the flight visibility to drop down to levels of 0–200 m. Moreover, considering the gust wind a mild mechanical turbulence occurred. The reduction in visibility to the levels in which it was not feasible to perform flights in VMC is evident from the pictures provided by the webcam.

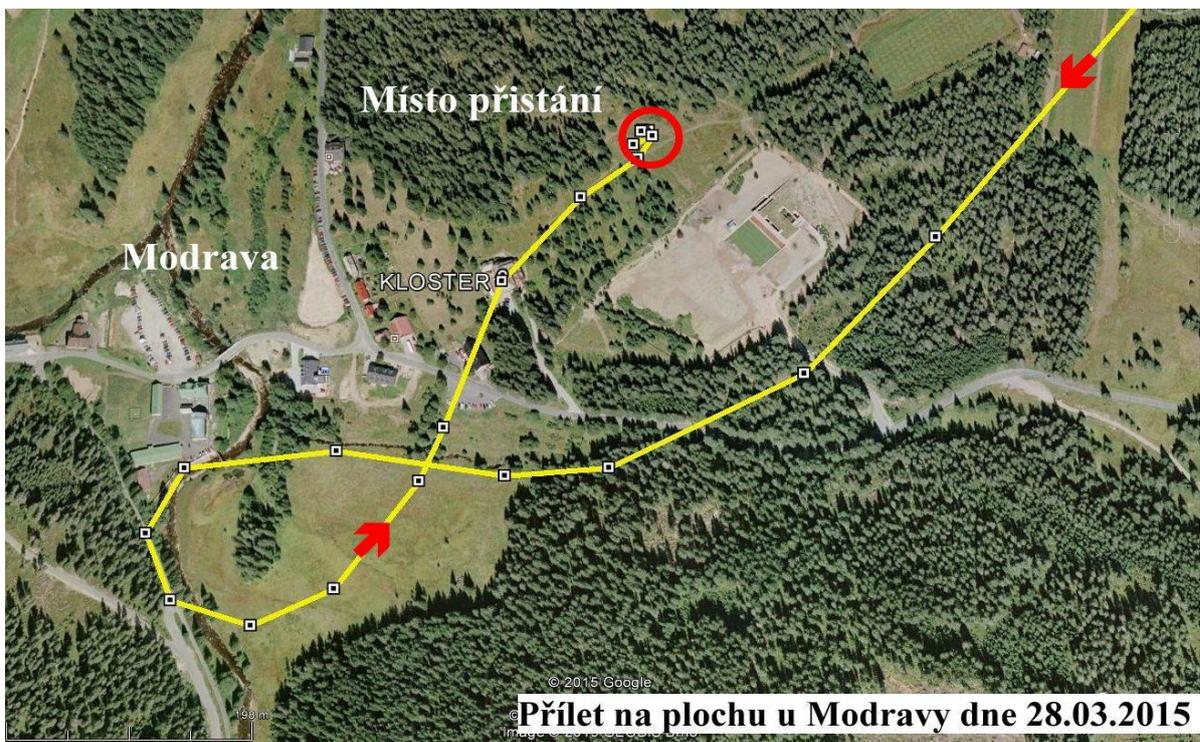
Fig. 3: Arrival and the landing site at the north-east edge of the village Modrava

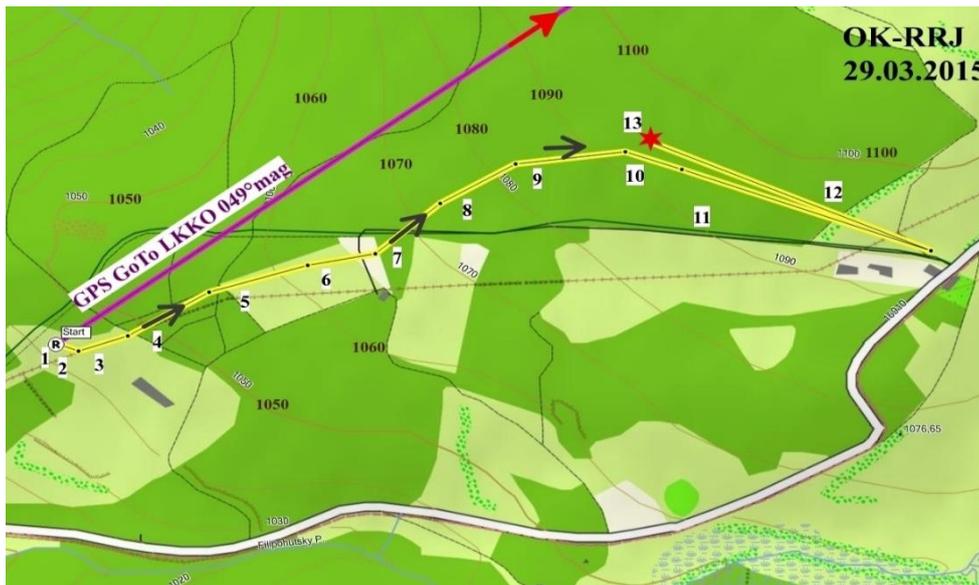
Fig. 4: Horizontal projection record of the event flight

The event situation occurred apparently as a consequence of the pilot's response to the significant deterioration of the flight visibility conditions after having flown for about 450 metres from the take-off point. At this point, a significant deceleration of the helicopter took place to the level of $36 \text{ km}\cdot\text{h}^{-1}$. The pilot interrupted the ascent and simultaneously changed the course slightly to the left. In this stage of flight, about 350 metres in length, the helicopter was moving over an ascending terrain with a fully grown spruce forest parallel to the right from the planned flight route. The pilot accelerated moderately up to $112 \text{ km}\cdot\text{h}^{-1}$ and climbing also moderately kept the vertical distance of approx. 25 metres from the treetops of the fully grown trees. At the end of this section, the helicopter was located 1,090 m AMSL. The further rising terrain ahead of the helicopter was very likely already covered by the clouds. The pilot performed a right turn by almost 90 degrees and continued in the flight in the south-east heading to the edge of the forest. At this stage, the pilot maintained an average speed of $70 \text{ km}\cdot\text{h}^{-1}$ and was descending gradually all the way down to 42 m AGL when he was located above the meadow by the road at the south edge of Filipova Huť. Here, at that moment, the meteorological conditions very likely prevented the pilot from continuing the flight in the given heading and the pilot lost visual contact with the ground. Therefore he, probably already in the clouds at that moment,
