**FINAL REPORT ON THE ACCIDENT  
TO THE HOT AIR BALLOON KUBICEK  
SPOL. S.R.O. – BB37N  
REGISTERED OO-BHA IN OUDENBURG ON  
22 APRIL 2011**

Ref. AAIU-2011-09  
Issue date: 30 September 2011  
Status: draft FINAL v2

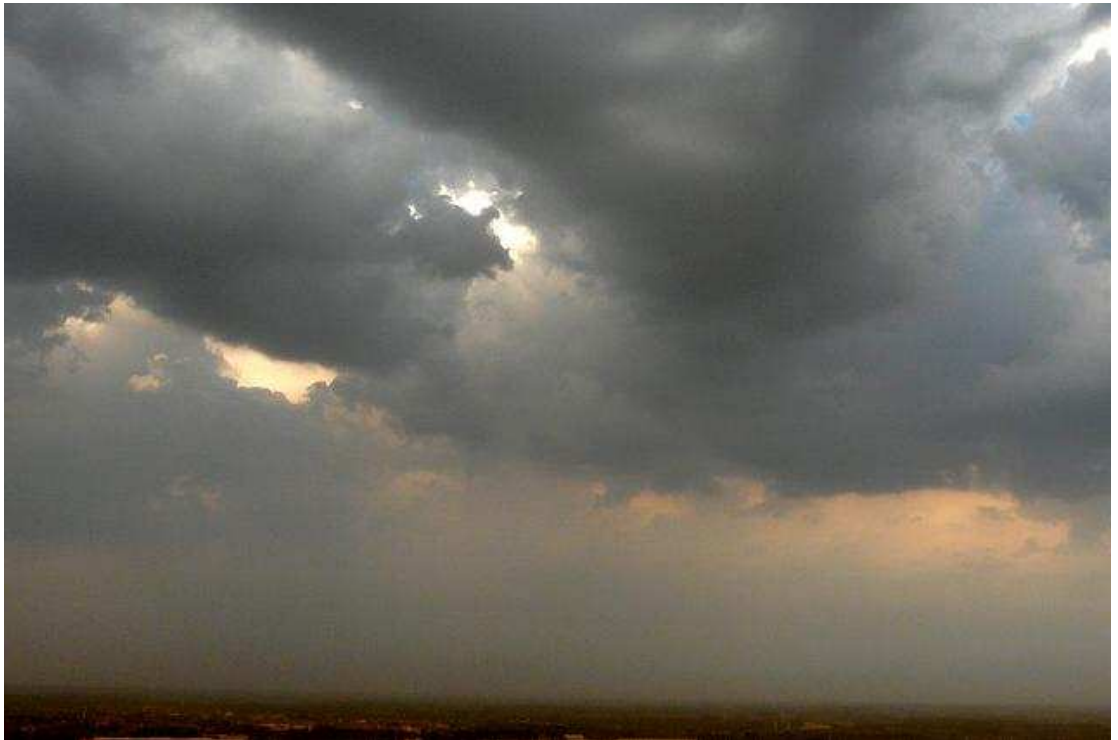
A passenger took a picture of the sky. The weather was becoming increasingly menacing.

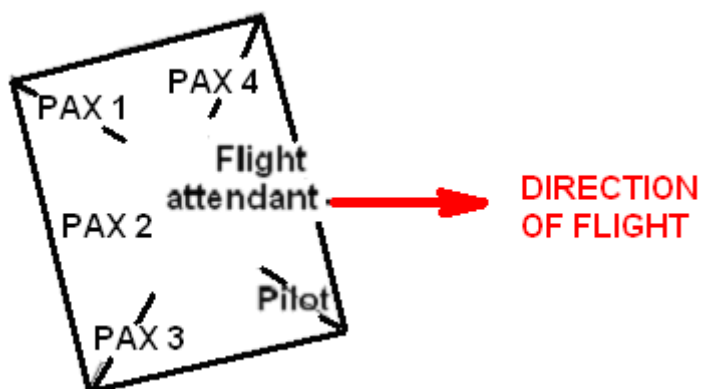
Passengers reported that the standing configuration inside the basket was as follows:

Passenger holding onto the burner support rods tend to have their center of gravity higher than those holding onto the handle; This would have contributed to one passenger to be drawn outside the basket, when the basket swivelled upon impact.

Also, holding onto the burner support rod implies that passengers have their arms outside the basket, and when the basket skidded on the ground, one passenger got her arms caught between basket and ground.

AAIU(Be) recommends BCAA to introduce the requirement to perform a safety briefing to the passengers of hot air balloon prior to the flight.

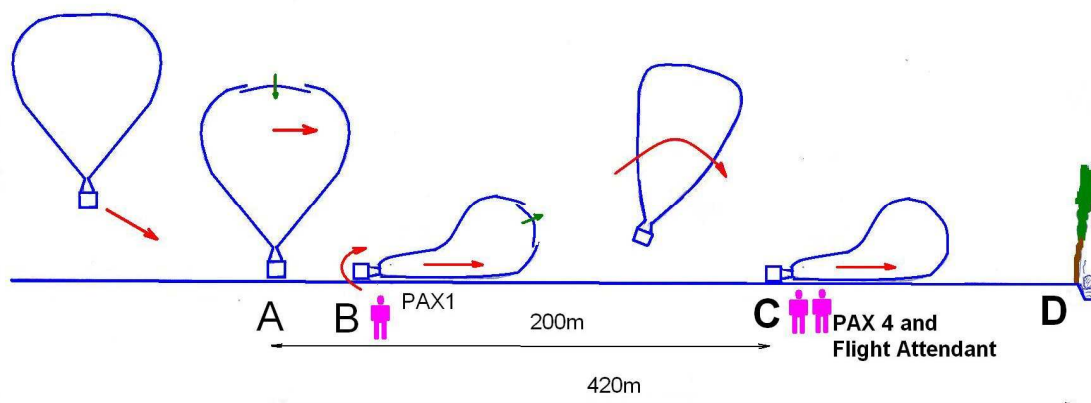
Fig 1. Impact sequences

All passengers and the flight attendant braced for impact. A corner of the basket touched ground first; the violent impact forced the basket to swing and rotate 180°.

During impact and rotation of the basket, the pilot lost balance, and was violently hit on the face. He fell unconscious.

The basket was dragged on the ground by the balloon. A passenger, clenching on one mount of the burner, was ejected outside the basket, and was hanging between basket and ground, and eventually fell out, seriously injured.

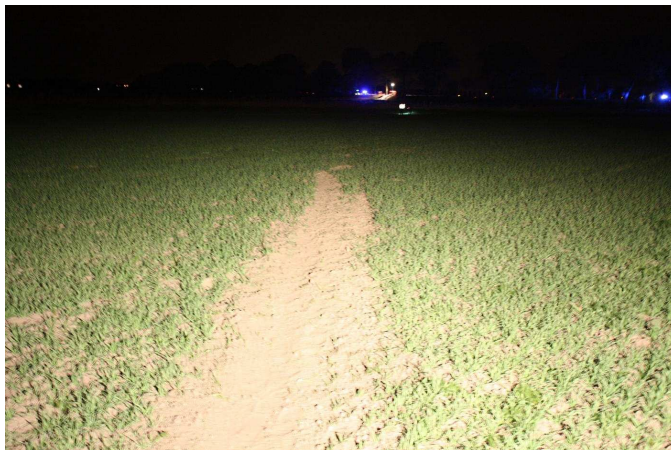
Ground trace between A and B

The basket was dragged on the ground for 50m.

PAX 1 was still hanging on the basket, caught between ground and the basket skidding on the ground. She asked to PAX 4 what to do, and he said her to let go. She did it, and escaped the basket breaking her hip in the process.

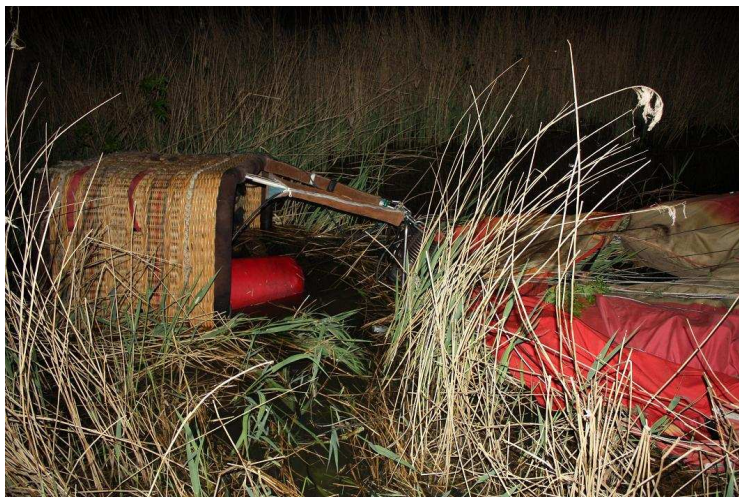
The balloon reached the tree line, and the basket went into the ditch, before stopping.

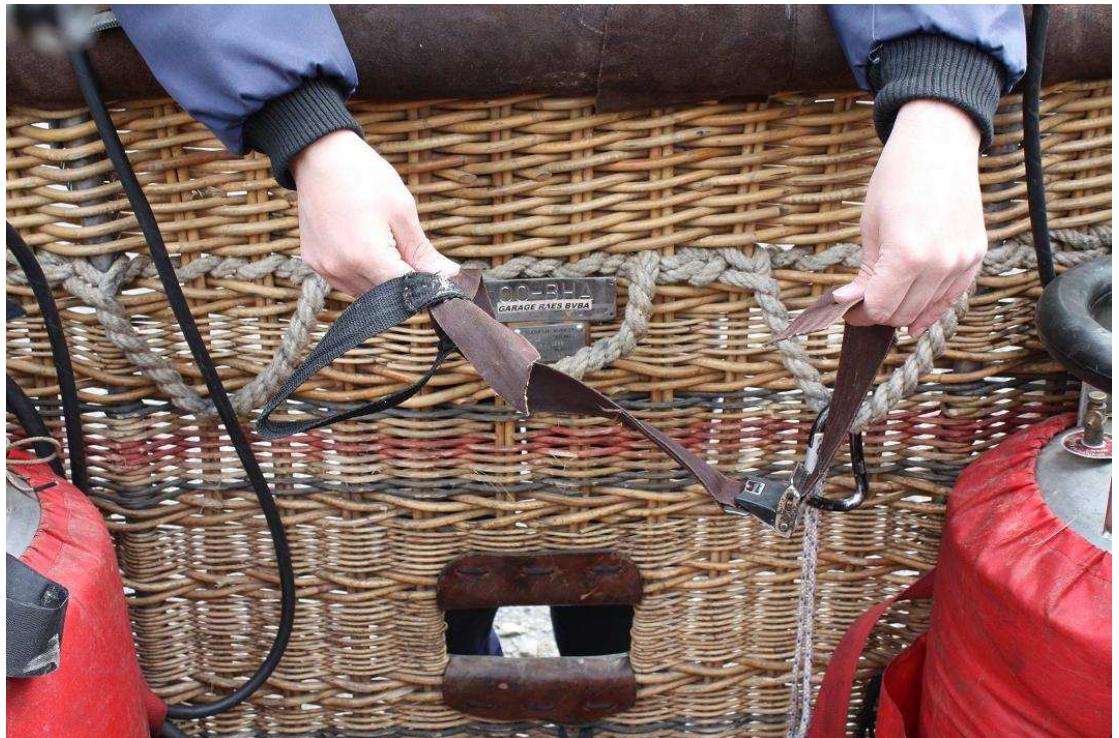
The pilot was using a safety belt; a loop was passed on a waist belt on one side, and was fastened to a basket's handle with a D-Ring. The waist belt was cut when extracting the pilot.

Although both systems were not designed to restrain the pilot in the vertical axis, the system used by the pilot allowed him to remain inside the basket, but would provide limited efficiency in the vertical axis, with the potential risk of hitting the burner structure with the head.

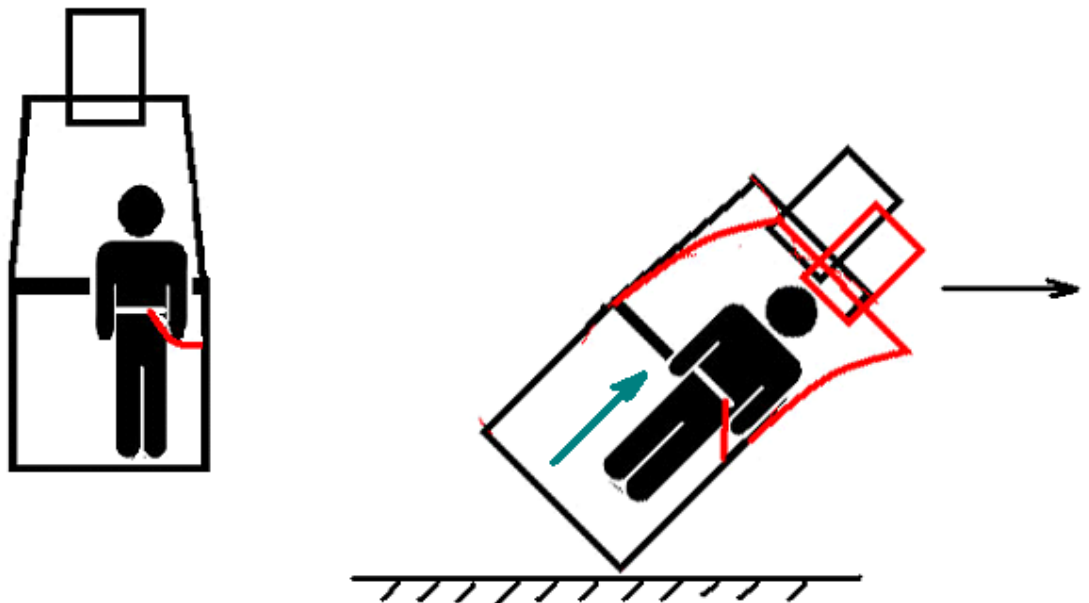
Since he was standing, he took the full blow of the impact, and it reasonable to think he banged his head to the burner frame during the rebound; the safety belt allowing a (limited) vertical movement.
