AIR ACCIDENTS INVESTIGATION
INSTITUTE OF CZECH REPUBLIC
Beranových 130
199 01 PRAHA 99

FINAL REPORT

**Investigation into an accident involving
The ground collision of a CL-600 aircraft registration mark D-ACPE
with the cab of a de-icing car at Prague/Ruzyně de-icing area
On 17 December 2010**

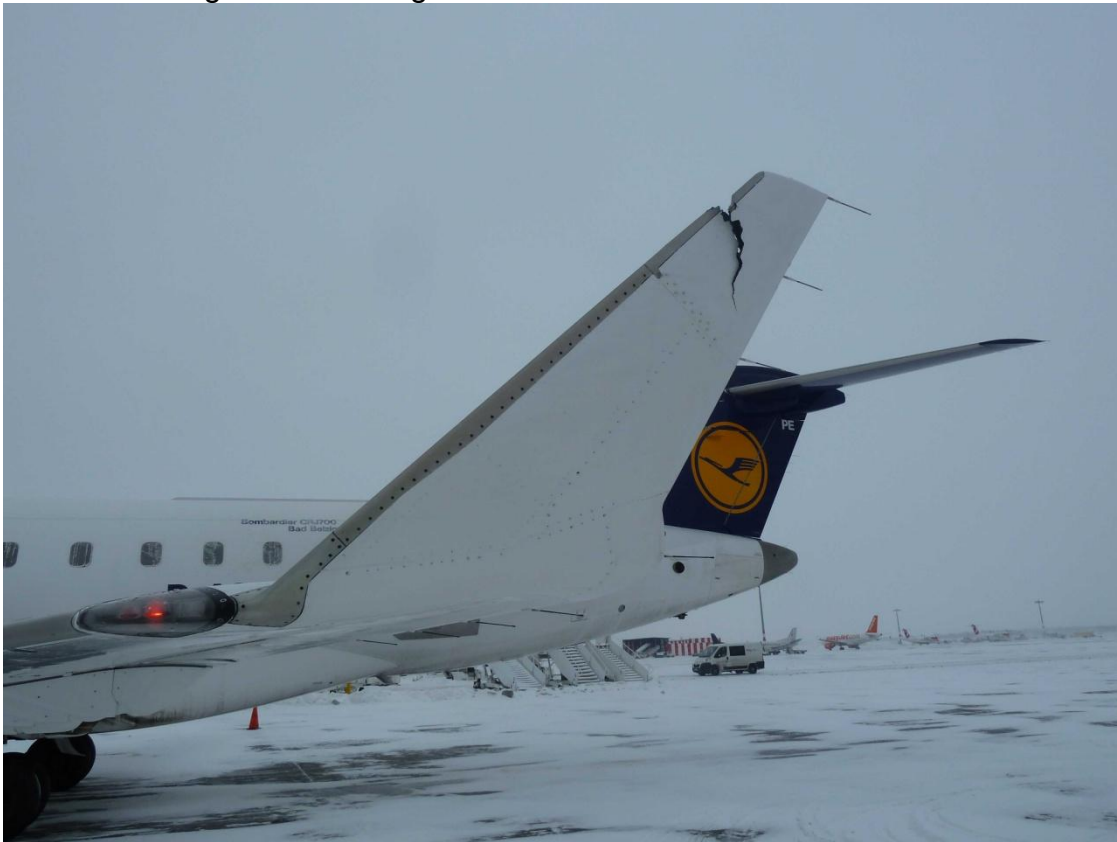
Left winglet was damaged

The accident took place in DE-ICING 3, TWY AA area.
Left winglet of the CL-600 plane was damaged by the impact.
