CZ-13-397

FINAL REPORT

**Investigation of causes of an incident
at Airport Karlovy Vary - fall of a person
from the aircraft A320, registration VQ-BRE,
on 6 August 2013**

Prague
December 2013

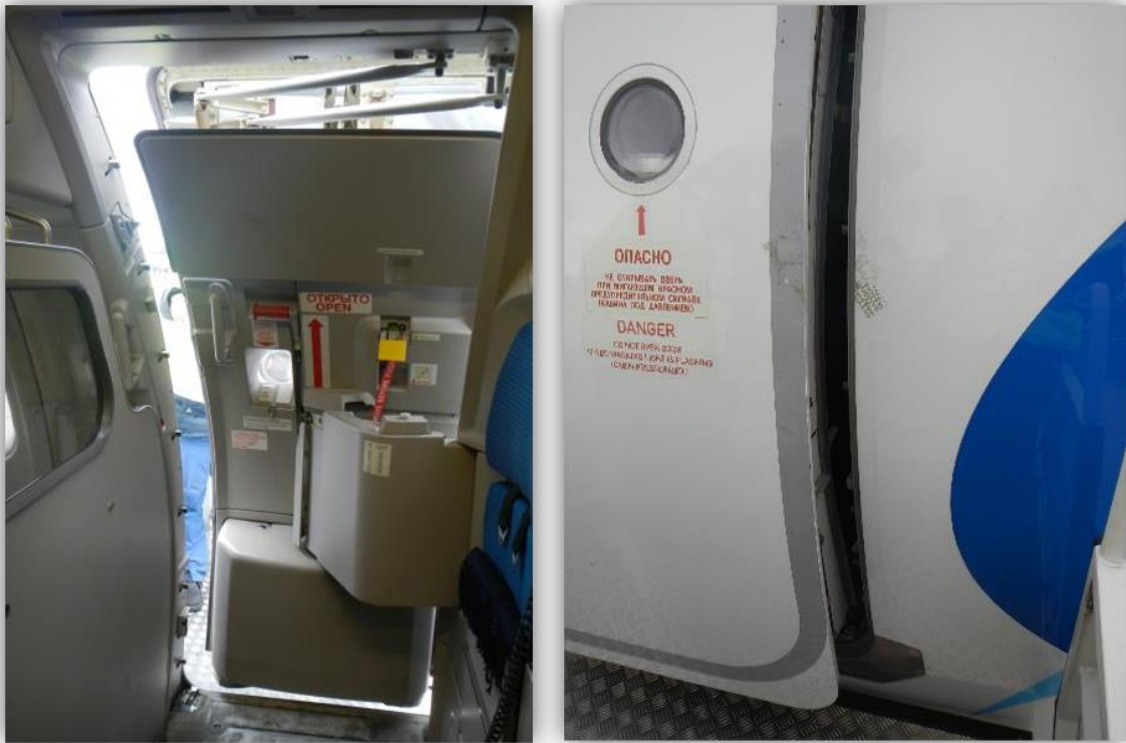
Fig. 2 The ajar front door from the cabin and from the vantage point of a person on the passenger stairs top platform

The Station Manager stepped out backwards with her head turned towards the aisle without making sure whether the stairs were in a position adjacent to the aircraft.

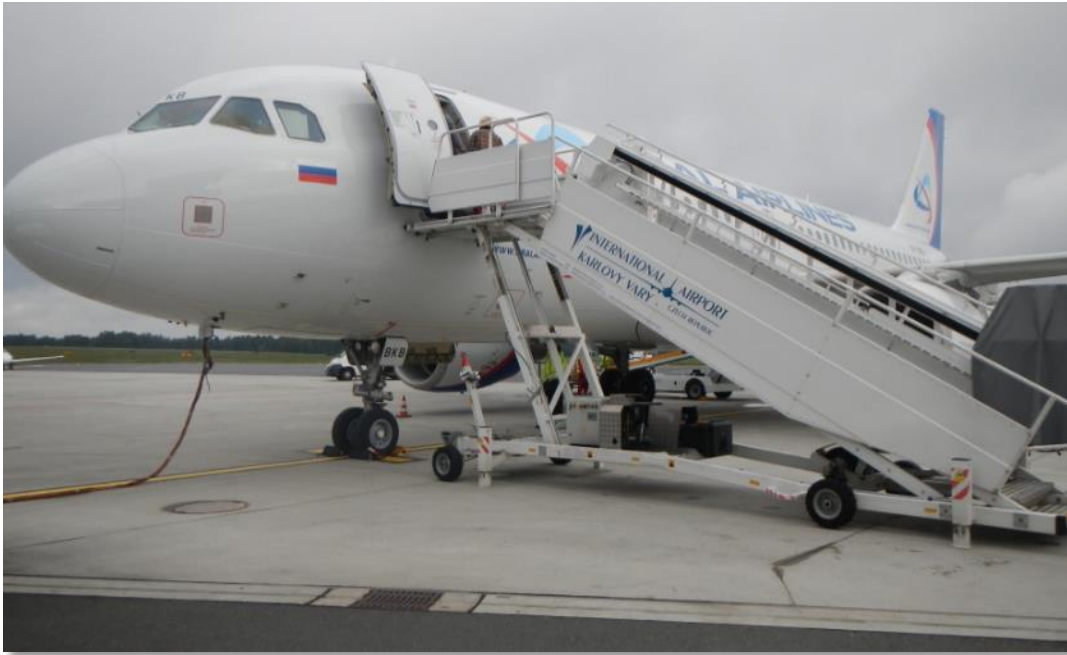
Fig. 3 Towed passenger stairs CDS 1842

The towed passenger stairs may be operated by instructed and trained personnel only. At least two staff members should operate the stairs at all times.

The general rule is that the command to detach and remove the stairs may be issued by the aircraft crew only whereas with a clearly formulated, comprehensible requirement to the handling personnel in charge of the ground operations.

The operator has not submitted any documentation specifying the RCA operation, the rules for communication with the aircraft crew and the methodological procedures for safe detachment and removal of the towed passenger stairs.
