AIR ACCIDENTS INVESTIGATION
INSTITUTE
Beranových 130
199 01 PRAHA 99

FINAL REPORT

**The investigation into an incident of COZY MARK IV,
violation of TMA II Praha,
May 10, 2006.**

**Prague
February 2007**

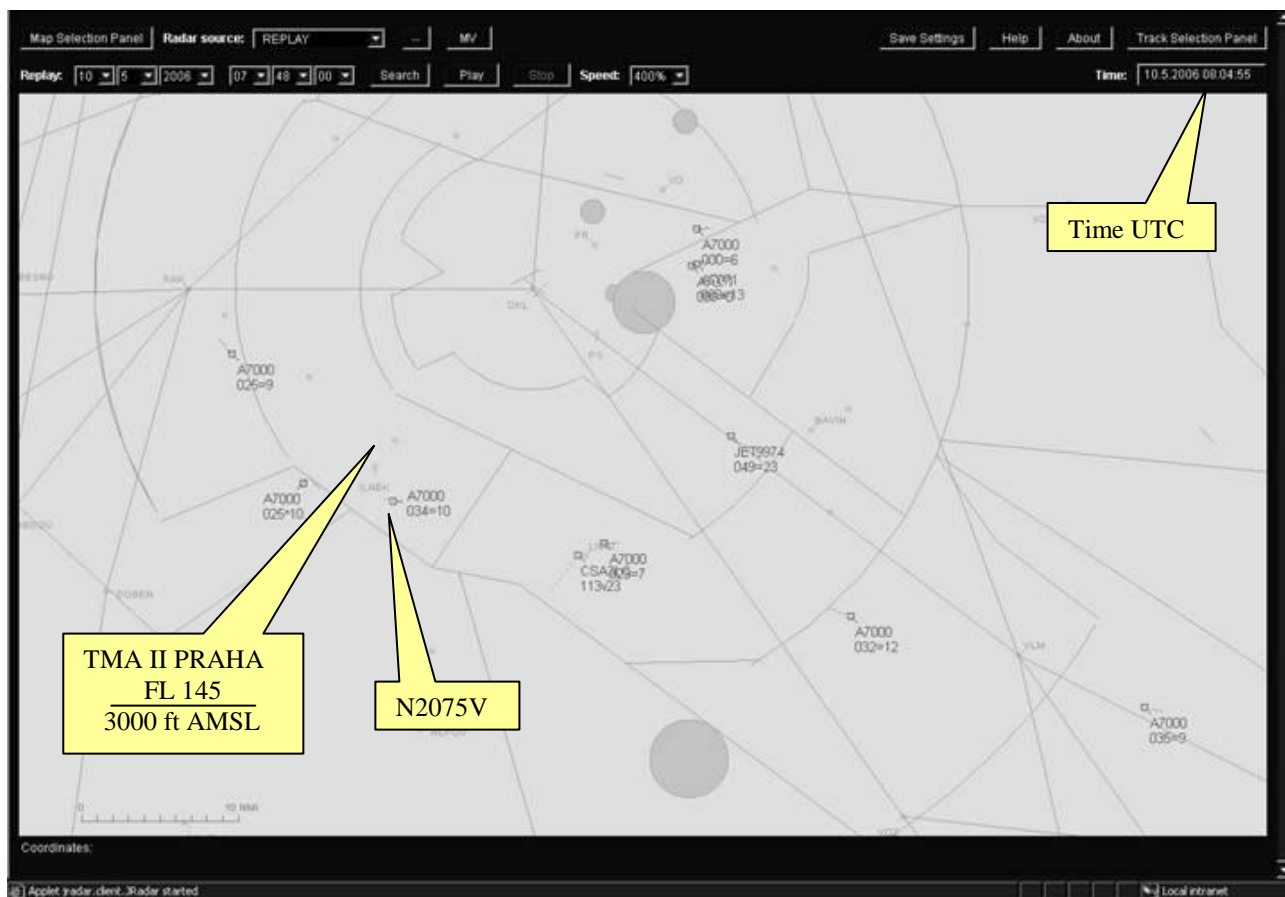
Radar record

The incident took place in the airspace TMA II PRAHA cca 5 NM S Beroun. TMA Praha is the Class C of control area. Vertical boundaries of the area are 3,000 ft AMSL and FL 145.

Radar information was interrupted due to low high of aircraft.

Timely identification of possible invasion of TMA PRAHA was blocked due to disconnected radar information for ATS.
