ÚSTAV PRO ODBORNĚ TECHNICKÉ ZJIŠŤOVÁNÍ  
PŘÍČIN LETECKÝCH NEHOD  
Beranových 130  
199 01 PRAHA 99

# **FINAL REPORT**

**The investigation of accident  
sailplane SZD-48, JANTAR-STANDARD 2,  
registration mark HA-4494,  
NE of airport Šumperk 30.4.2005**

**Praha  
September 2005**

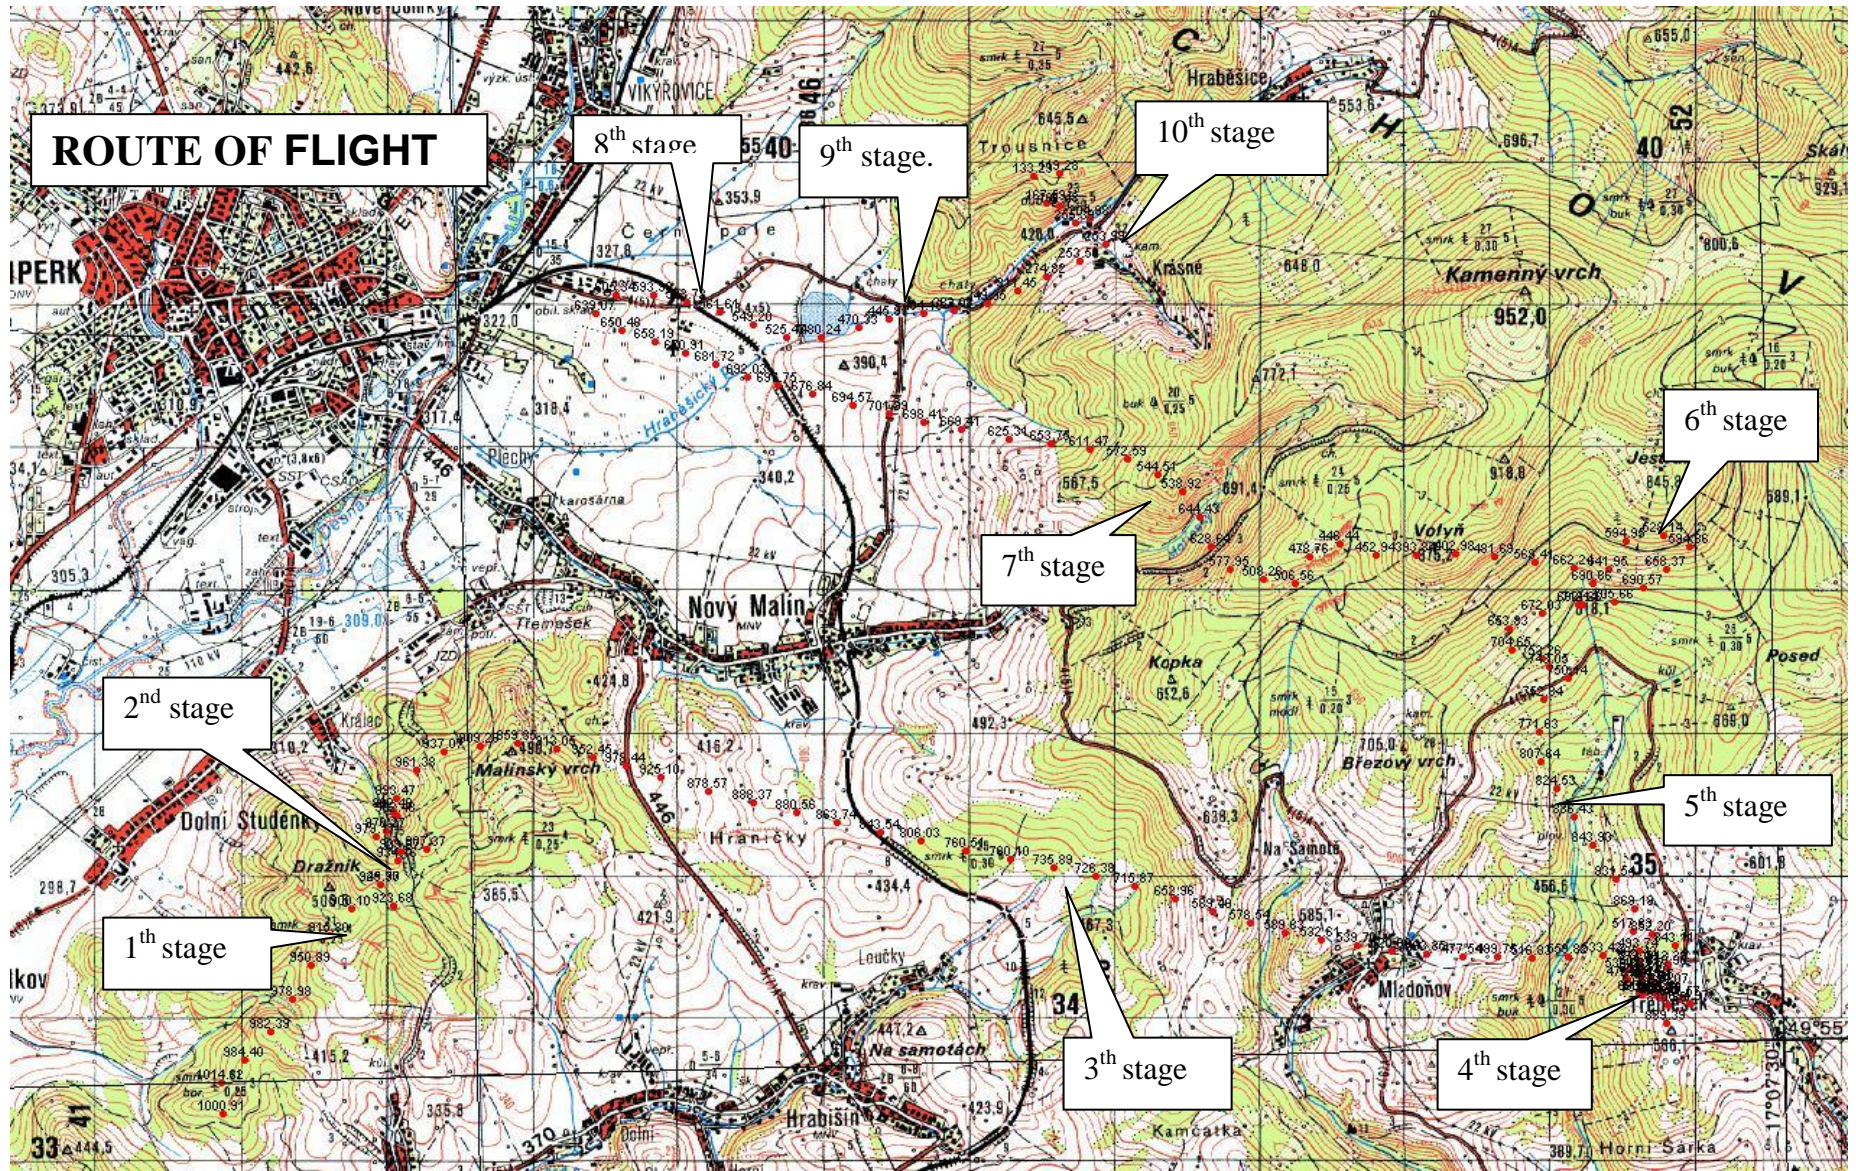
The flight time starting from GARMIN V recorder switch-on till the crash was 26 min 40 sec. This time is possible to divided as follows :

course :	329°	297°	000°	266°	156°	126°	035°
altitude [ ft ]:	2311	2251	2276	2262	2282	2303	2309
GS [kmhod <sup>-1</sup> ]:	77	81	79	65	76	86	50
AGL [ m ]:	253	204	161	119	133	167	255
