Ref. No 16/06/ZZ

FINAL REPORT

**Investigation of Incident A/C Boeing B737- 400, Registration Mark OK-YGU,
during the flight on 25th January 2006**

Prague
September 2006

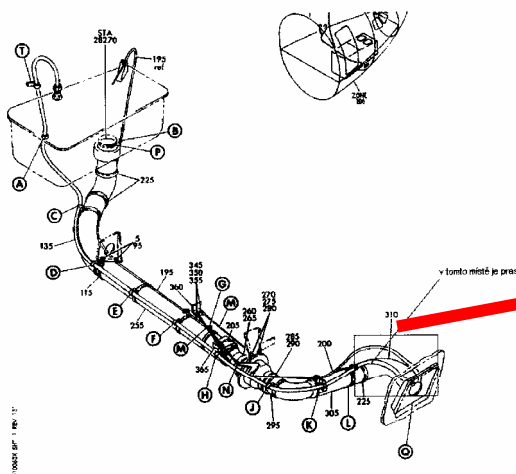
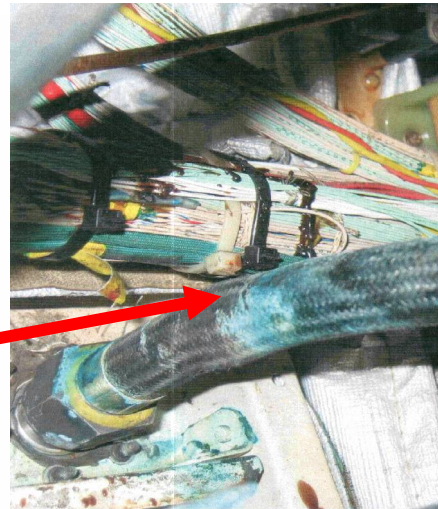
After arrival in Prague, checks revealed surface leak in the front toilet filling hose P/N 41-201-355 around 50 mm away from the filling hole screwing. Liquid leak from the hose contaminated the sound-thermal insulation of the inside front space under the front toilet. The contamination had a form of blue crystals and sediments of dried liquid. This state had probably lasted for a longer time and might have contaminated air in this space.

Zjištěna prasklá hadice plnění kapaliny do předního WC-pozice 135.

Pic No.1 Filling hose leak on front toilet tank

tanks are filled with pure water or disinfectant water solution, some liquid in the hose could have frozen due to frost after the filling liquid was disconnected. The front toilet filling adapter is not heated, so the liquid could have frozen in the filling screwing. The untightness was detected 50 mm from the filling screwing.

The primary cause of the incident was the contaminated room from which air is taken for EFIS cooling and contamination penetration into the cockpit. The contamination was caused by the leaking filling hose of the aircraft's front toilet tank. The leaking disinfection solution penetrated the insulation panels and the intensity of panel contamination depended upon the way the tank had been filled up. At the home airport, the tank was filled with pure water, so the air contamination level in the front section was low, not causing trouble to the crew. Where the tank had been filled with a disinfection solution, contamination was higher and might have had an adverse effect on more sensitive persons. Crewmembers' reaction to smell is strictly individual, depending on how one perceives aromatic stuff. The moment the leak began could not be determined exactly, it might have been a few days to one week. Considering the witnesses' statements and technical findings, the investigation commission has re-qualified the event from the serious incident to an incident for technical reasons.

- The operator will inform B737 FC and CC squadrons and technicians of this final report in full;
- The operator will inform his and contractual handling agencies of this report in full;
- The operator will take other measures of his own to enhance technical maintenance of aircraft.
