## Synopsis

On 3 July 2021, the AAI was notified by the Rescue Coordination Centre of an air accident of the above-mentioned aircraft. Having taken off from LKZA to carry out tandem parachute drops, while the aircraft was climbing, it started descending at the altitude of approx. 20 m. In this descent, the aircraft hit the ground at a small angle. The pilot sustained severe injuries. Three other persons were taken to hospital for examination and subsequent hospitalisation. One person was treated by a physician on site. The aircraft has been destroyed.

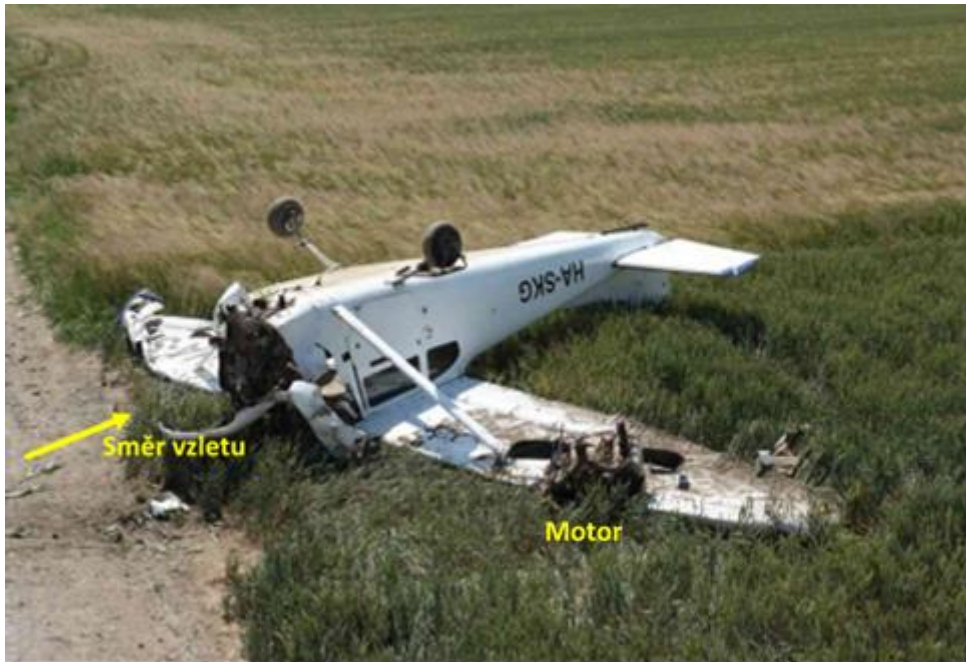
The location of the air accident was the area of the airport and a field covered with 50 cm high maize in the direction of RWY 28, approx. 33 m in front of an unpaved local road perpendicular to the direction of take-off. After the first impact on the ground, the aircraft continued to move on the ground. It overturned behind the said road and stopped. The front of the aircraft fuselage was lying on the road with the nose heading opposite to take-off direction. The final position of the aircraft was about 57 m west of RWY10 THR. Coordinates 49°55'43''N, 18°04'05''E, altitude of 241 m.

The aircraft has been completely destroyed. The overturned wreckage lying opposite to take-off direction was in one place. The engine, torn out of its bed, was found on the bottom side of the right half of the wing.

Fig. 12 – Aircraft wreckage behind an unpaved road
