## Pravidelná porada bezpečnosti letů za rok 2022

Petr Slavík, Safety Manager

# Serious Incident 2022

Sandstorm Operation Q1/2022

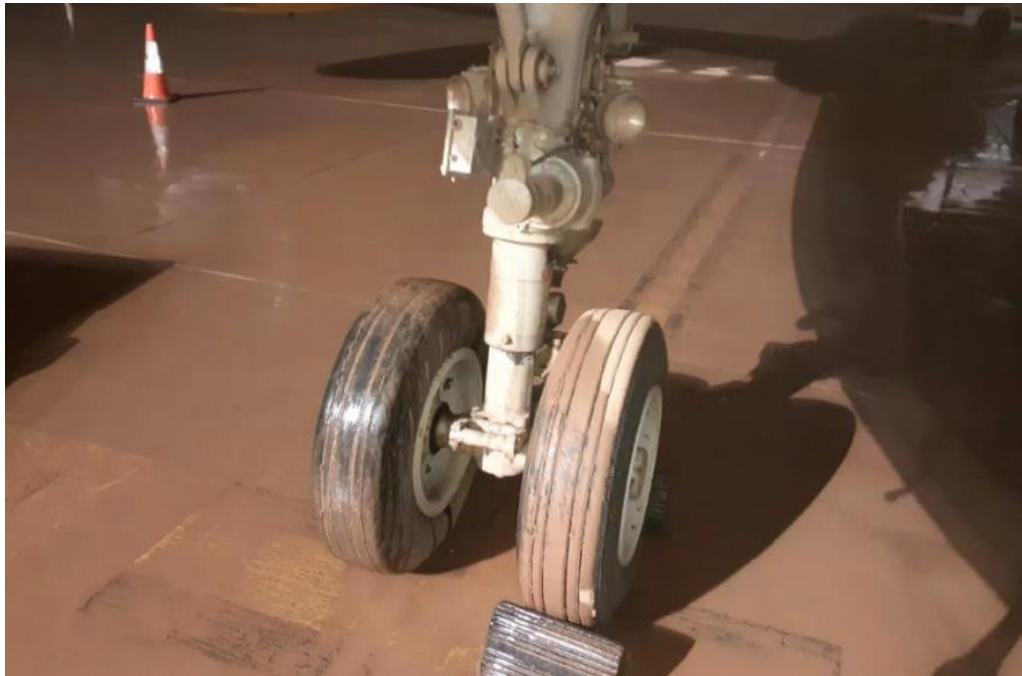
Sandstorm Operation- ost. provozovatelé: Finnair, Air France, Vueling.

- závěr:**
- změna postupů letiště Malaga na základě reportů a závěrečných zpráv zaslaných zde uvedenými provozovateli a naší společností.
  - posádka je řešena CAA

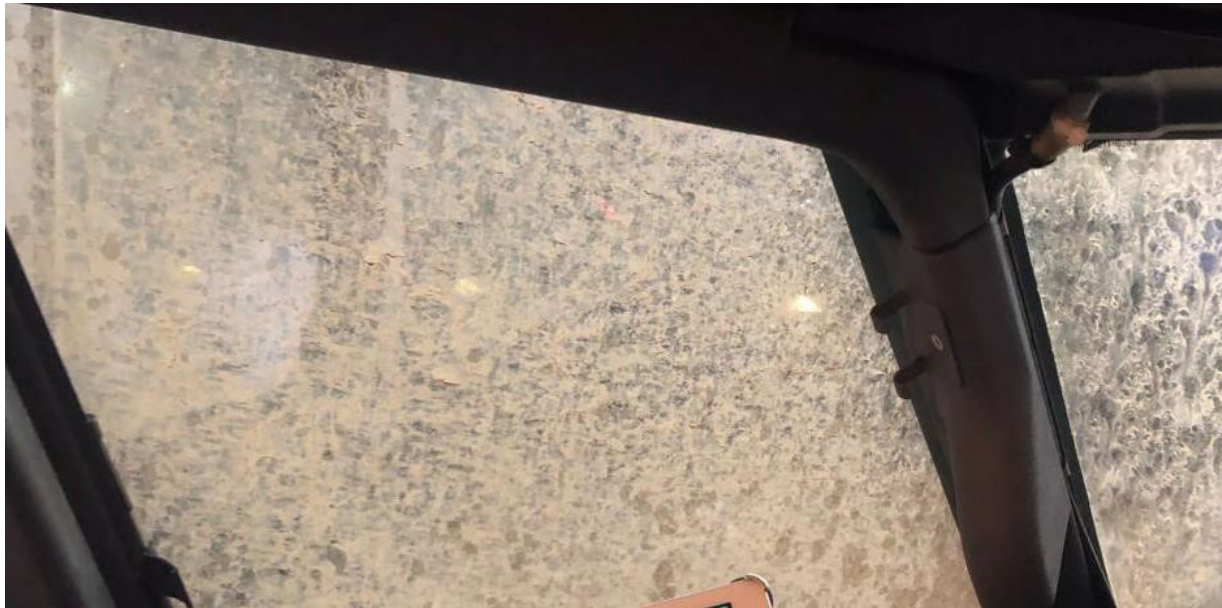
Sandstorm Operation- výhled z pilotní kabiny

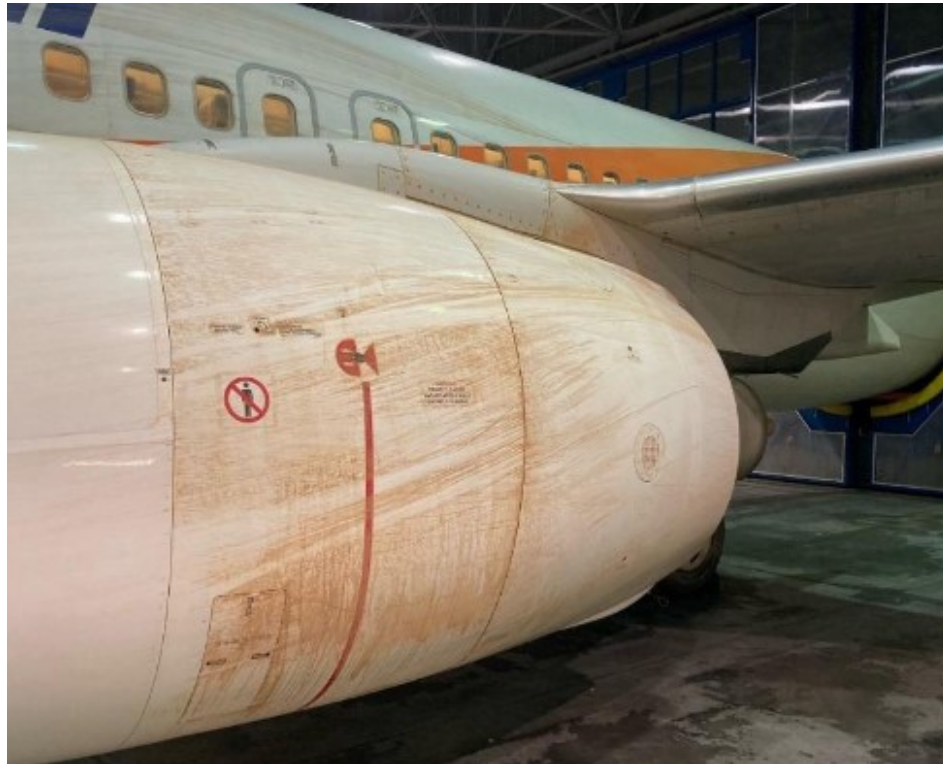
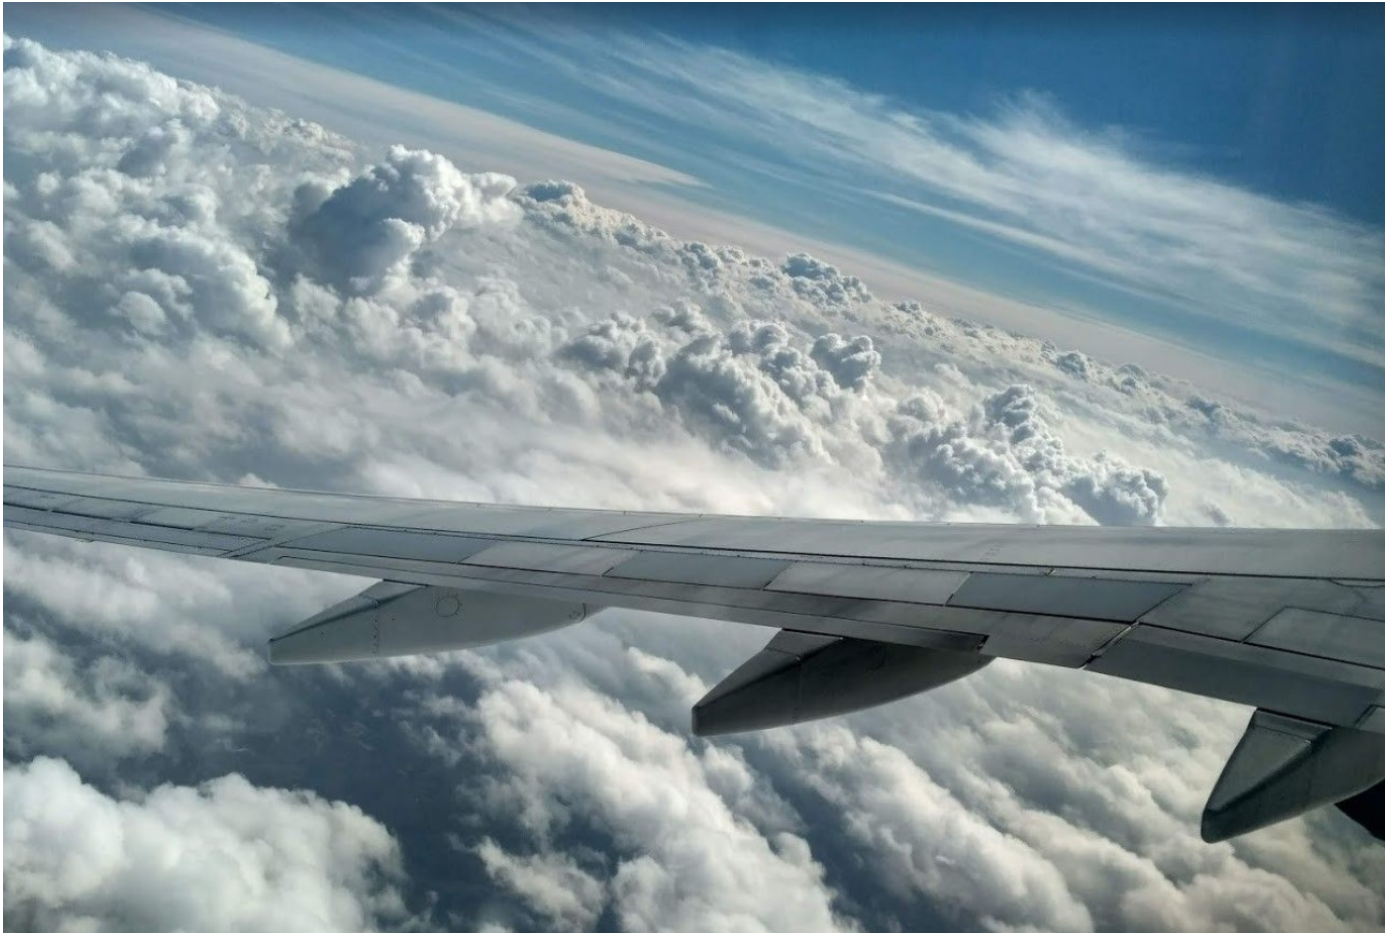
Sandstorm Operation- letoun po přistání v PRG

CAUTION: Particular care should be taken to ensure that the fuselage and all surfaces are clean after a sand storm that occurs with a rain storm.
