Investigation Report

Type of Occurrence:	Accident
Date:	14 September 2009
Location:	Near Jena-Schöngleina Airfield
Aircraft:	Airplane
Manufacturer / Model:	G. J. Vicherek, Czech Republic / Europa XS
Injuries to Persons:	Two persons fatally injured
Damage:	Aircraft destroyed
Other Damage:	Minor damage to forest
Information Source:	Investigation by BFU external experts for field investigation
State File Number:	BFU CX014-09

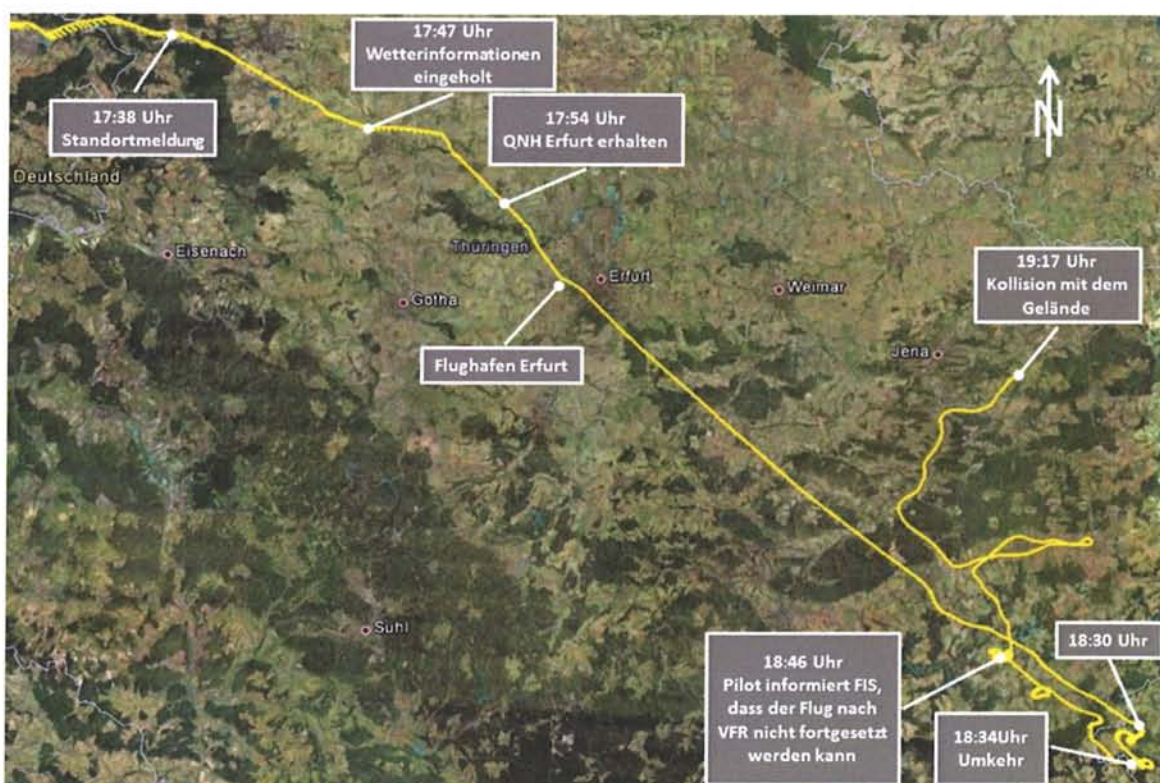
Flight path and course of events

According to the GPS recording, until 1830 hrs the airplane flew with almost constant south-east heading and constant altitude toward the destination airport.

After several changes in heading, at 18:34 hrs it was on opposite course, i.e. on a north-west track.
