FINAL REPORT

**Investigation of causes of an incident
of the R 22 Beta II helicopter,
registration mark OK-OBA
at the Podhořany aerodrome,
on 2 April 2014**

Prague
October 2014

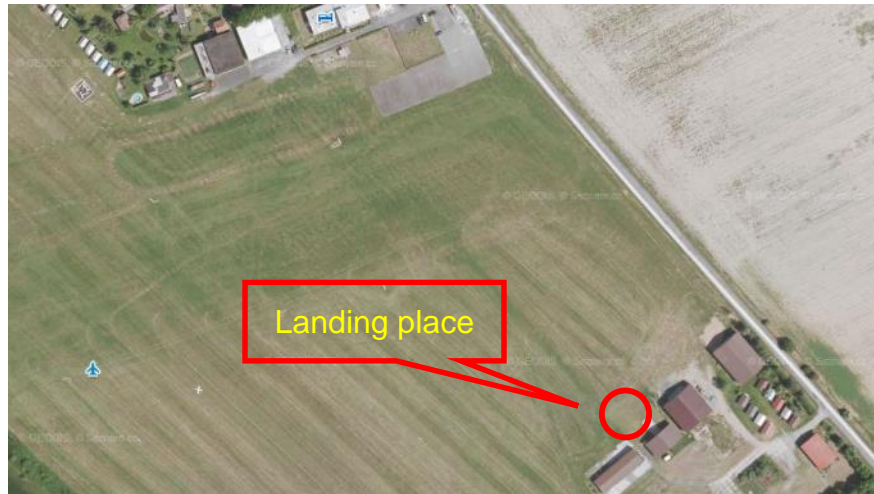
Fig. 4 Helicopter landing place.

The pilot landed on the grass manoeuvring area of the aerodrome in front of the hangar. Location coordinates were N 49° 56' 32", E 15°33' 03".
