# FINAL REPORT

## of civil aviation safety investigation

<b>CLASSIFICATION</b>	<b>Accident</b>
Owner	Romanian Air Club
Operator	Romanian Air Club
Manufacturer	Moravan, n.p., Otrokovice Czech Republic
Aircraft	ZLIN Z 142
Registration country	Romania
Registration	YR-ZCC
Location	Climceni Aerodrome
Date and time	23.08.2013 / 08:40 LT

**NR. A 16-03**  
**Date: 10.06.2016**

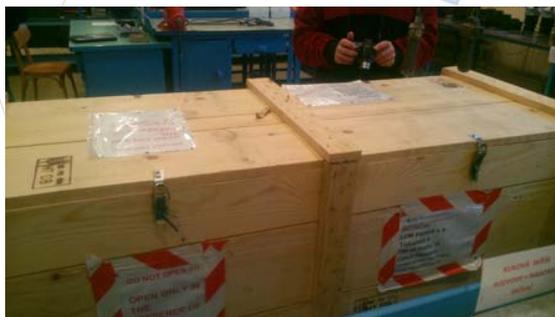
**Fig. 4 – Sealed engine box**

The box in which the engine was transported was unsealed and opened in the presence of the two representatives of investigation institutions – CIAS and AAIL. The engine was properly transported, not suffering further damage.

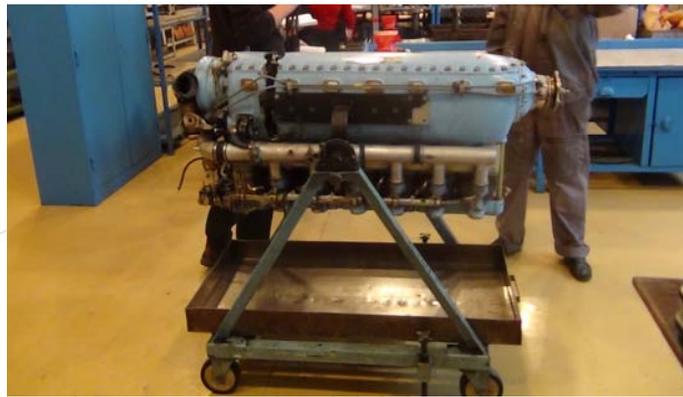
**Fig. 5 – Engine installed for expertise**

there were also the engine fastening holes to the support. Thus, there were made two holes in the engine block, in the area where it was broken, for an easier fastening of the engine support, and then it was mounted on the engine stand (see figure 5).

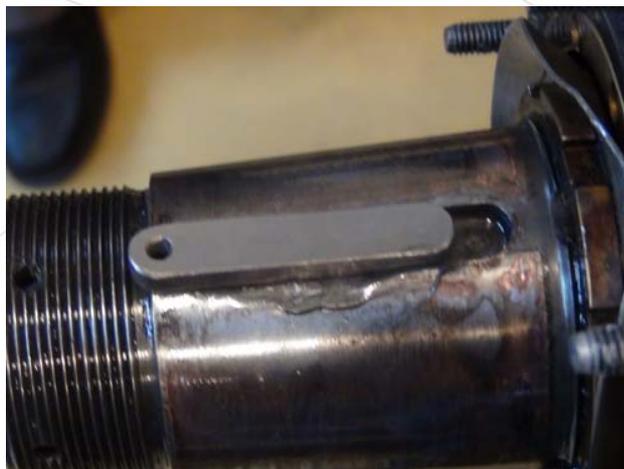
Fig. 16 – Example of undeformed latch key

While demounting the propeller flange it was noticed that it was incorrectly mounted on the conical surface of the crankshaft. The latch key was improperly installed.
