Final Report No. 2325

by the Swiss Transportation Safety Investigation Board STSB

Concerning the serious incident (near-collision)
involving the commercial aircraft Fokker 50, OO-VLF,
operated by Vlaamse Luchttransportmaatschappij N.V.
(VLM) under the flight plan call sign VLM 22TX
and the Piper PA-28RT-201T aircraft, OK-ELL,
on 21 April 2016
approximately 10 NM north-east of
Friedrichshafen airport (EDNY), Germany

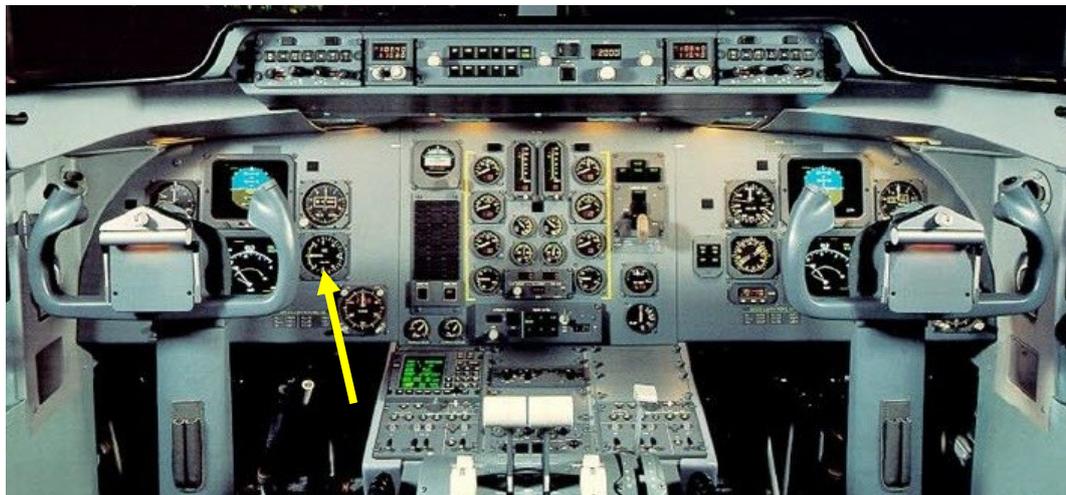
Figure 2: Flight deck of a Fokker 50. The yellow arrow shows the installation location of the commander's variometer. The copilot's instrument is concealed by the right control column.

The information of the traffic alert and collision avoidance system are presented on an integrated vertical speed indicator (IVSI), found in place of the existing VSI, to the right of the commander's and copilot's navigation displays (ND) (cf. figure 2).

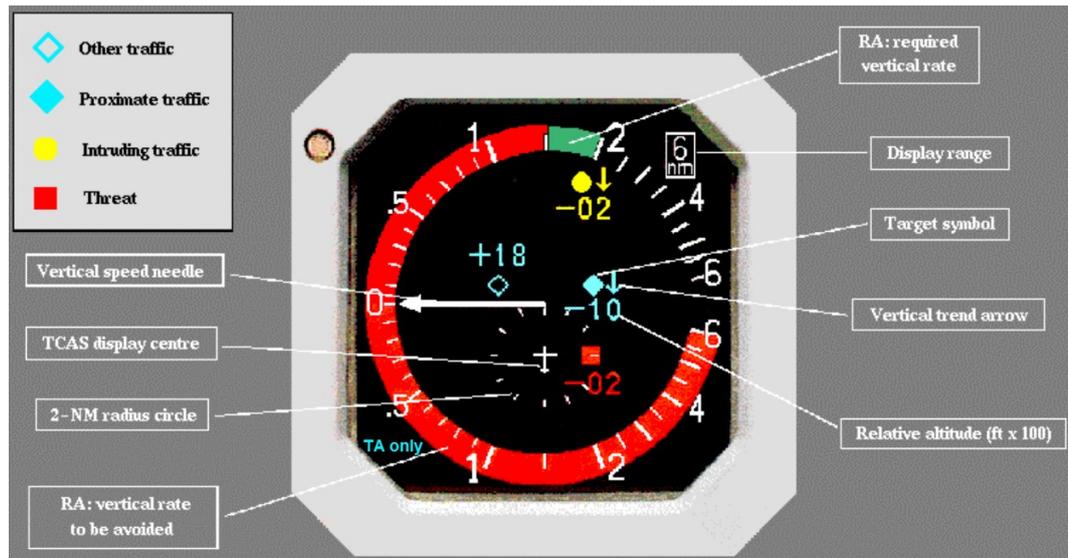
Figure 3: Illustration of the working principle of an integrated vertical speed indicator with a display function for the traffic alert and collision avoidance system. The relative altitudes of the other aircraft equipped with a transponder transmitting altitude data are indicated in hundreds of feet. The „TA only“ (blue) message appears in the lower left corner of the instrument display if the TCAS is in the mode „traffic advisories (TA) only“.

If a resolution advisory (RA) is triggered on board a Fokker 50, the flight crew must change the attitude of the aircraft to such an extent that the resulting vertical speed indicated by the variometer remains in the green band. In the example shown in Figure 3, a rate of climb of 1500 to 2000 ft/min is required.

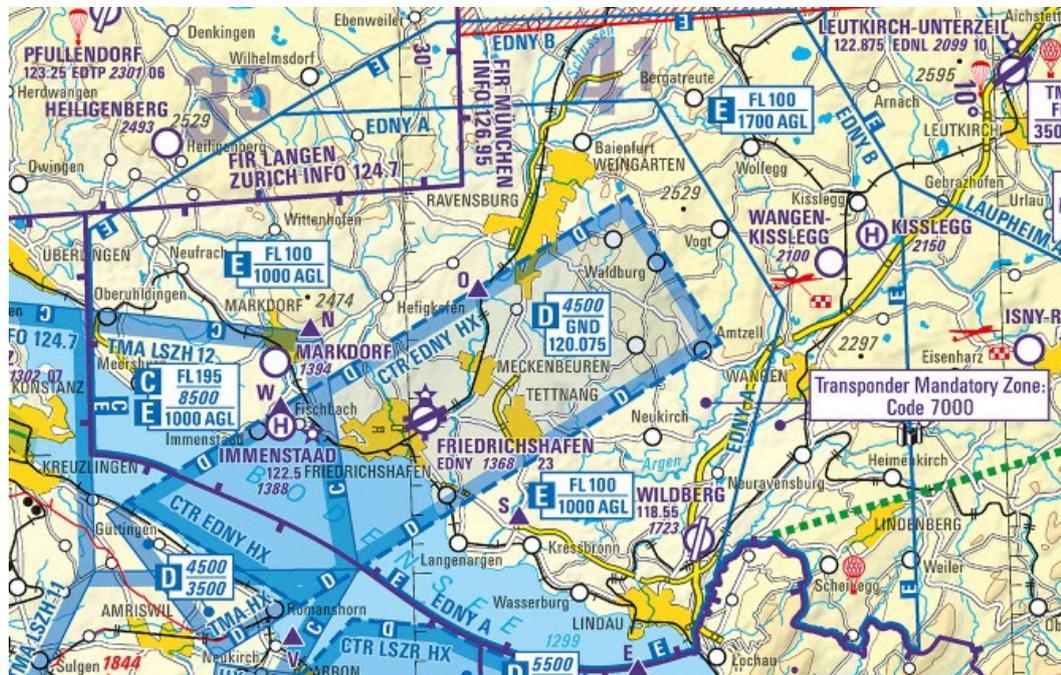
Furthermore, there are two transponder mandatory zones (TMZ) classified as class E (cf. figure 4):

Figure 4: Aeronautical map of Switzerland and Liechtenstein of 31 March 2016 with the two transponder mandatory zones (TMZ) EDNY A and EDNY B, source: Swiss federal office of topography (Swisstopo)

Both transponder mandatory zones (TMZ) (cf. figure 4) around Friedrichshafen Airport not only make VFR traffic visible to the air traffic control units equipped with a radar, they also lay the foundation for the safety net of the airborne collision avoidance system (ACAS) relying on the transponder signal.

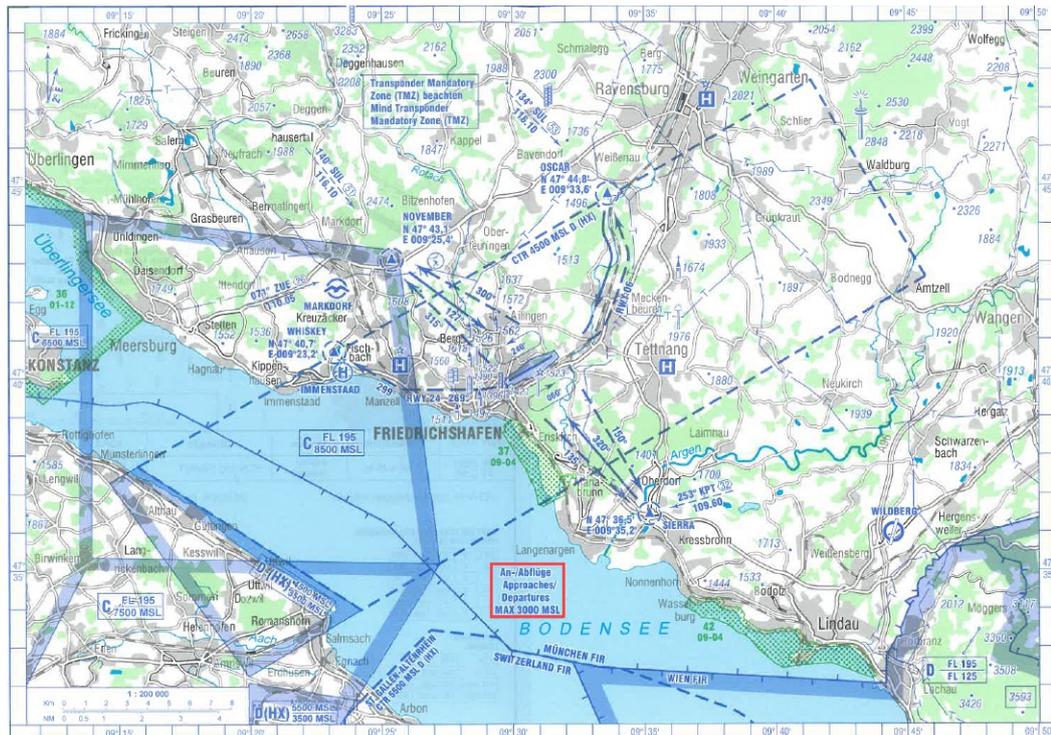
The visual approach chart for Friedrichshafen Airport, as published in the aeronautical information publication (AIP) for Germany, contains defined flight routes over the VFR reporting points OSCAR, NOVEMBER, WHISKEY and SIERRA. Also, a maximum flight altitude of 3000 ft AMSL is prescribed for arrival and departure (cf. figure 6). The arrival and departure routes over the reporting points NOVEMBER and SIERRA are almost perpendicular to the runway axis.

Figure 6: Visual approach chart for the airport of Friedrichshafen as per the aeronautical information publication (AIP) for Germany with a maximum flight altitude of 3000 ft AMSL for arrivals and departures (red frame)

Concentrating the VFR traffic over and across the runway, via the VFR waypoints NOVEMBER and SIERRA for the approach and departure during normal operation, allows for a geographical segregation from the IFR traffic on both runways 06 and 24 (cf. figure 6). Likewise, the VFR traffic in close proximity to the CTR is separated from the IFR traffic by the altitude limit of 3000 ft AMSL during arrival and departure, as the latter intercepts the glide slope of the ILS at 4000 ft AMSL.
