**ACCIDENT**

<b>Aircraft Type and Registration:</b>	HPH Glasflugel 304 eS, G-GSGS	
<b>No &amp; Type of Engines:</b>	1 LZ Design D.O.O FES-HPH-M100 brushless electric motor	
<b>Year of Manufacture:</b>	2016 (Serial no: 059-MS)	
<b>Date &amp; Time (UTC):</b>	10 August 2017 at 1121 hrs	
<b>Location:</b>	Parham Airfield, West Sussex	
<b>Type of Flight:</b>	Private	
<b>Persons on Board:</b>	Crew - 1	Passengers - None
<b>Injuries:</b>	Crew - None	Passengers - N/A
<b>Nature of Damage:</b>	Fire damage to FES <sup>1</sup> batteries and FES battery compartment	
<b>Commander's Licence:</b>	British Gliding Association Gliding Certificate	
<b>Commander's Age:</b>	55 years	
<b>Commander's Flying Experience:</b>	314 hours (of which 25 were on type) Last 90 days - 9 hours Last 28 days - 7 hours	
<b>Information Source:</b>	AAIB Field Investigation

**Synopsis**

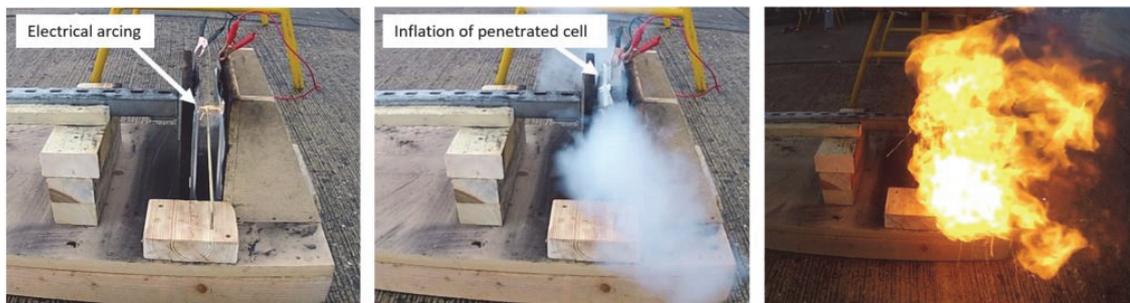
**Figure 12**

In order to create an internal short circuit within a battery cell under controlled conditions, the AAIB conducted a series of tests in which fully charged cells were penetrated with a 2.0 mm diameter steel nail. The nail, which was ground to a sharp point at both ends, was positioned between two cells and the cells were then moved together until the nail penetrated the cells. The testing showed that the nail initially penetrated only one of the cells and that shortly after cell penetration occurred, electrical arcing took place with ejection of sparks from the penetrated cell pouch due to the internal short circuit of that cell's electrode (Figure 12).

The electrical arcing was immediately followed by rapid inflation of the cell pouch and the ejection of light grey smoke, followed shortly by flames. The fire continued for approximately two minutes until the gel electrolyte polymer, which was the main fuel source involved in the fire, was fully consumed.

Electrical arcing following cell penetration

Examination of the steel nail after the tests showed that it had melted in the initial electrical arcing event, indicating that the temperature generated during the arcing was in excess of 1,400°C. The cell electrodes at the penetration site had a hole of larger size than the nail diameter, the edges of which were formed from solidified molten electrode material, consistent with the melting of the electrodes during the arcing event. The remaining copper and aluminium electrodes were relatively intact, demonstrating that the temperature reached during the combustion of the cell's gel electrolyte was relatively cool compared to the electrical arcing temperature. A pattern of combustion 'beachmarks' originating at the nail penetration site was observed (Figure 13) these were similar to those observed in the fire-damaged battery from G-GSGS.

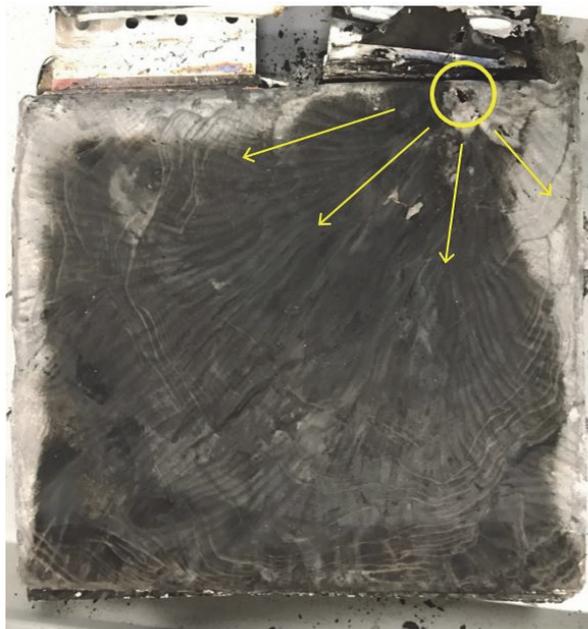
**Figure 13**

Combustion beachmarks from AAIB cell penetration tests
