# FINAL REPORT

**Investigation of causes of an air accident  
of the Cessna 421B aircraft, ID mark OK-TKF,  
on 26 September 2017 approx. 1.5 km NE of Noviny pod Ralskem**

Prague  
January 2019

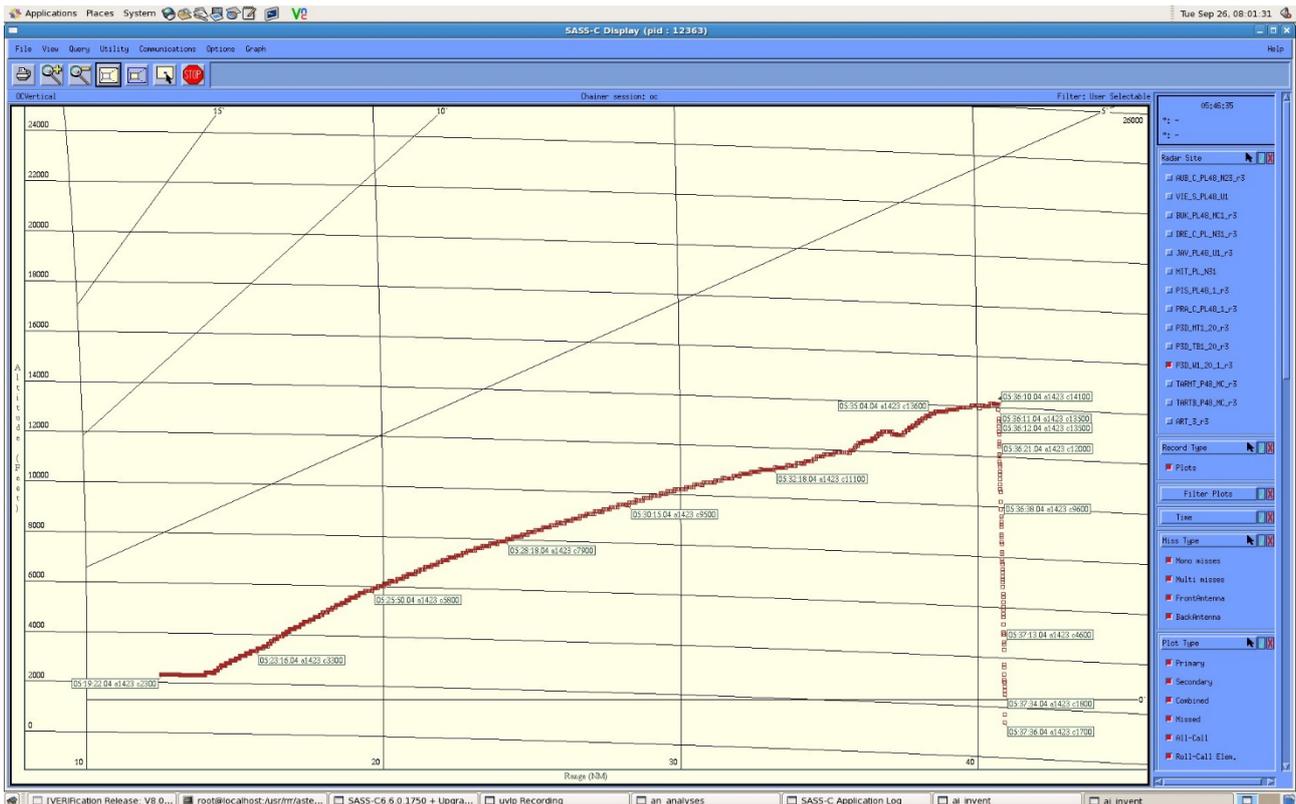
Fig. 3: Flight altitude profile

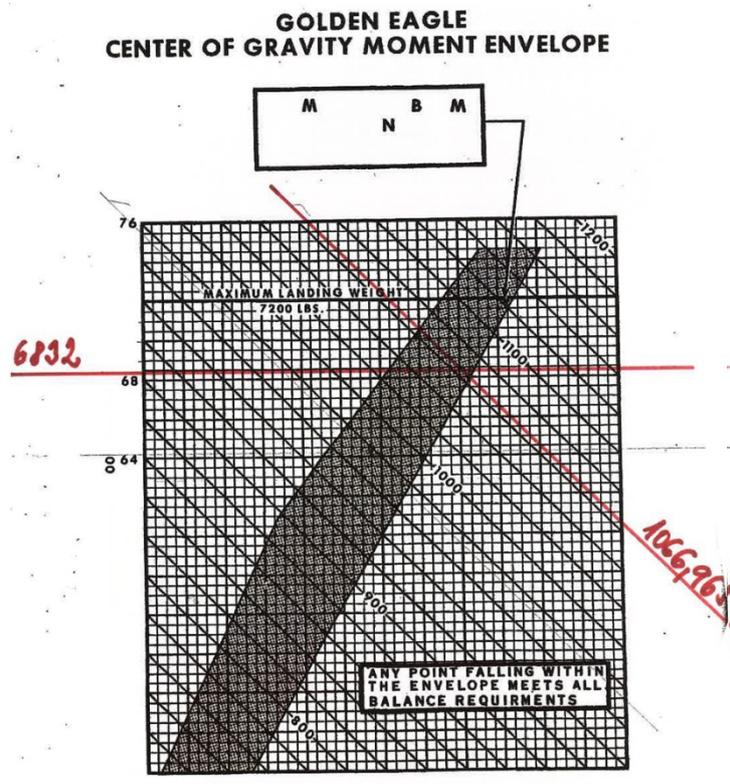
The total aircraft weight of 6,832 lb at take-off was below MTOW. (MTOW 7,200 lb). Balance, actual moment 1,066.955. When recorded in a diagram, the centre-of-gravity position is located close to the rear centre-of-gravity position. The centre-of-gravity position was standard and compliant.

Fig. 5: Centre-of-gravity position diagram

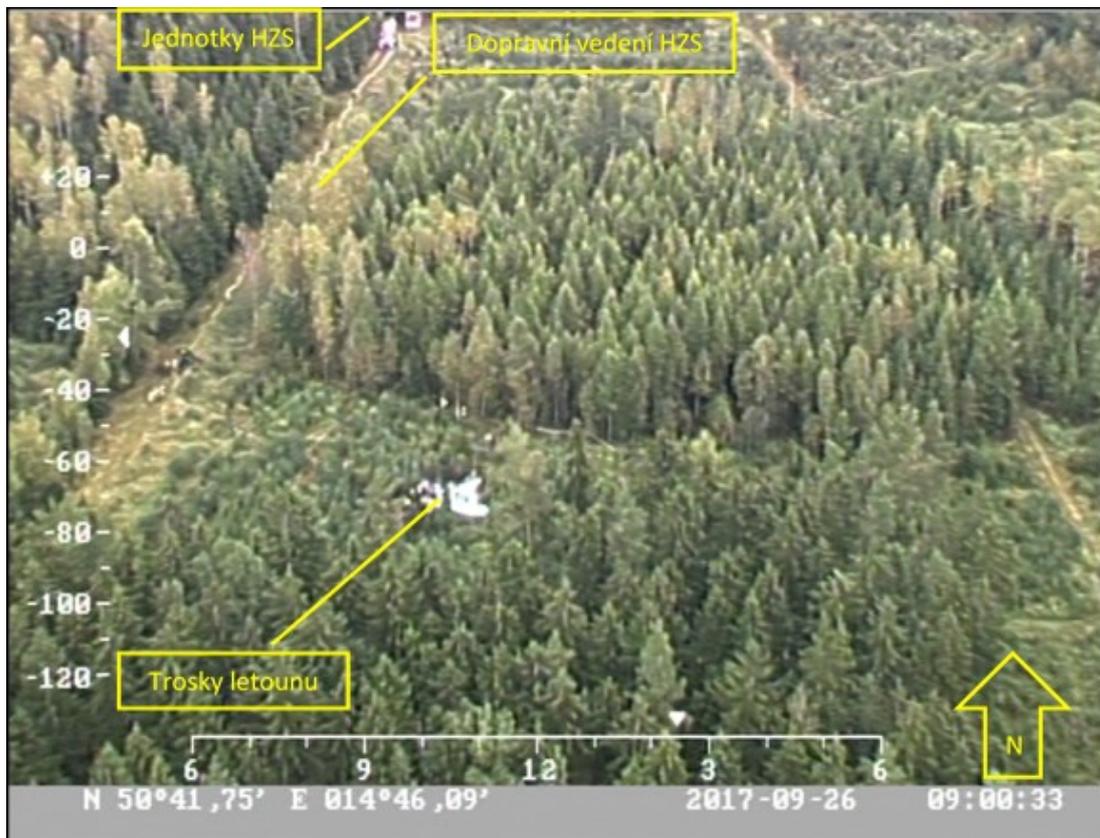
Fig. 10: Air accident site surroundings, Trosky letounu – Wrecks of ACFT  
 Jednotky HZS – FRS Units, Dopravní vedení HZS – Transport line of FRS

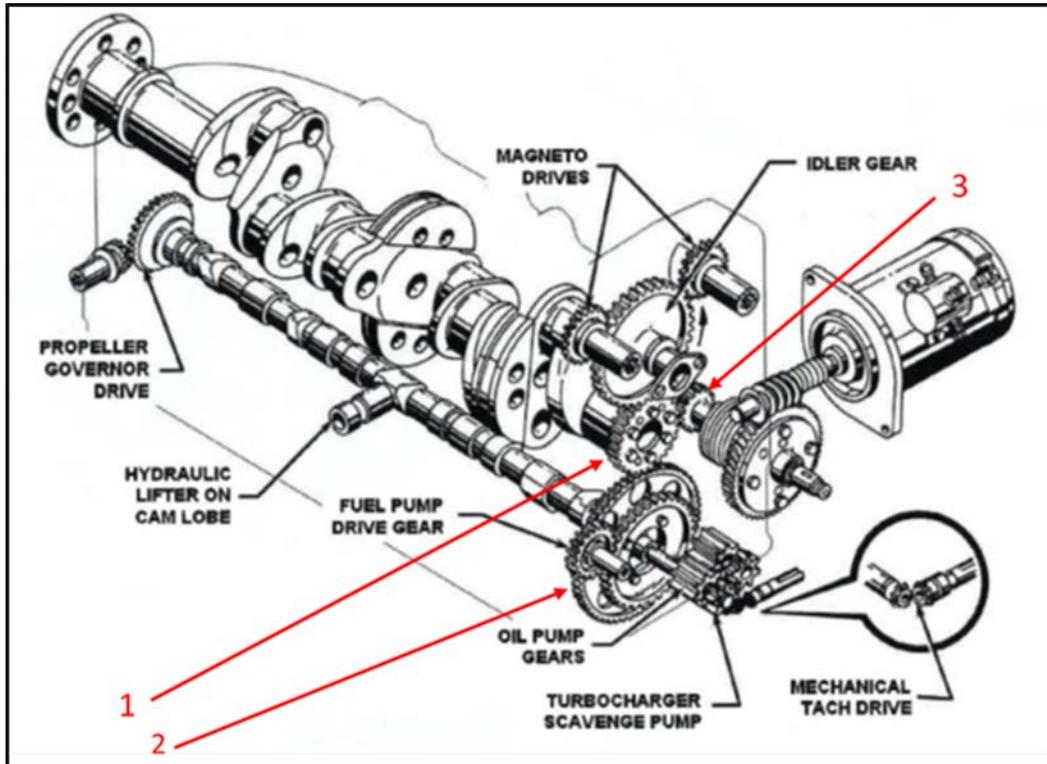
Fig. 3.1: Diagram of engine train of gears

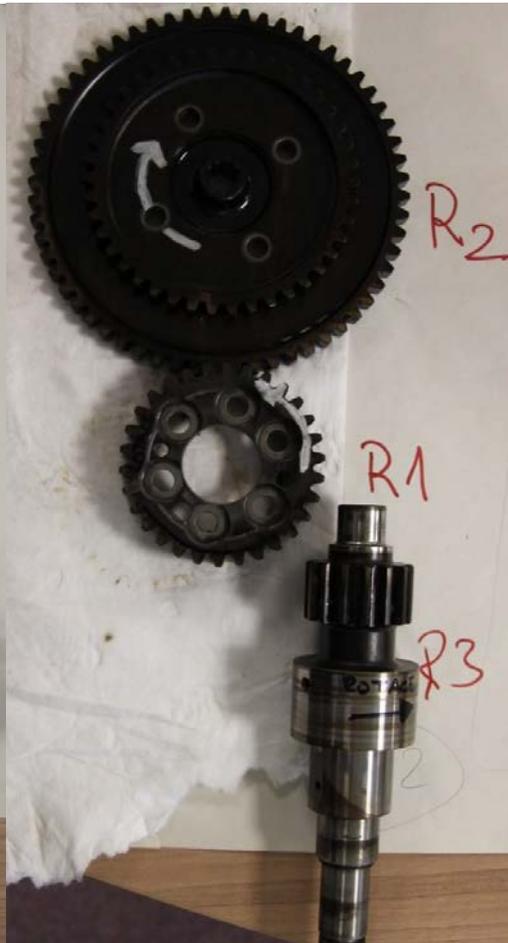
In the like manner for the right engine SN 817543-R, WO E34/2017 (see Fig. 3.3) markings R1 – crankshaft drive gear, R2 – camshaft driven gear, R3 – starter pinion were used.

Fig. 3.3: Right engine teeth
