AIR ACCIDENTS
INVESTIGATION INSTITUTE
Beranových 130
199 01 PRAGUE 99

CZ-18-0679

FINAL REPORT

**Investigation of causes of a serious incident
of Boeing B737-800 aircraft,
identification mark N624XA
at LKPD
on 1 August 2018**

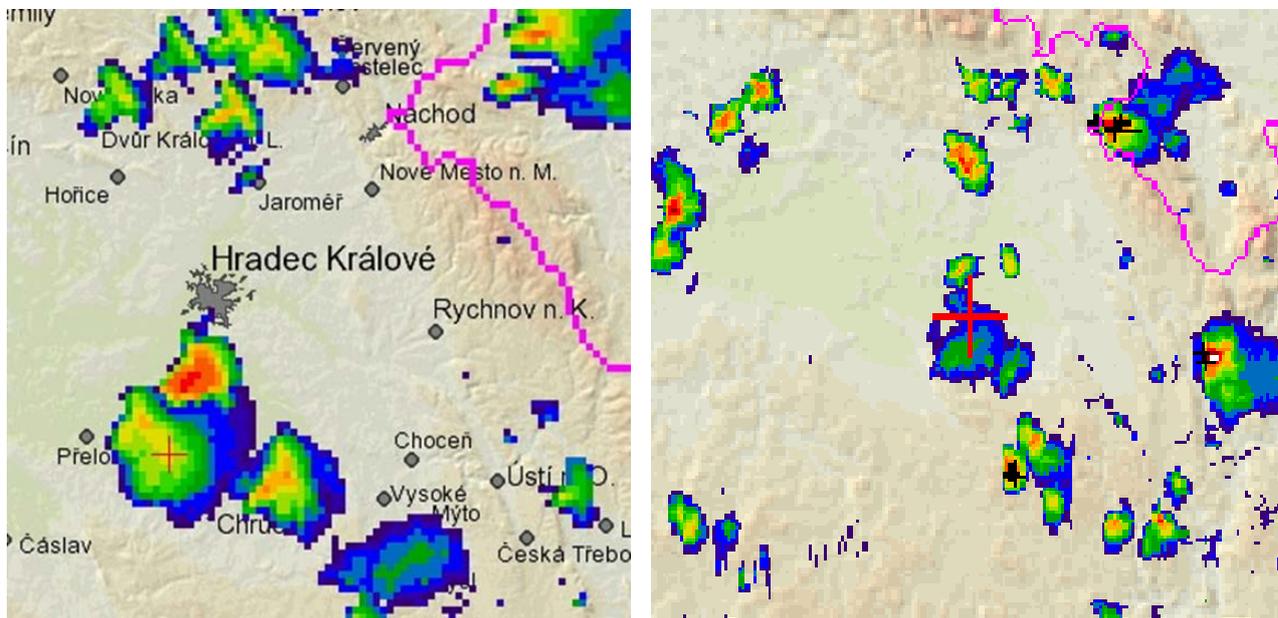
Figure 3 Radar image

The left part of Fig. 3 from 1 August 2018 15:30 shows the distribution of reflections corresponding to shower and storm cloud cover near Pardubice from 15:05 to 15:45, when a thunderstorm was recorded above LKPD (see the red cross for the LKPD location). The radar image in the right part of Fig. 3 shows the cloud cover at 16:10.

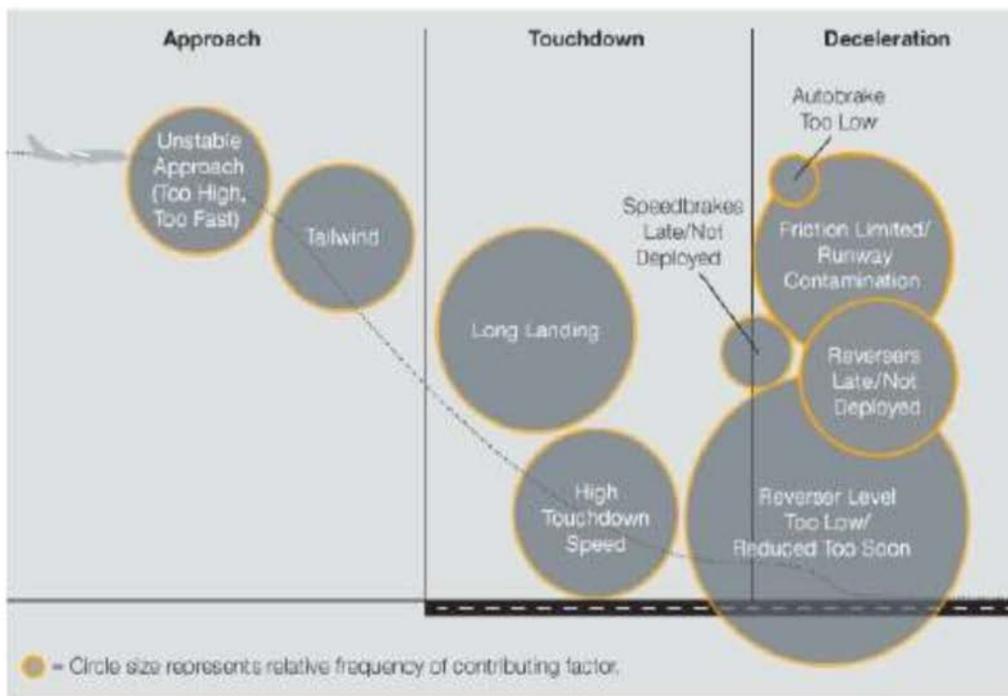
Figure 12 Go-Around, Float, Causes of Runway Overruns

If the flare is too abrupt and thrust is excessive near touchdown, the airplane tends to float in ground effect. Do not allow the airplane to float or attempt to hold it off. Fly the airplane onto the runway at the desired touchdown point and at the desired airspeed. If you are floating, slightly release the back pressure on the stick and it should touch down.

A stabilized approach terminating with a landing in the TDZ, timely deployment of airplane deceleration devices, and braking technique are critical elements to mitigating the landing runway-overrun risk. It is the pilot's responsibility to apply the landing assessment process, exercise conservative aeronautical decision-making (ADM), be proficient in the landing techniques for the conditions to be encountered, and that a go-around or diversion are mitigations to prevent a runway overrun.

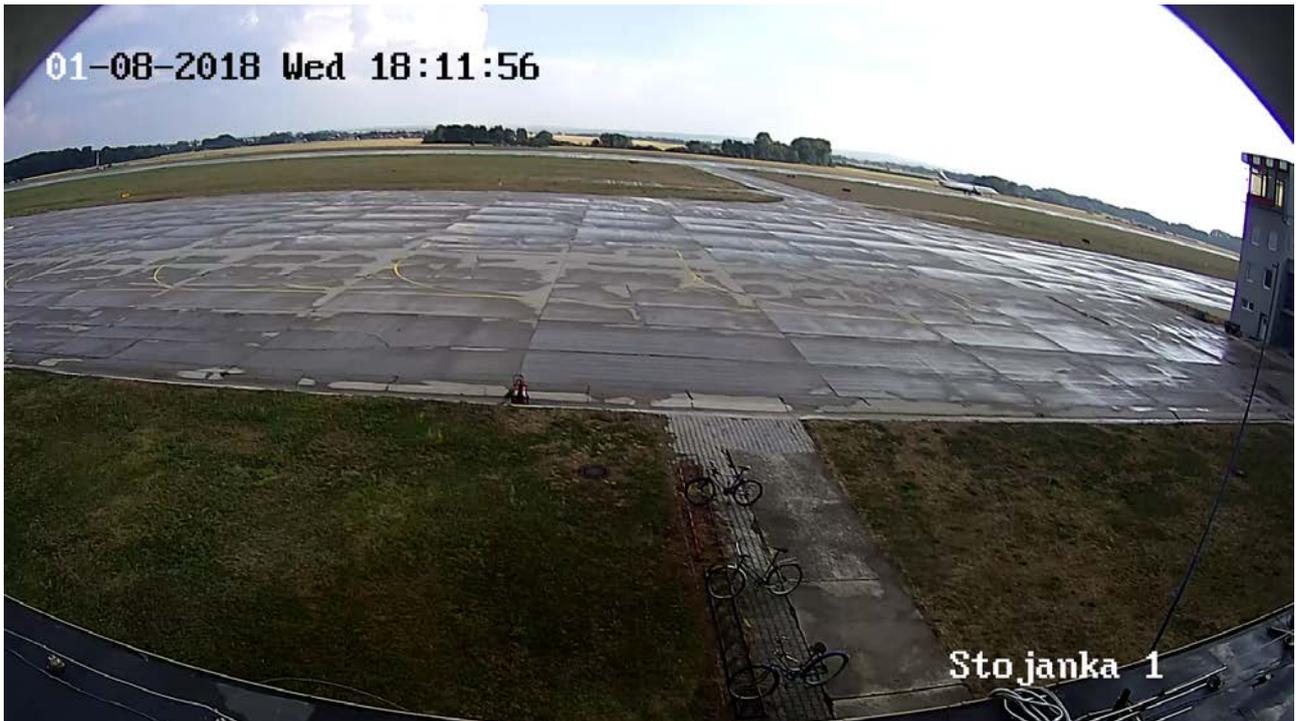
Figure 16 Over-the-stand view of the B 737 1 sec prior to touchdown on RWY
