AIR ACCIDENTS
INVESTIGATION INSTITUTE
Beranových 130
199 01 PRAGUE 99

CZ-19-0144

FINAL REPORT

**Investigation of causes of an accident
helicopter ENSTROM 480 B
registration mark OK-CLV
on the field near Blažkov,
on 22 March 2019**

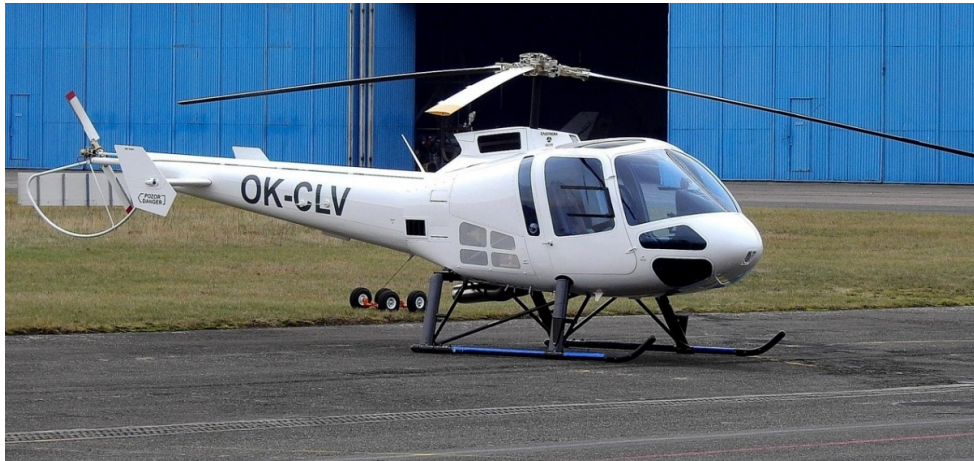
Fig. 4 – Crashed Enstrom 480 B helicopter, identification mark OK-CLV.

The considerably deformed and burnt helicopter fuselage was lying upside down with its nose pointing north-east. The helicopter frame was damaged by the forces generated by the helicopter impact at a sharp angle in the upside flying position with simultaneous forward movement. Subsequently, the fuselage was destroyed by fuel explosion and fire (JET A1 kerosene) which splashed out from fuel tanks upon the crash on the ground. Various significant construction elements disintegrated from the helicopter fuselage upon the crash on the ground were located both in the close proximity and in the surrounding area of the wreckage. Upon the first contact of the main rotor, one of the three blades (T2) was separated and found approx. 48 m north of the wreckage. The left stabiliser was found north

During the impact, primarily the pilot cabin was destroyed. Majority of the glass areas in the cabin, except for a few larger pieces in the overhead windows, were found scattered in the helicopter surroundings at the impact site. The frames of the chin windows were loosened from the front lower part of the cabin. The front part was made of laminate shell that was destroyed by the impact and only fragments of the fibreglass cloth and the landing headlight remained from the whole structure. Fragments of the lower parts of the cabin frame in the door area were preserved. Both the doors were found in the vicinity of the helicopter. The windows were missing from the doors. The doors were seriously damaged by fire. The right door was severely devastated by the fire. The handle and lock were missing from this door. Only the fibreglass cloth was remaining in greater part of this door. Two securing pins were preserved. Both of the pins were in the extended position confirming that at the moment of impact the door was closed. The left door was found on the right side of the helicopter in the distance of approx. 1.8 m. An unharmed pneumatic brace was fixed to it, in an extended position. The condition of the said pneumatic brace showed that at the time of impact this brace was in retracted position. The door was closed. The closed position of the door was confirmed also by the control lever position, the lock position, as well as the extended position of the securing pins. Due to intensity of fire, only the parts with hinges remained preserved.

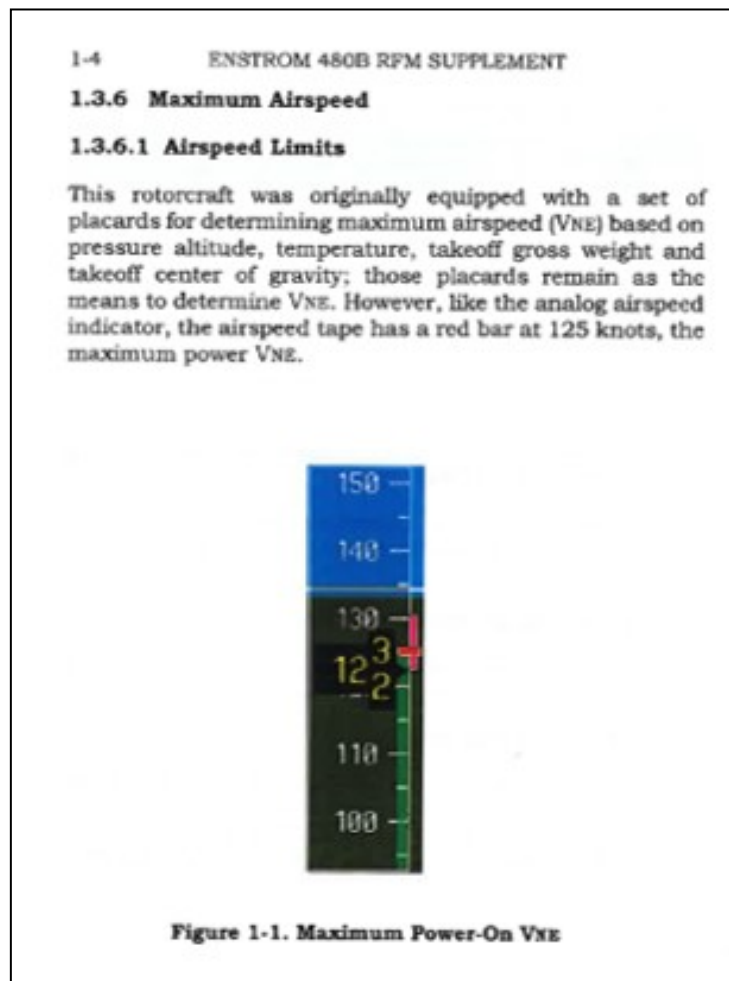
Fig. 14 – Scan of the Flight Manual, p. 1–4. Electronic speed indicator with the fixed index V_{NE}

Although the helicopter is equipped with *glasscockpit* Garmin G 1000H, the indication of V_{NE} is the same as for the analogue speedometer, i.e. by fixed marking with a red bar at 125 KIAS
